Experiences of remote maintenance for the mercury target system for the pulsed neutron source

Neutron Source Section, MLF Division

J-PARC / JAEA

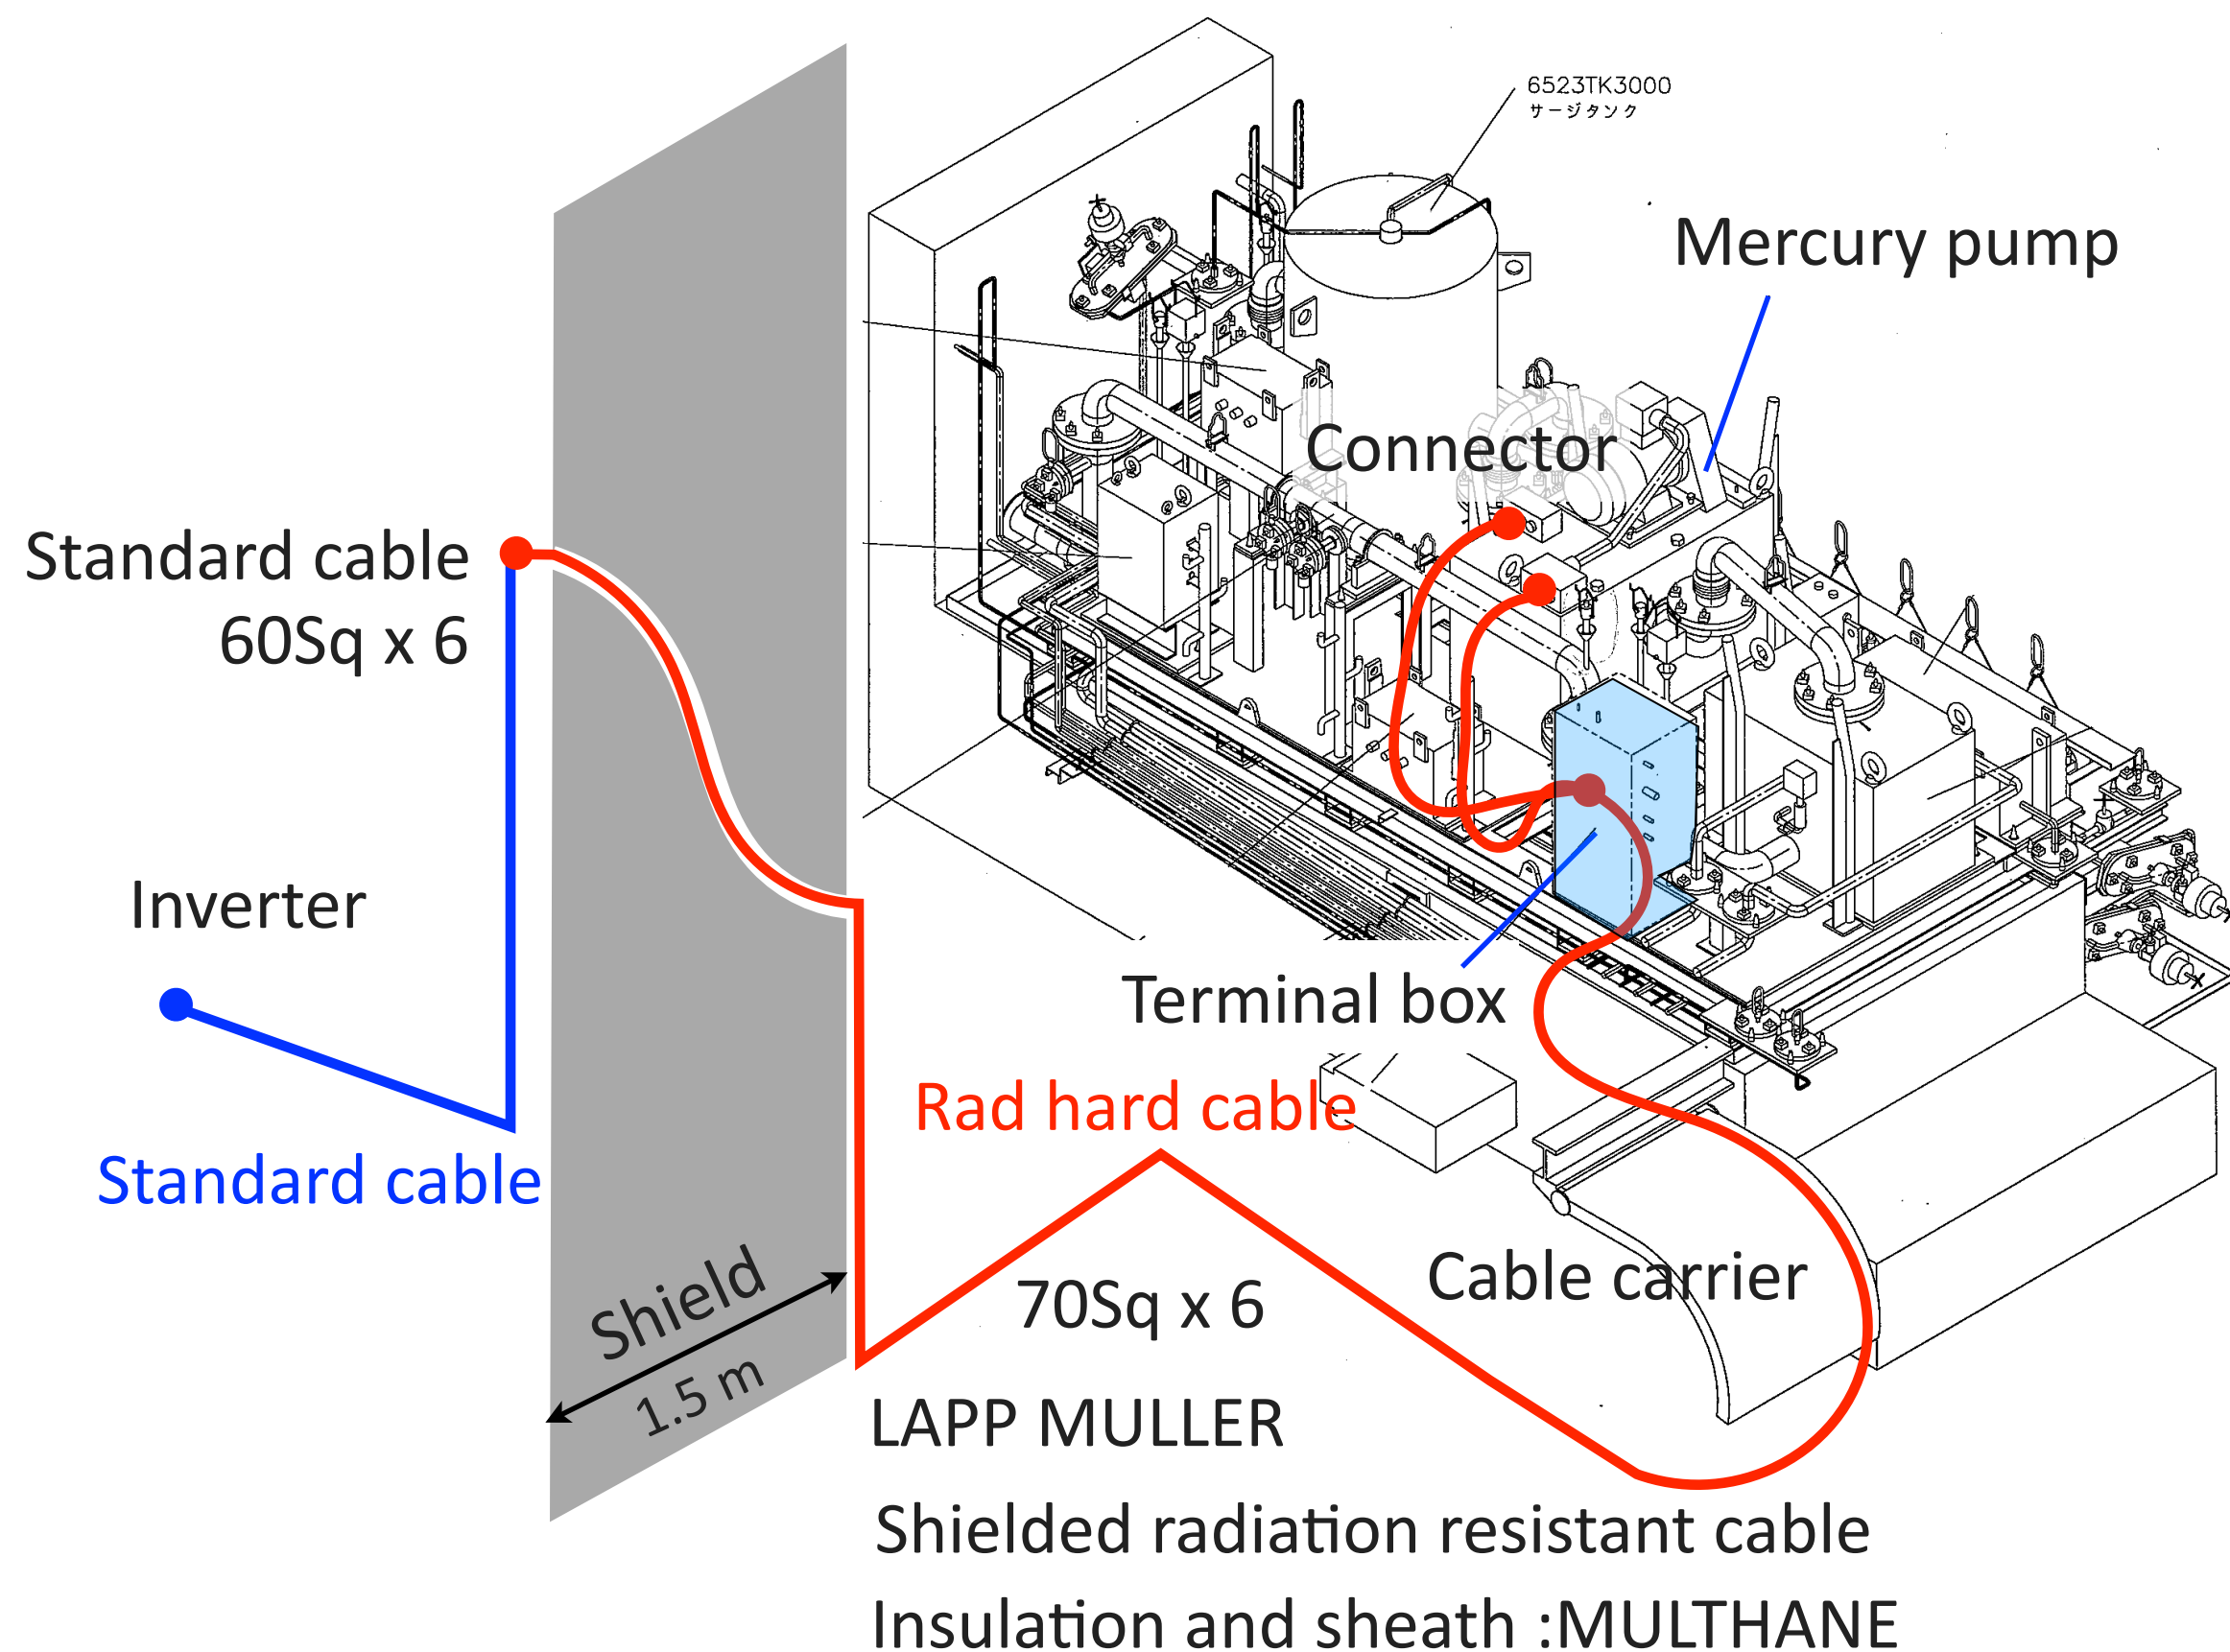
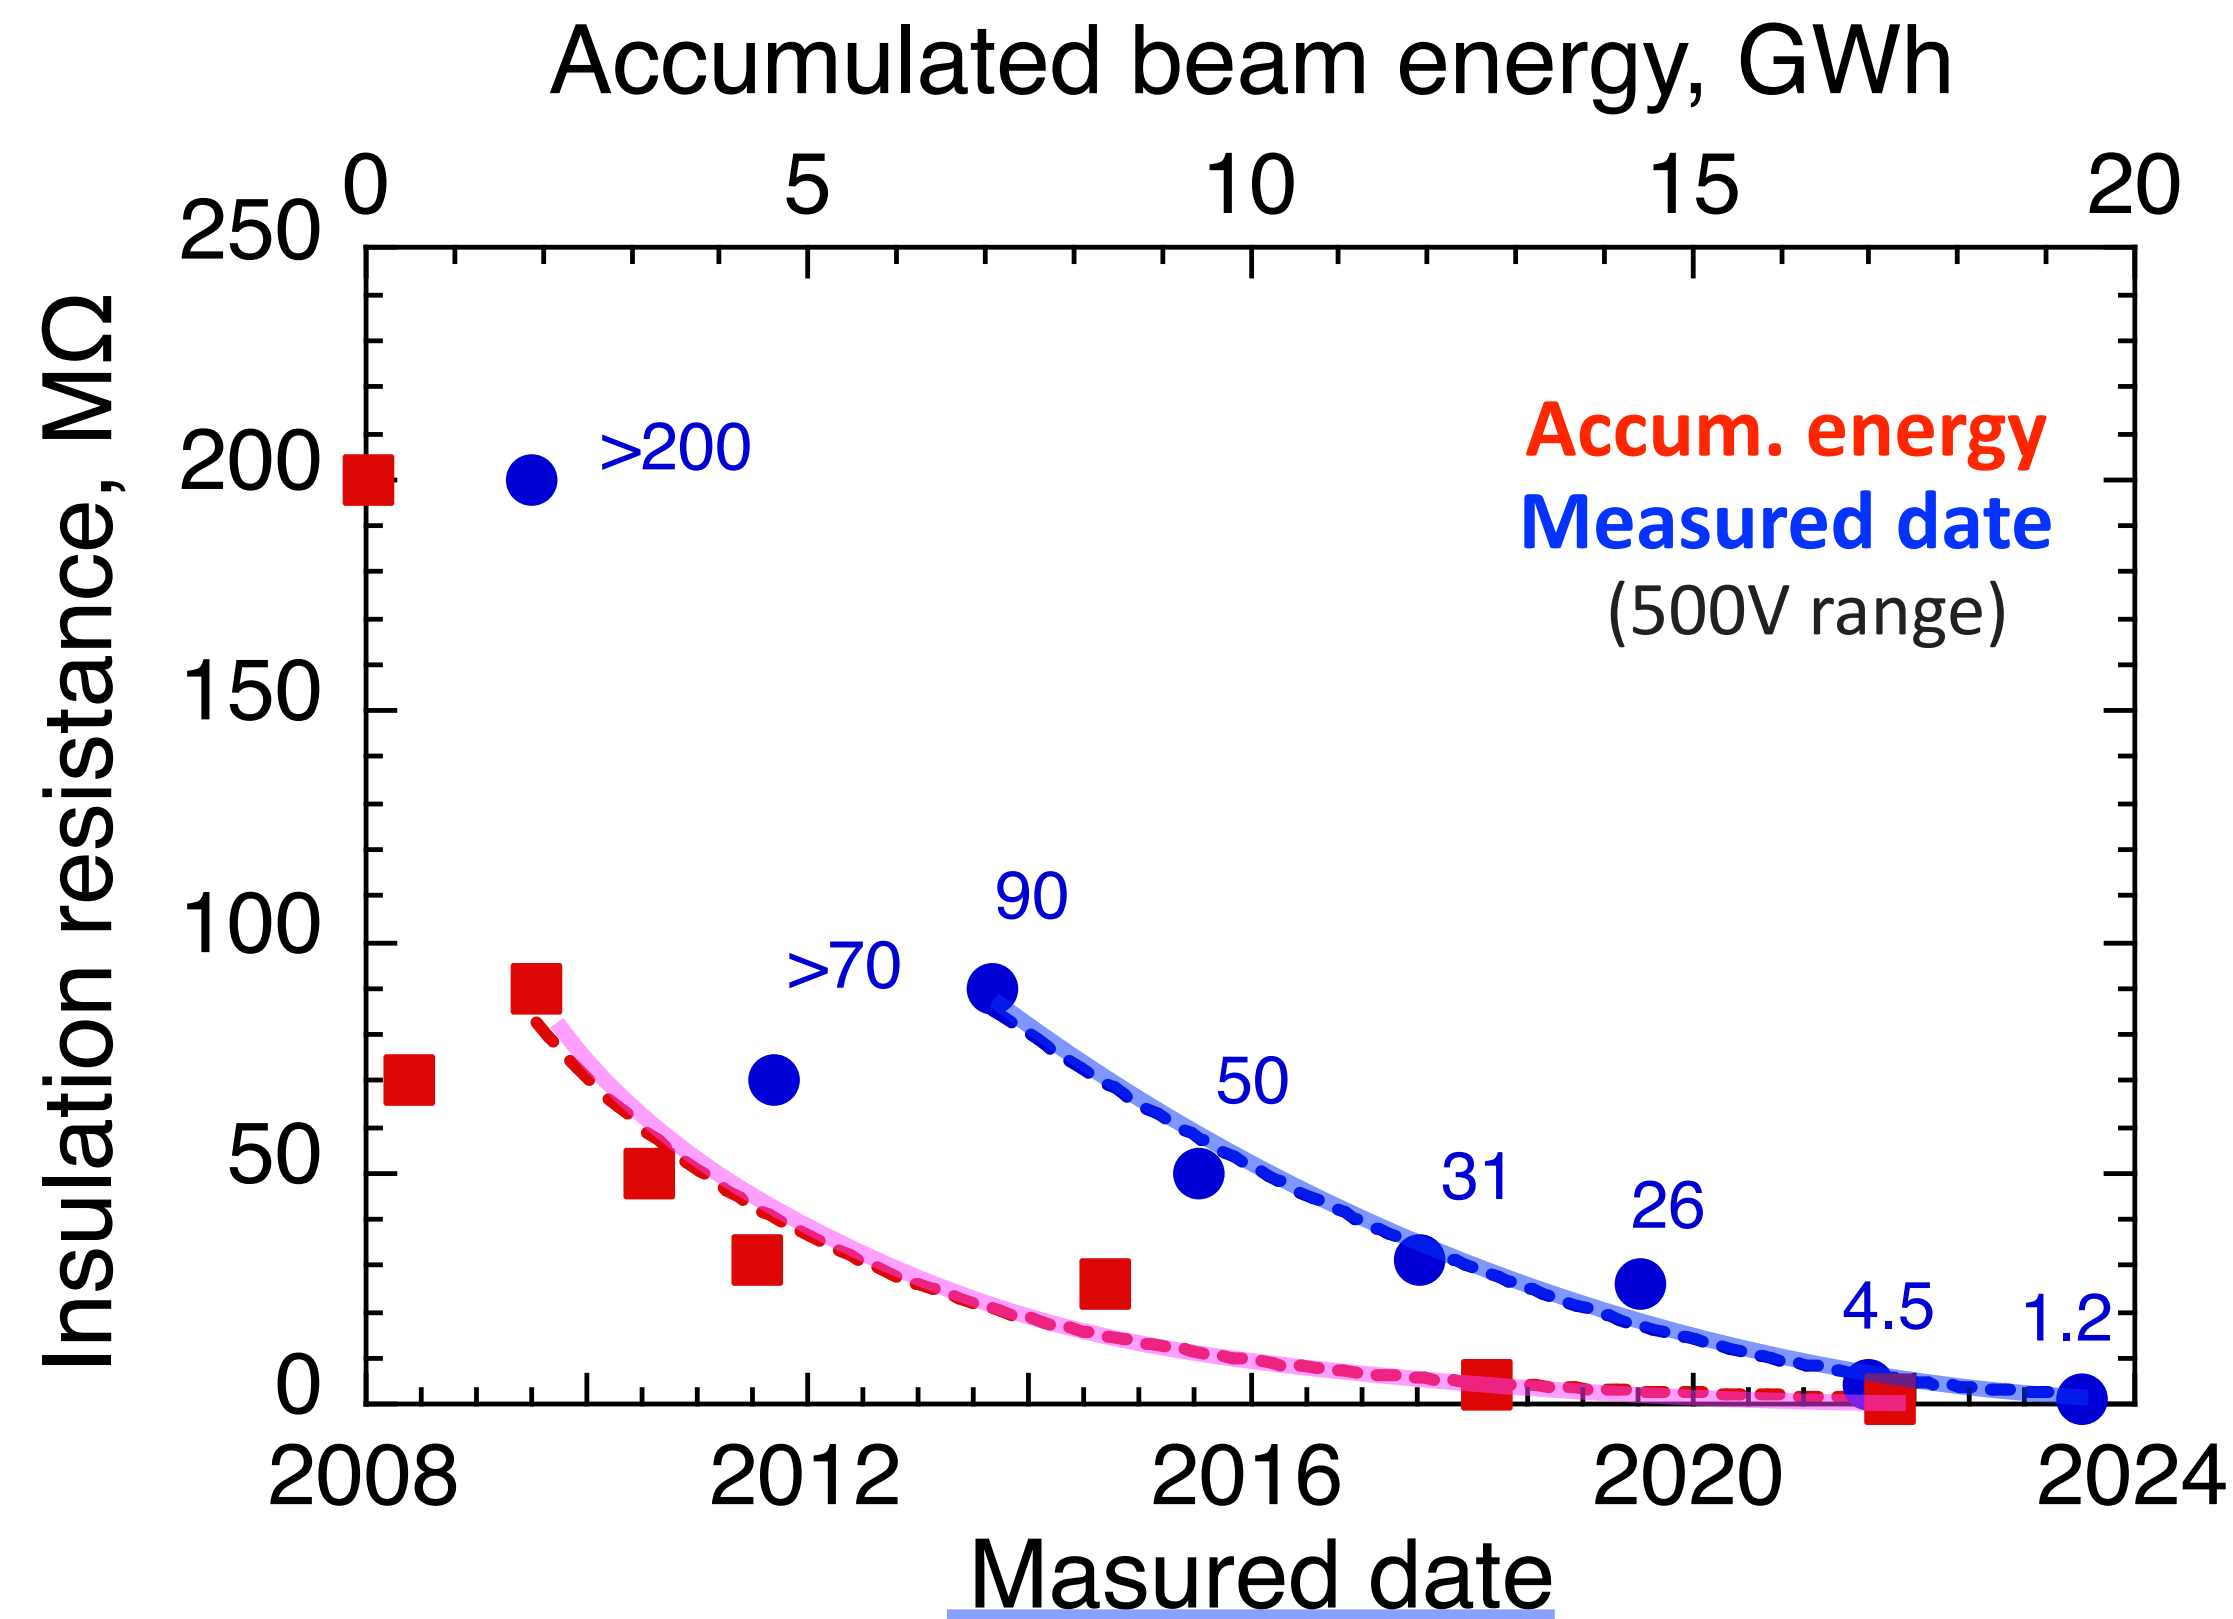
Insulation resistance of pump motor

- Insulation resistance between each phase and earth are measured at the outside of hot-cell
- Results including the effects of motor (class F insulation), connector, rad-hard cables (~40 m)
- Replacement was decided resistance showed near the acceptable value of 1.0 MΩ in 2024

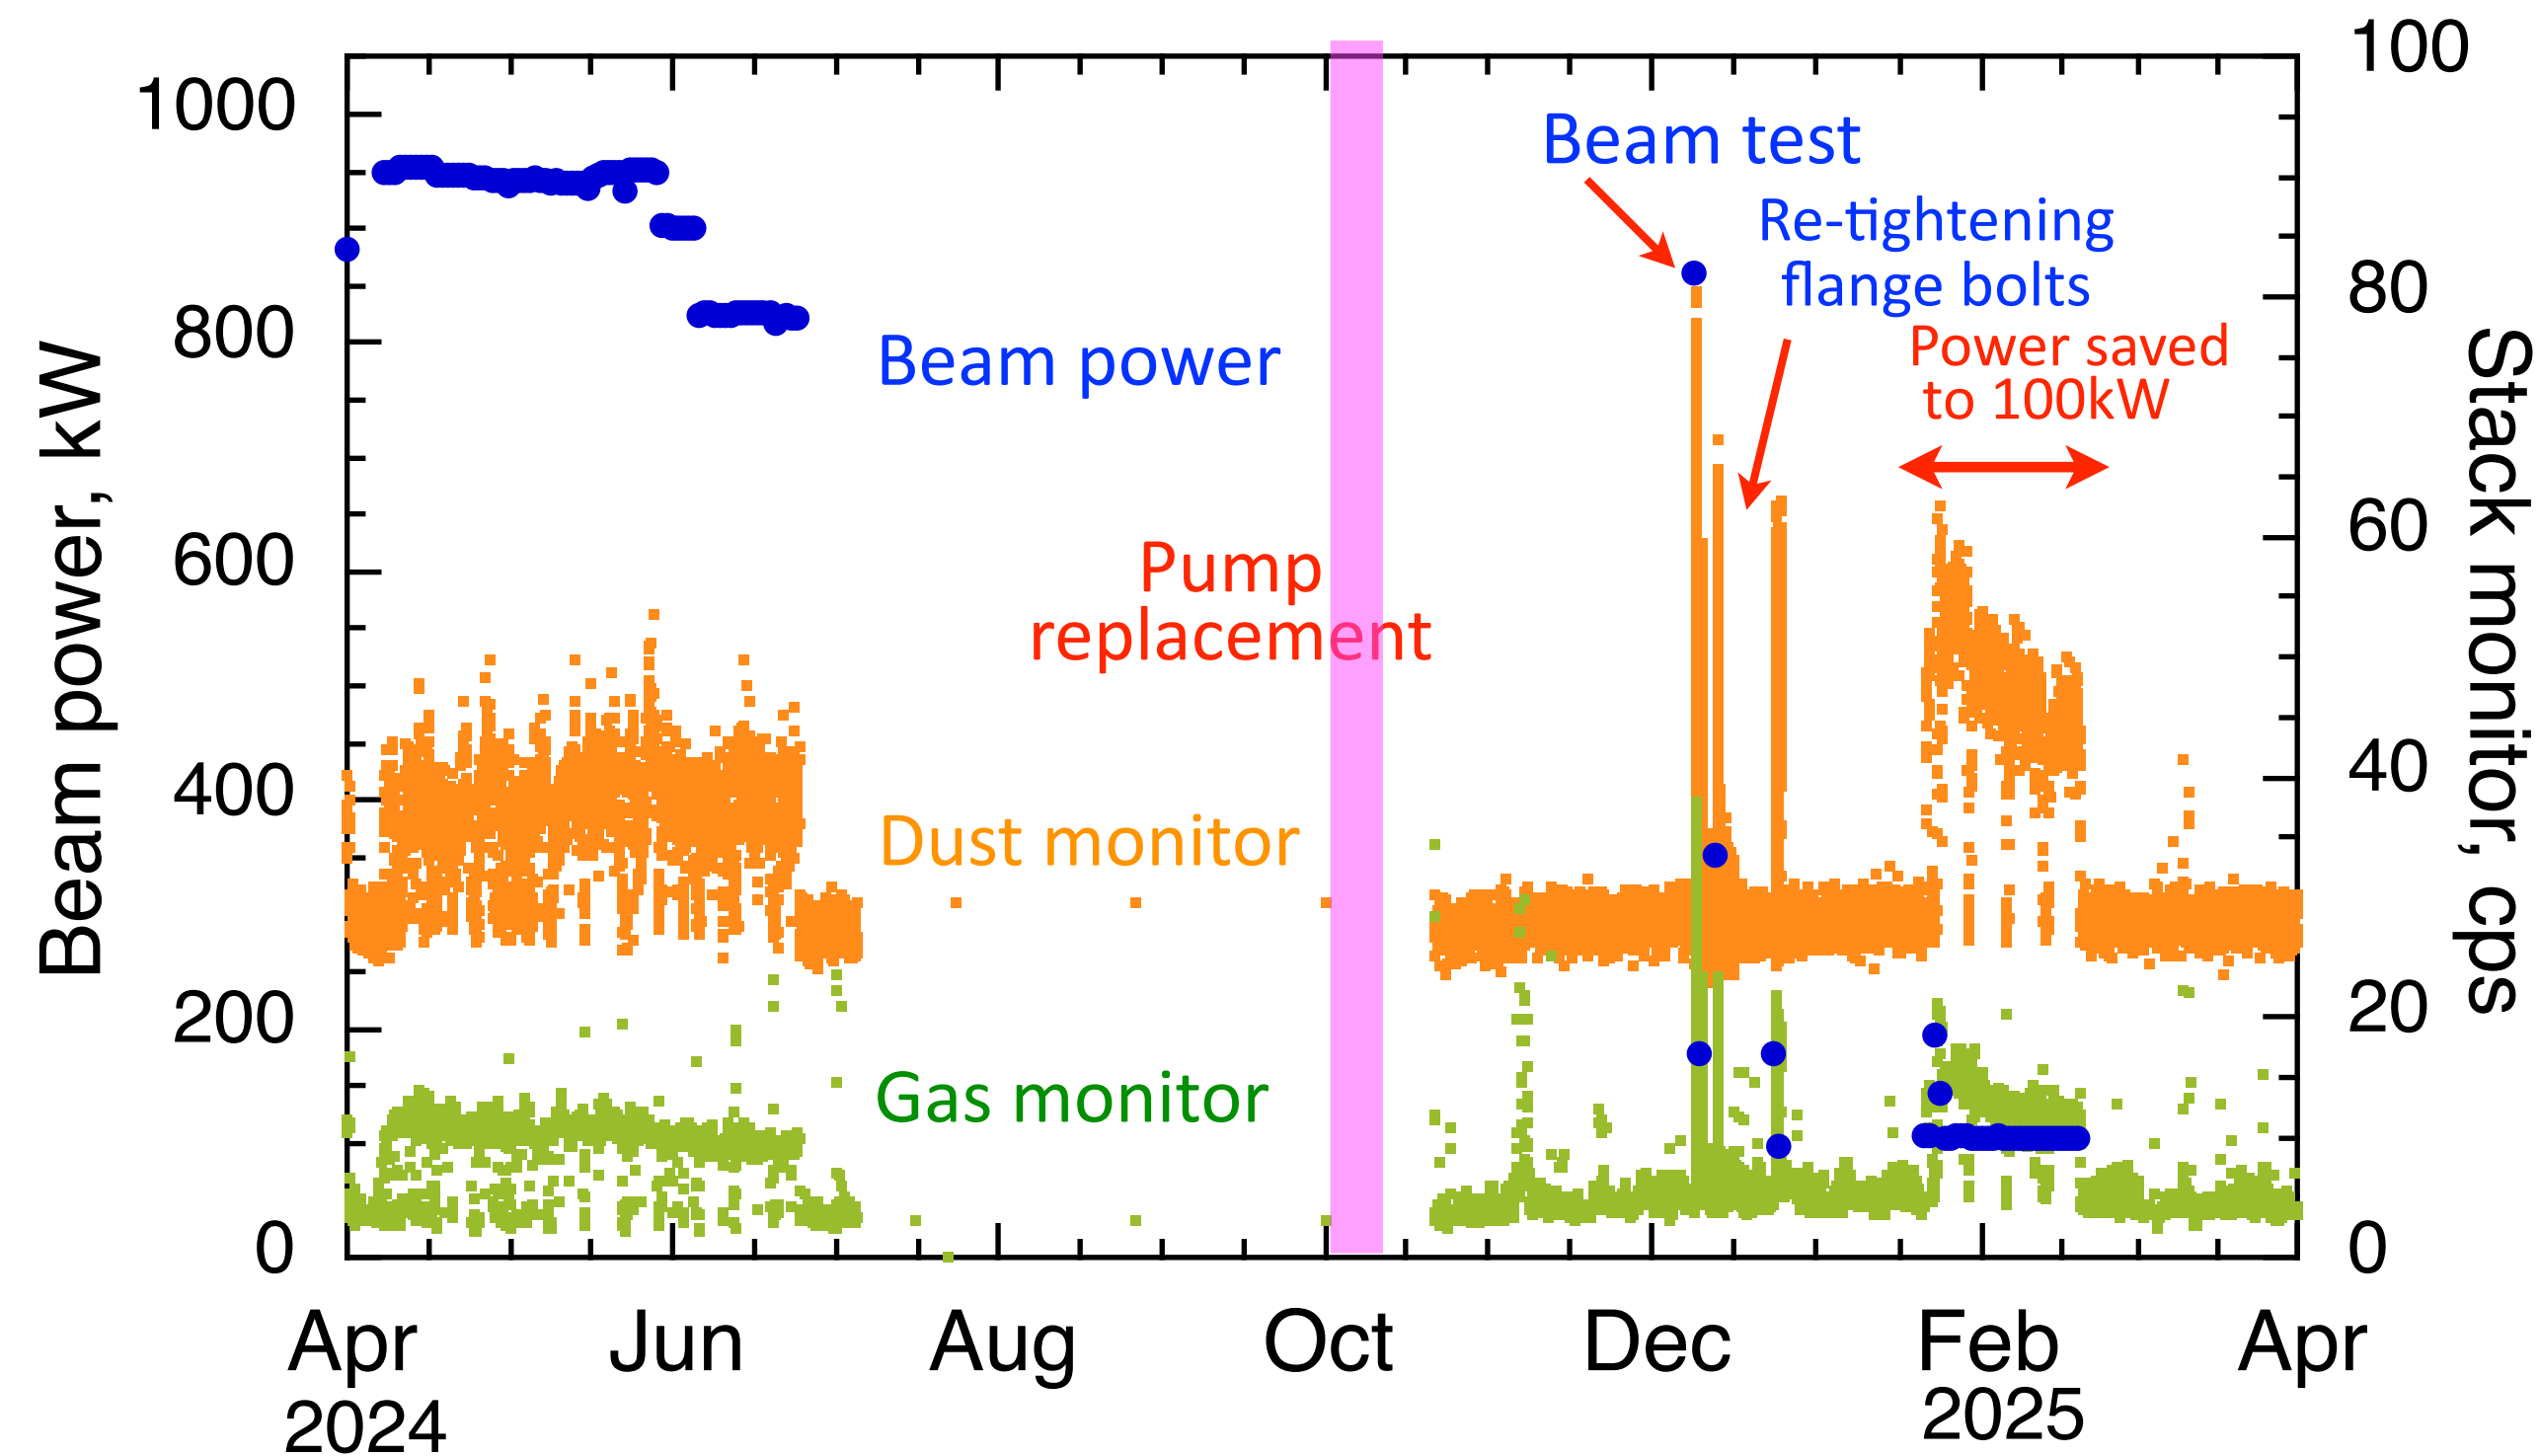
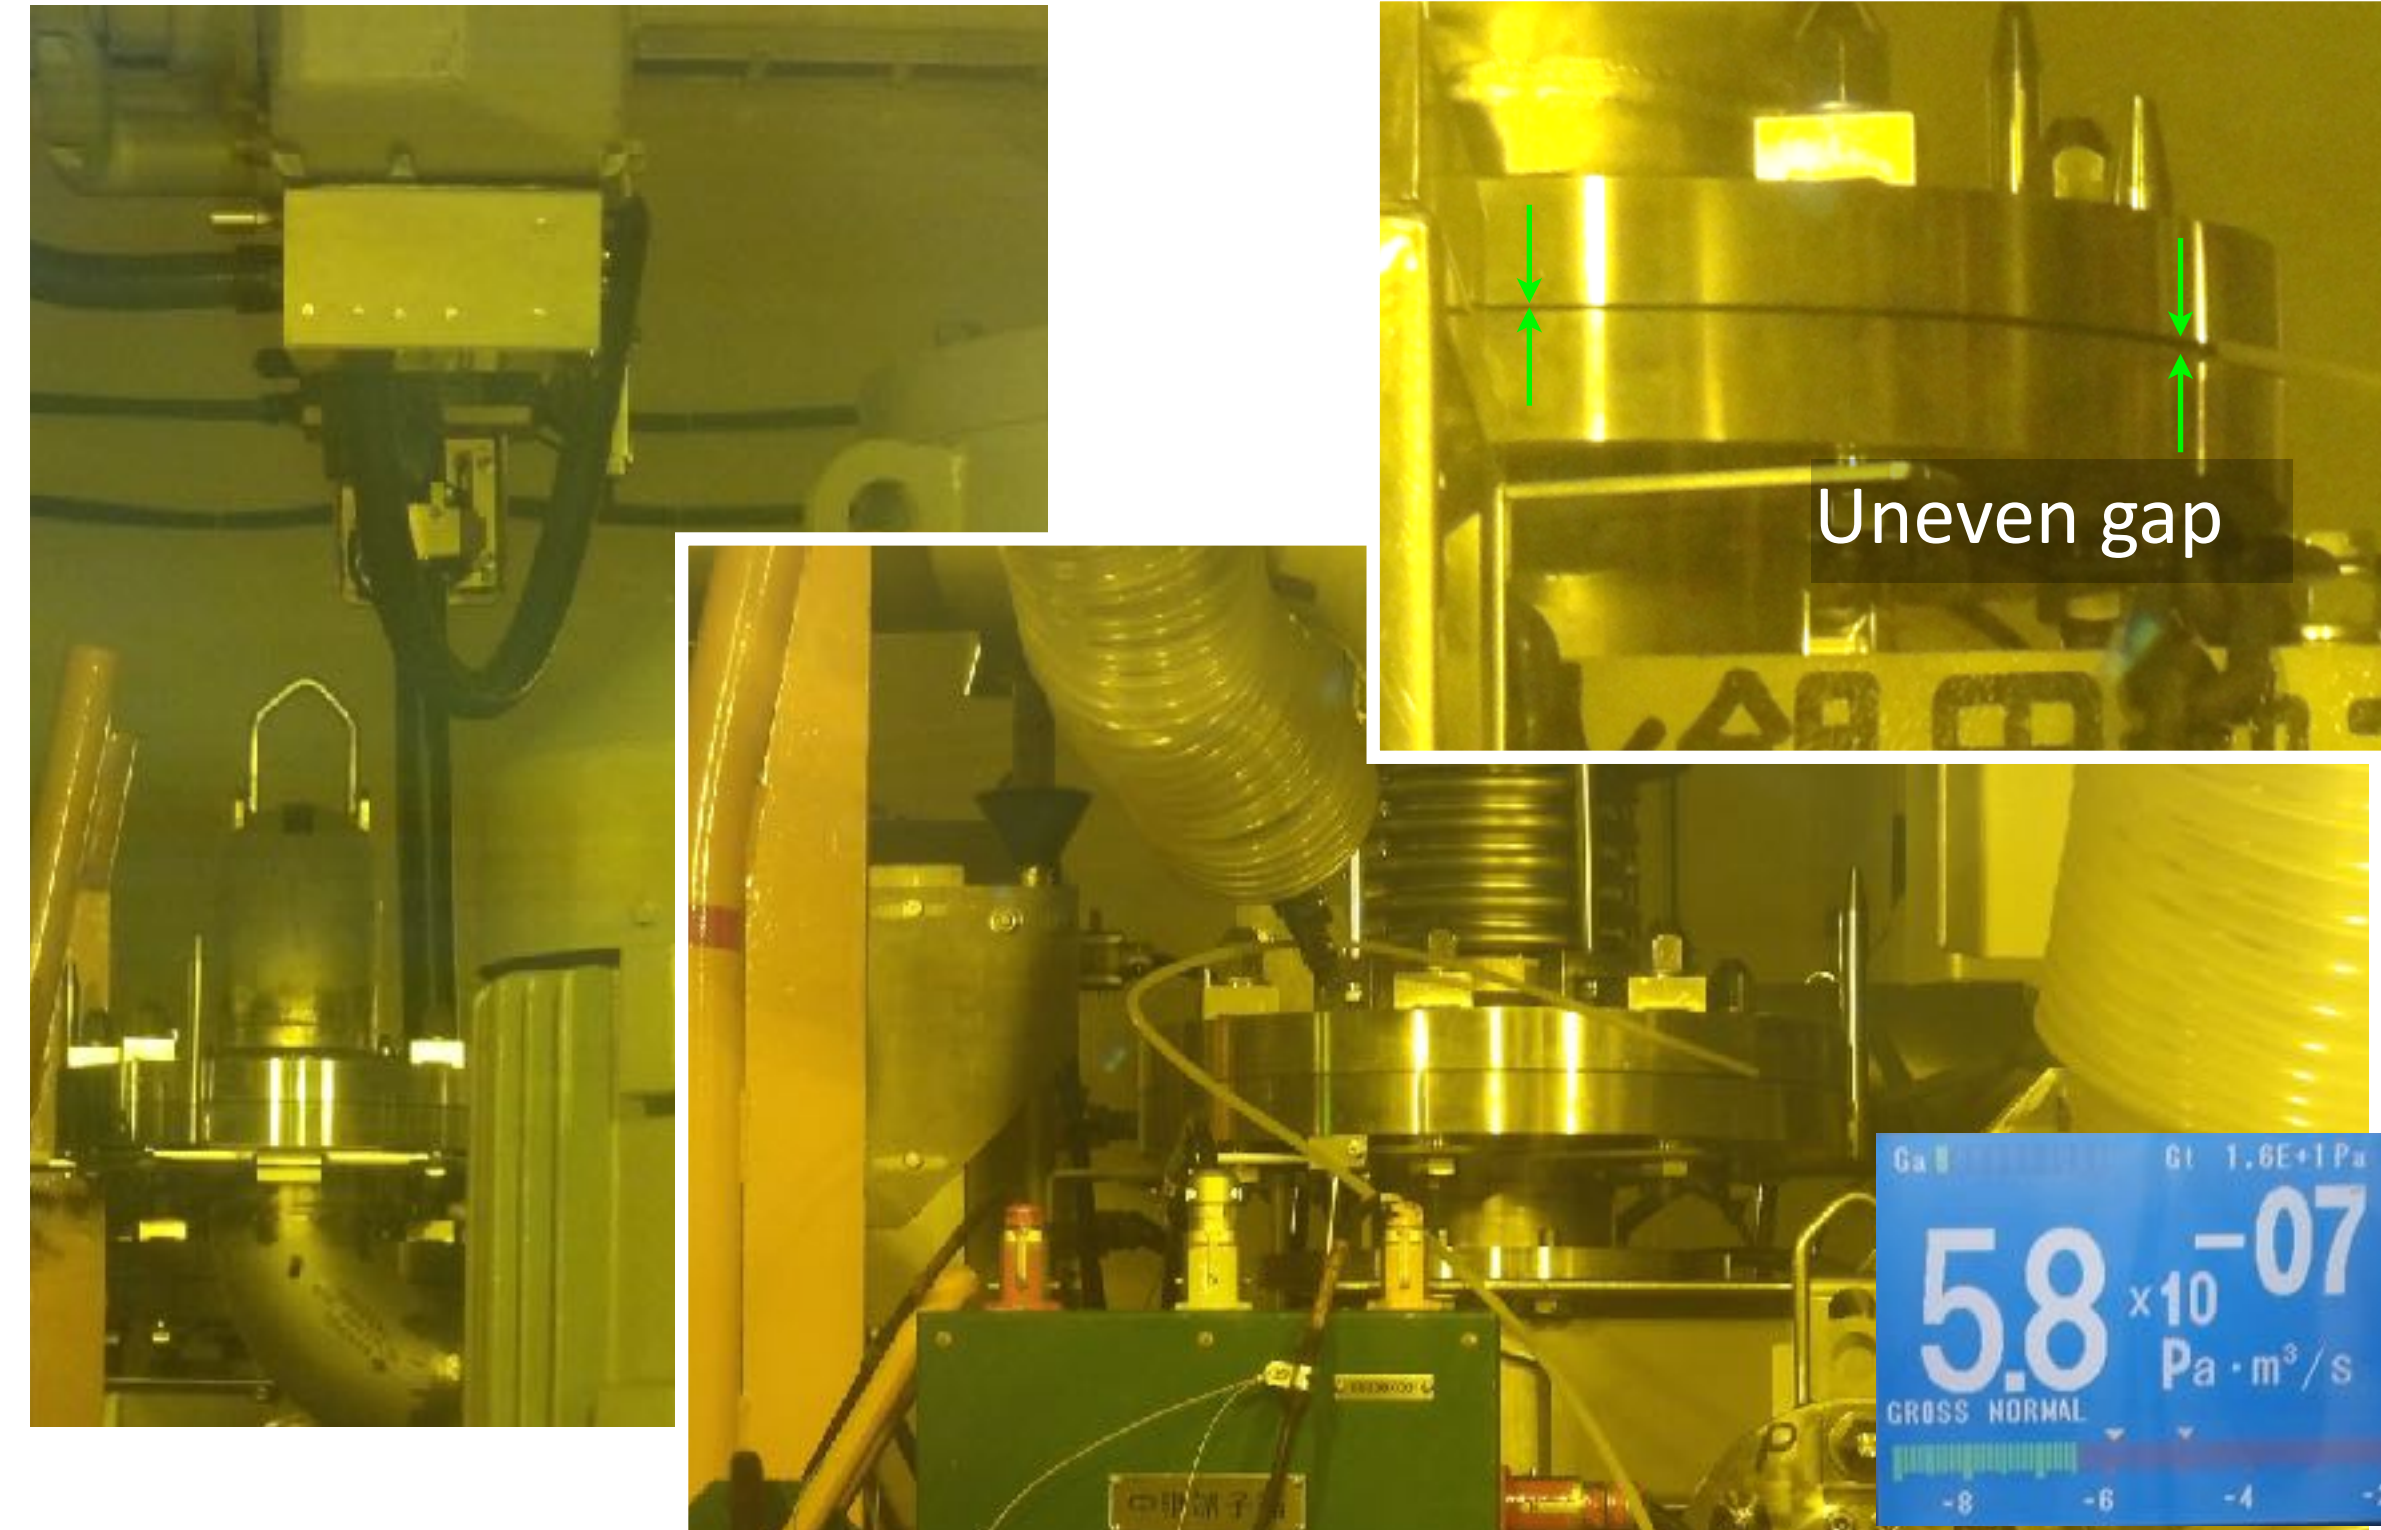
Increase of stack radiation monitor during operation

- Helium leak test was passed but rise of stack monitors counts were detected during beam test before user operation
- Inspection criteria was set to $1\text{E-}6 \text{ Pa}\cdot\text{m}^3/\text{s}$ by focusing on to prevent mercury leakage at that time
- Re-inspection after beam test, tiny gas leak was detected on pump flange $5.8\text{E-}7 \text{ Pa}\cdot\text{m}^3/\text{s}$
- Retightening of flange bolts was not effective to reduce leak, and decided to reduce beam power to 100 kW and to replace flange seal in March

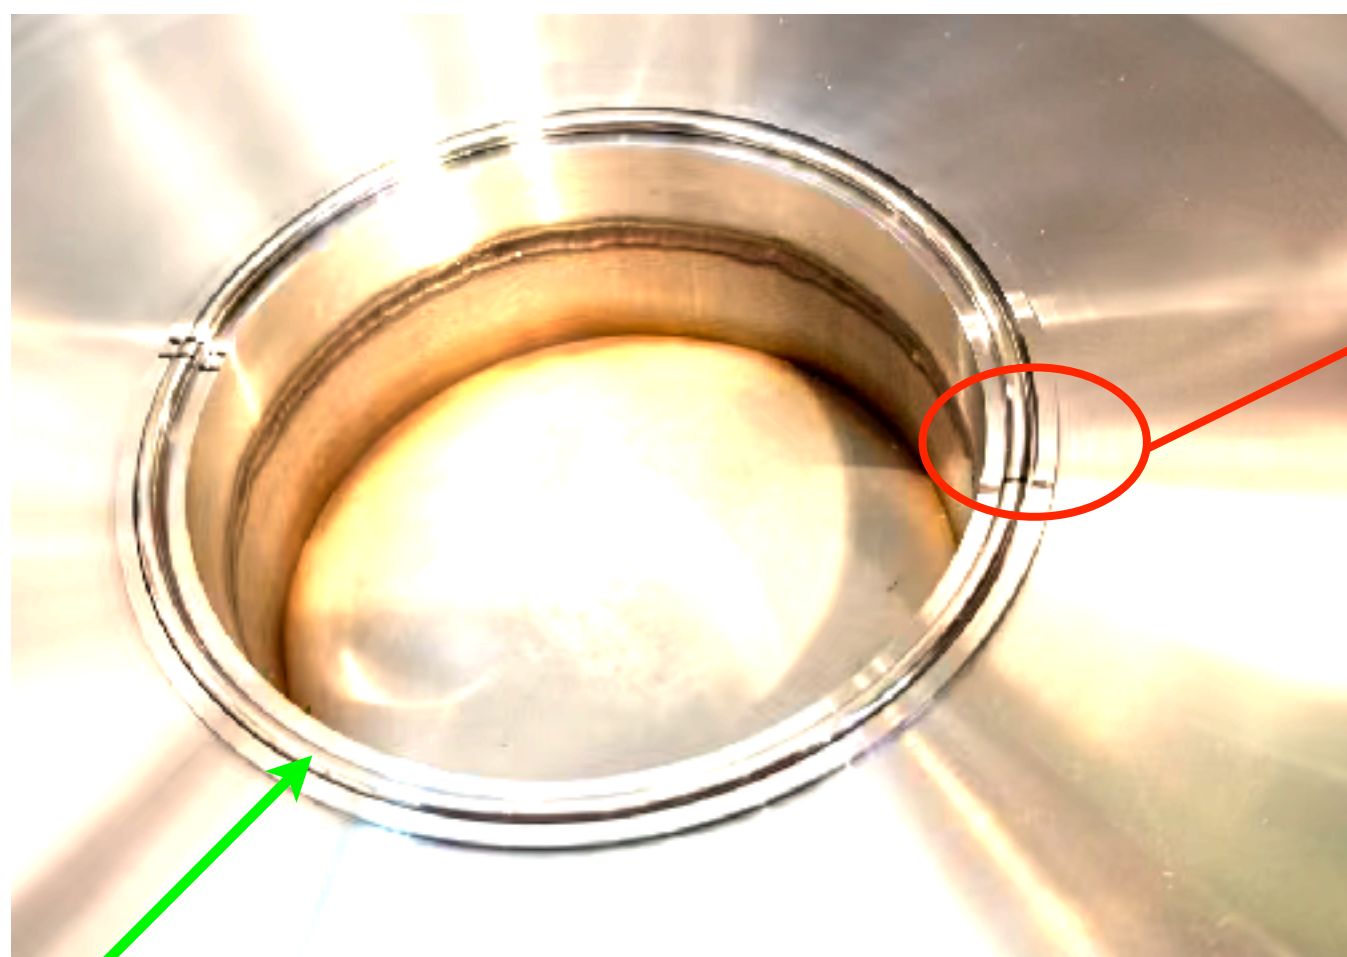
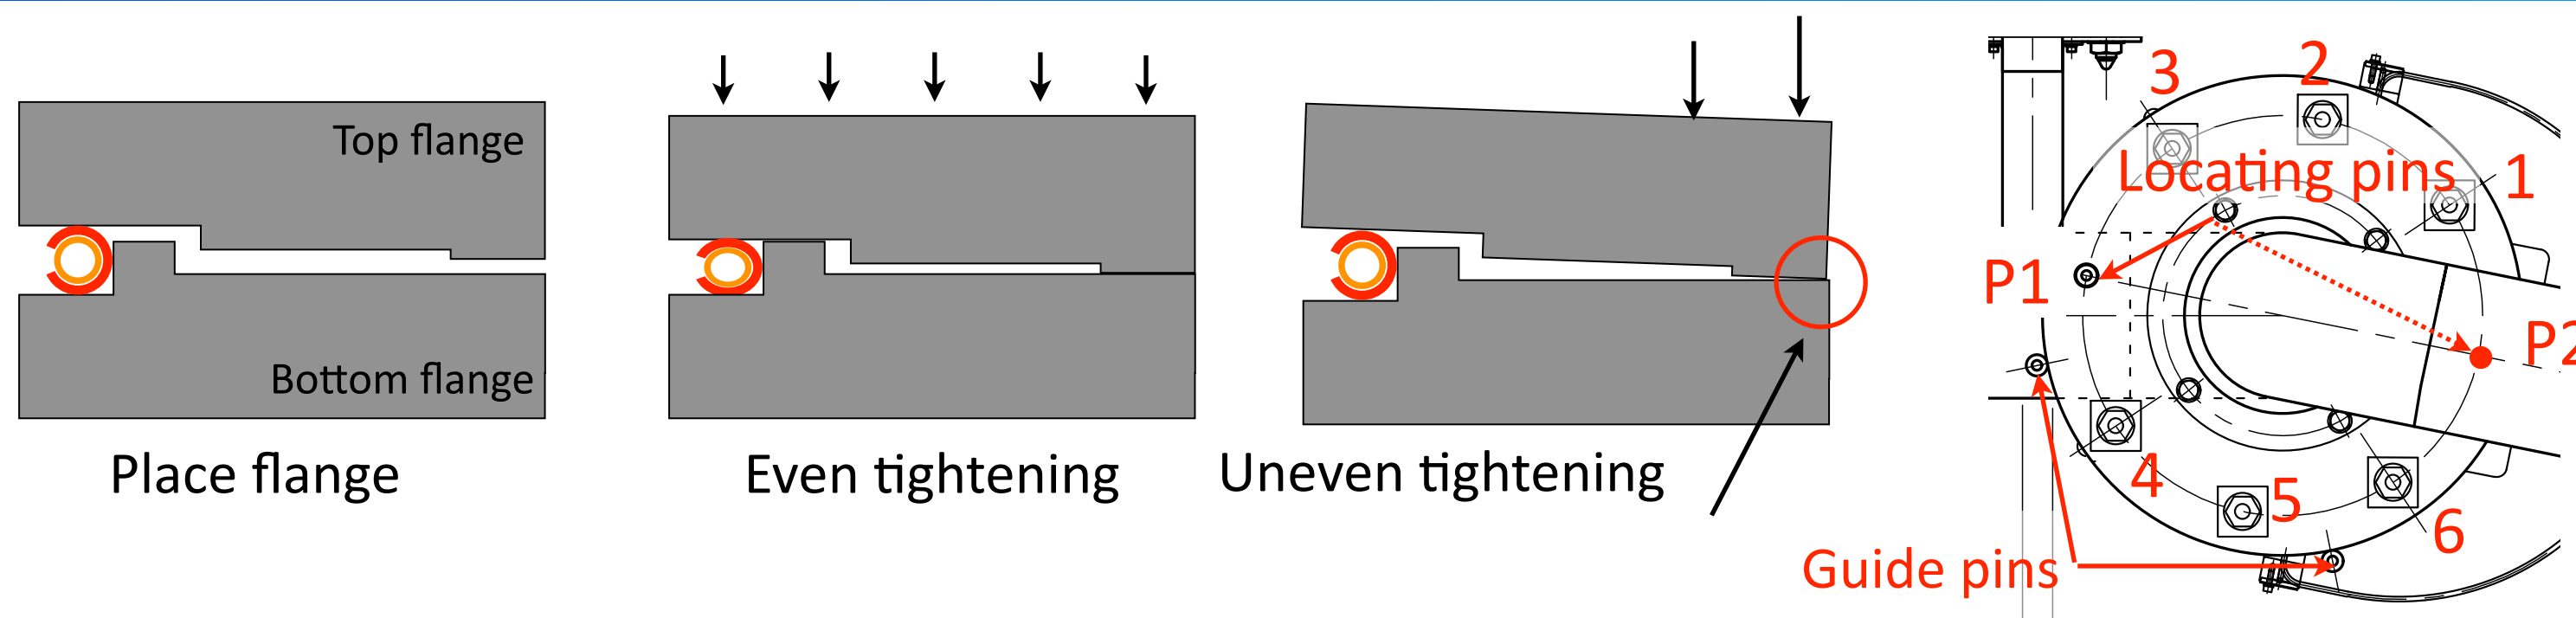
Flange structure and cause analysis of flange leak

Loose 1 rotation did not
affected for even gap

- Leak was reproduced (5E-8 Pam³/s in vacuum helium leak test) traced scenario at pump replacement bolts tightened 60 Nm (1) → loose 1 rotation → 60 Nm (1,4,6,3,5,2) → 120 Nm(1,4,6,3,5,2) → 200 Nm (1,4,6,3,5,2)
- No leak occurred (<10E-11 Pam³/s) when the bolts were tightened evenly, as an ideal hands tightening procedure

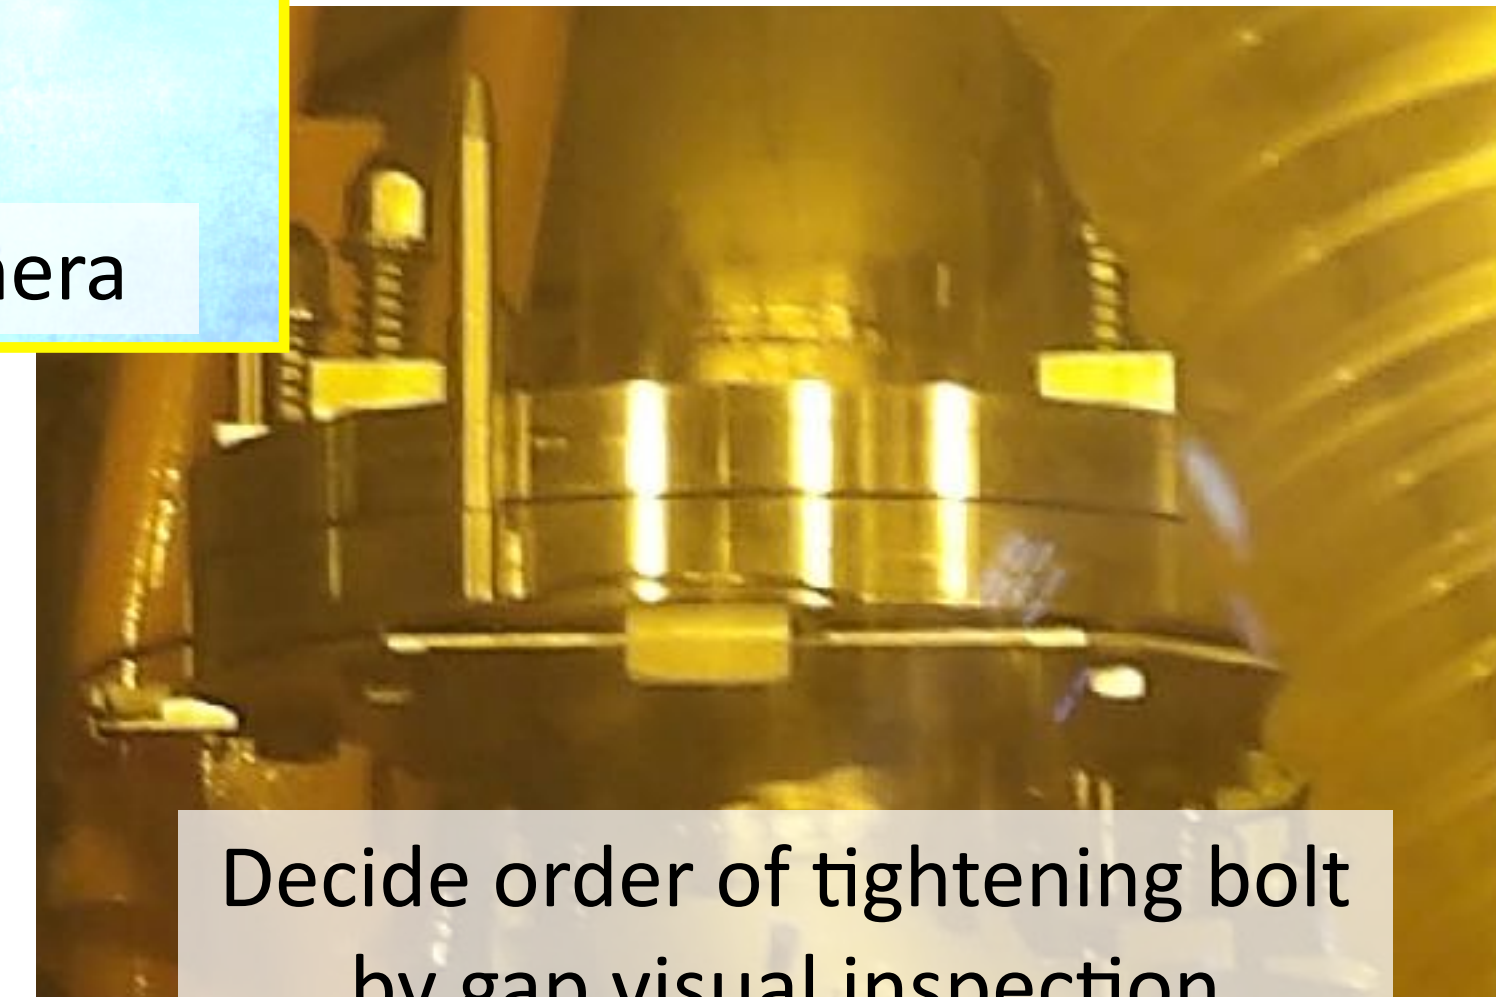
Decide order of tightening bolt by gap visual inspection

- We learned that the ideal fine-torque management (5–10 Nm steps) is effective for securing leak tightness, but it is not feasible for a power manipulator
- To reproduce the even tightening achieved by manual work using the power manipulator, we conducted 10 flange mock-up tests and 6 jumper-pipe mock-up tests, varying the bolt-tightening procedures to confirm reproducibility
- Based on these results, we decided to focus on achieving even flange gap, rather than managing tightening torque
- The final procedure is: Initial tightening at 20 Nm (sequence: 1, 2, 3, 6, 5, 4), Adjust as needed to achieve an even flange gap at 40–120 Nm, Apply final star-pattern tightening at 160 Nm and 200 Nm
