Experiences of remote maintenance for the mercury target system for the pulsed neutron source

Neutron Source Section, MLF Division

J-PARC / JAEA

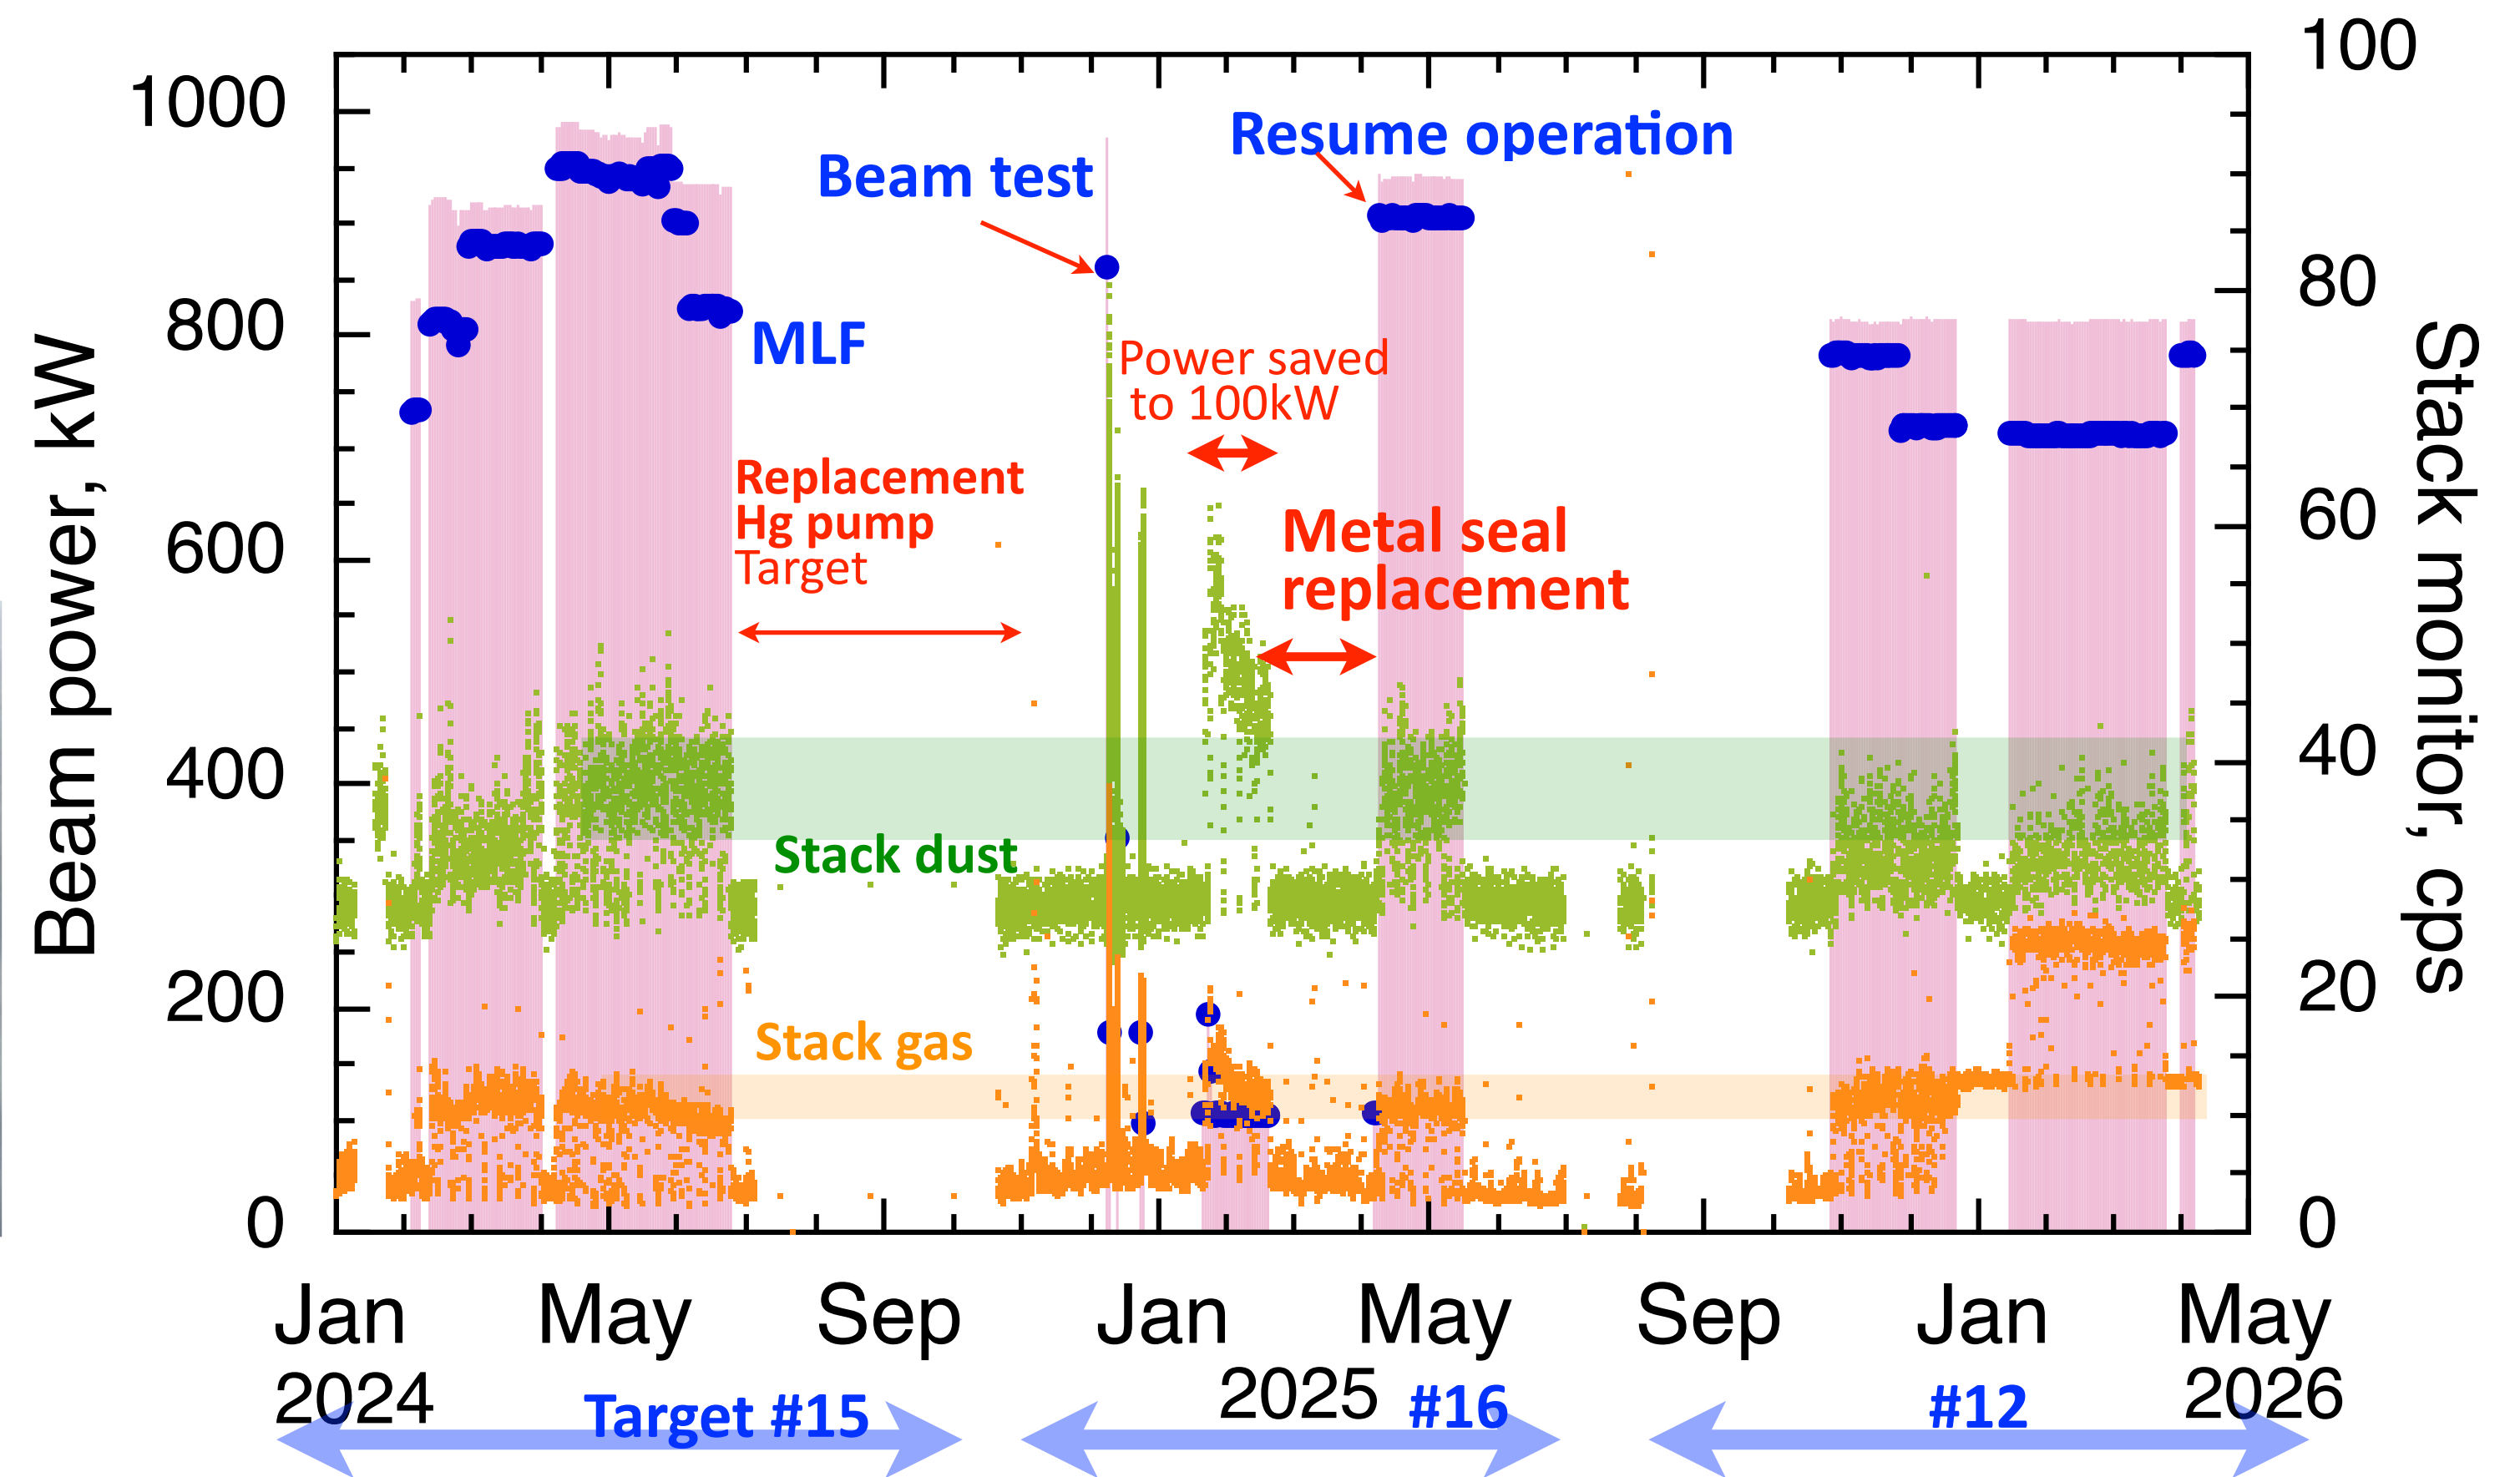
Beam operation after seal replacement

- Helium leak test showed below detectable limit for all flanges after seal replacement
- Stuck monitors are recovered usual value in beam operation

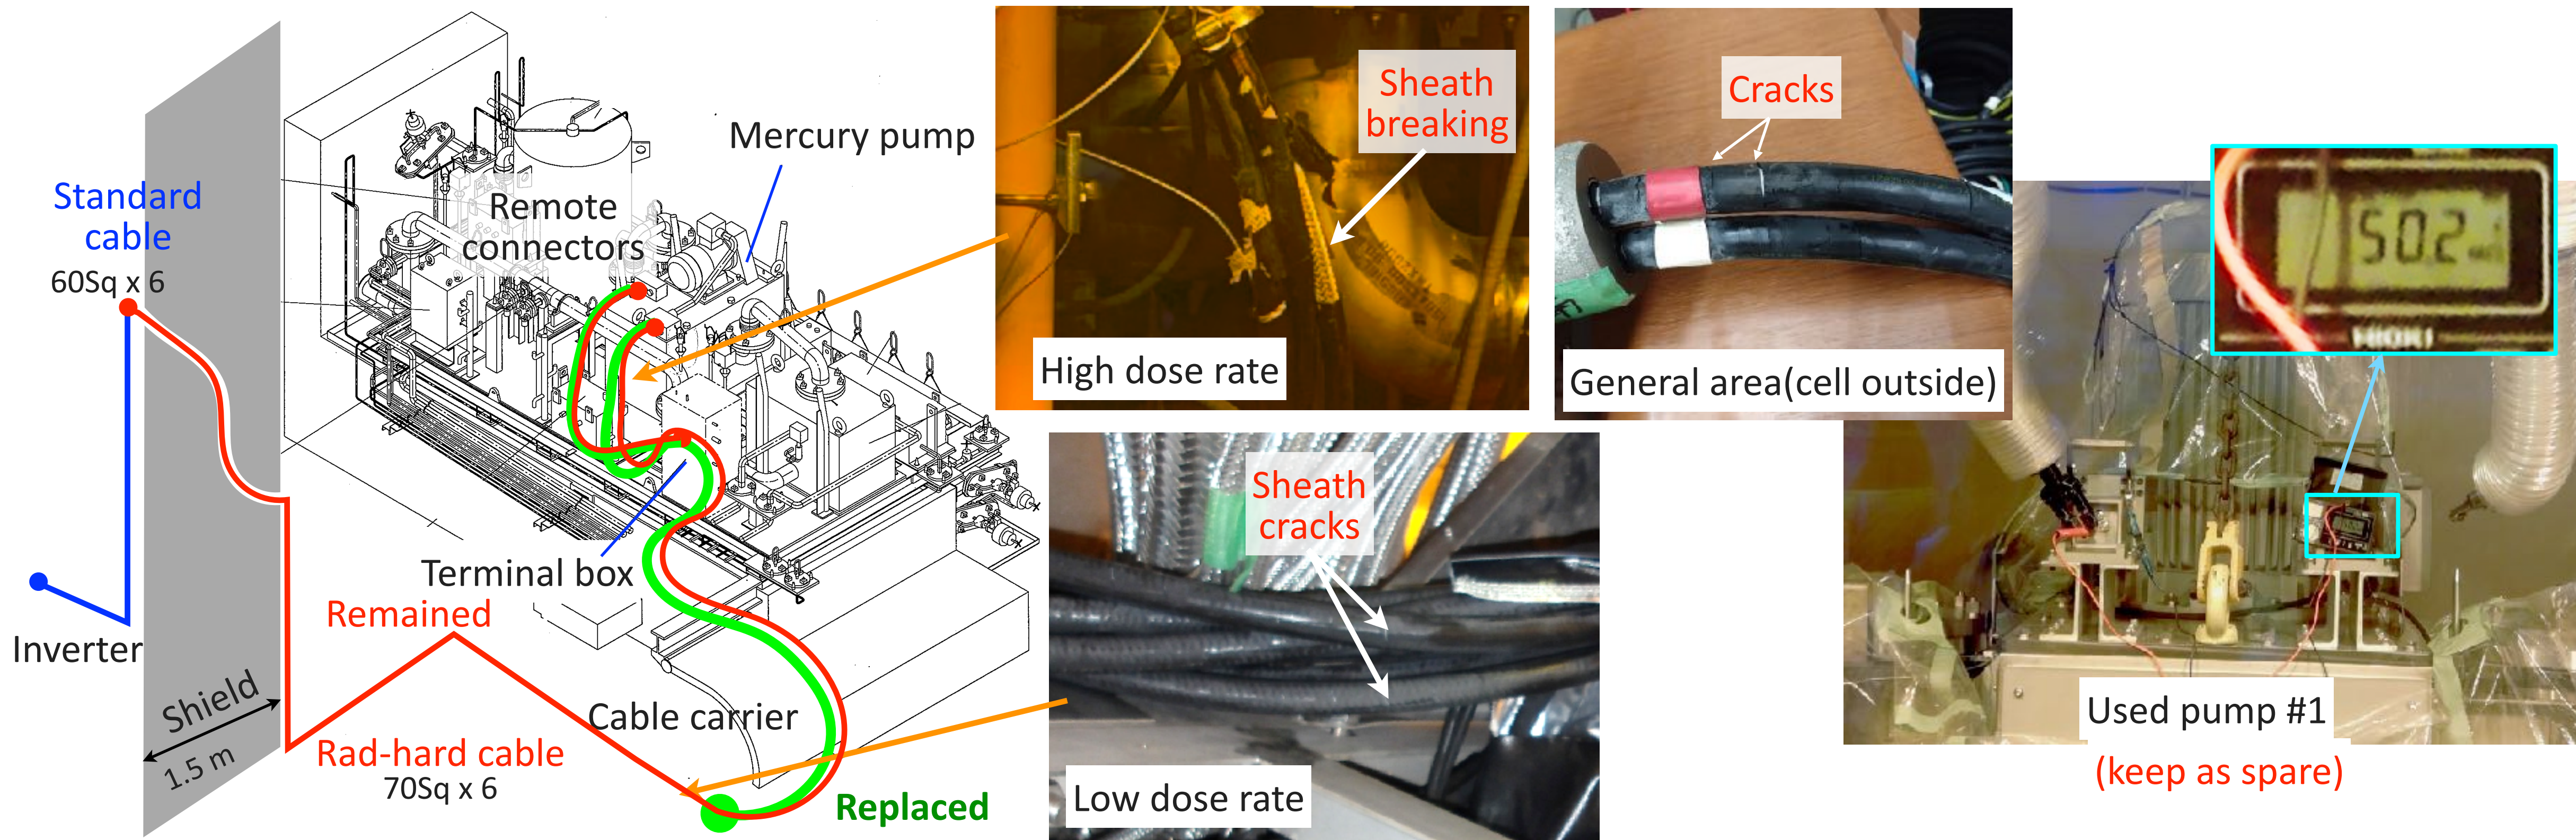
Pump power cables replacement

Total resistance
Jul. 2024	Before pump replacement	Cable+Connector+Pump#1(50 MΩ)	0.8 MΩ
Nov. 2024	After pump replacement	Cable+Connector+Pump#2	3.8 MΩ
Jul. 2025	After 1 year operation	Cable+Connector (0.72 MΩ)+Pump#2 (75 MΩ)	0.27 MΩ
Nov. 2025	After cable replacement	Cable+Connector (7.4 MΩ)+Pump#2 (75 MΩ)	2.7 MΩ

- Rad-hard (5MGy) cable was damaged not only high dose area but also low dose area in 15 years
- Reduction of insulation resistance since cables stored in general area was also damaged

- **Full rad-hard cables and connectors replacement are planned in Oct. 2026**

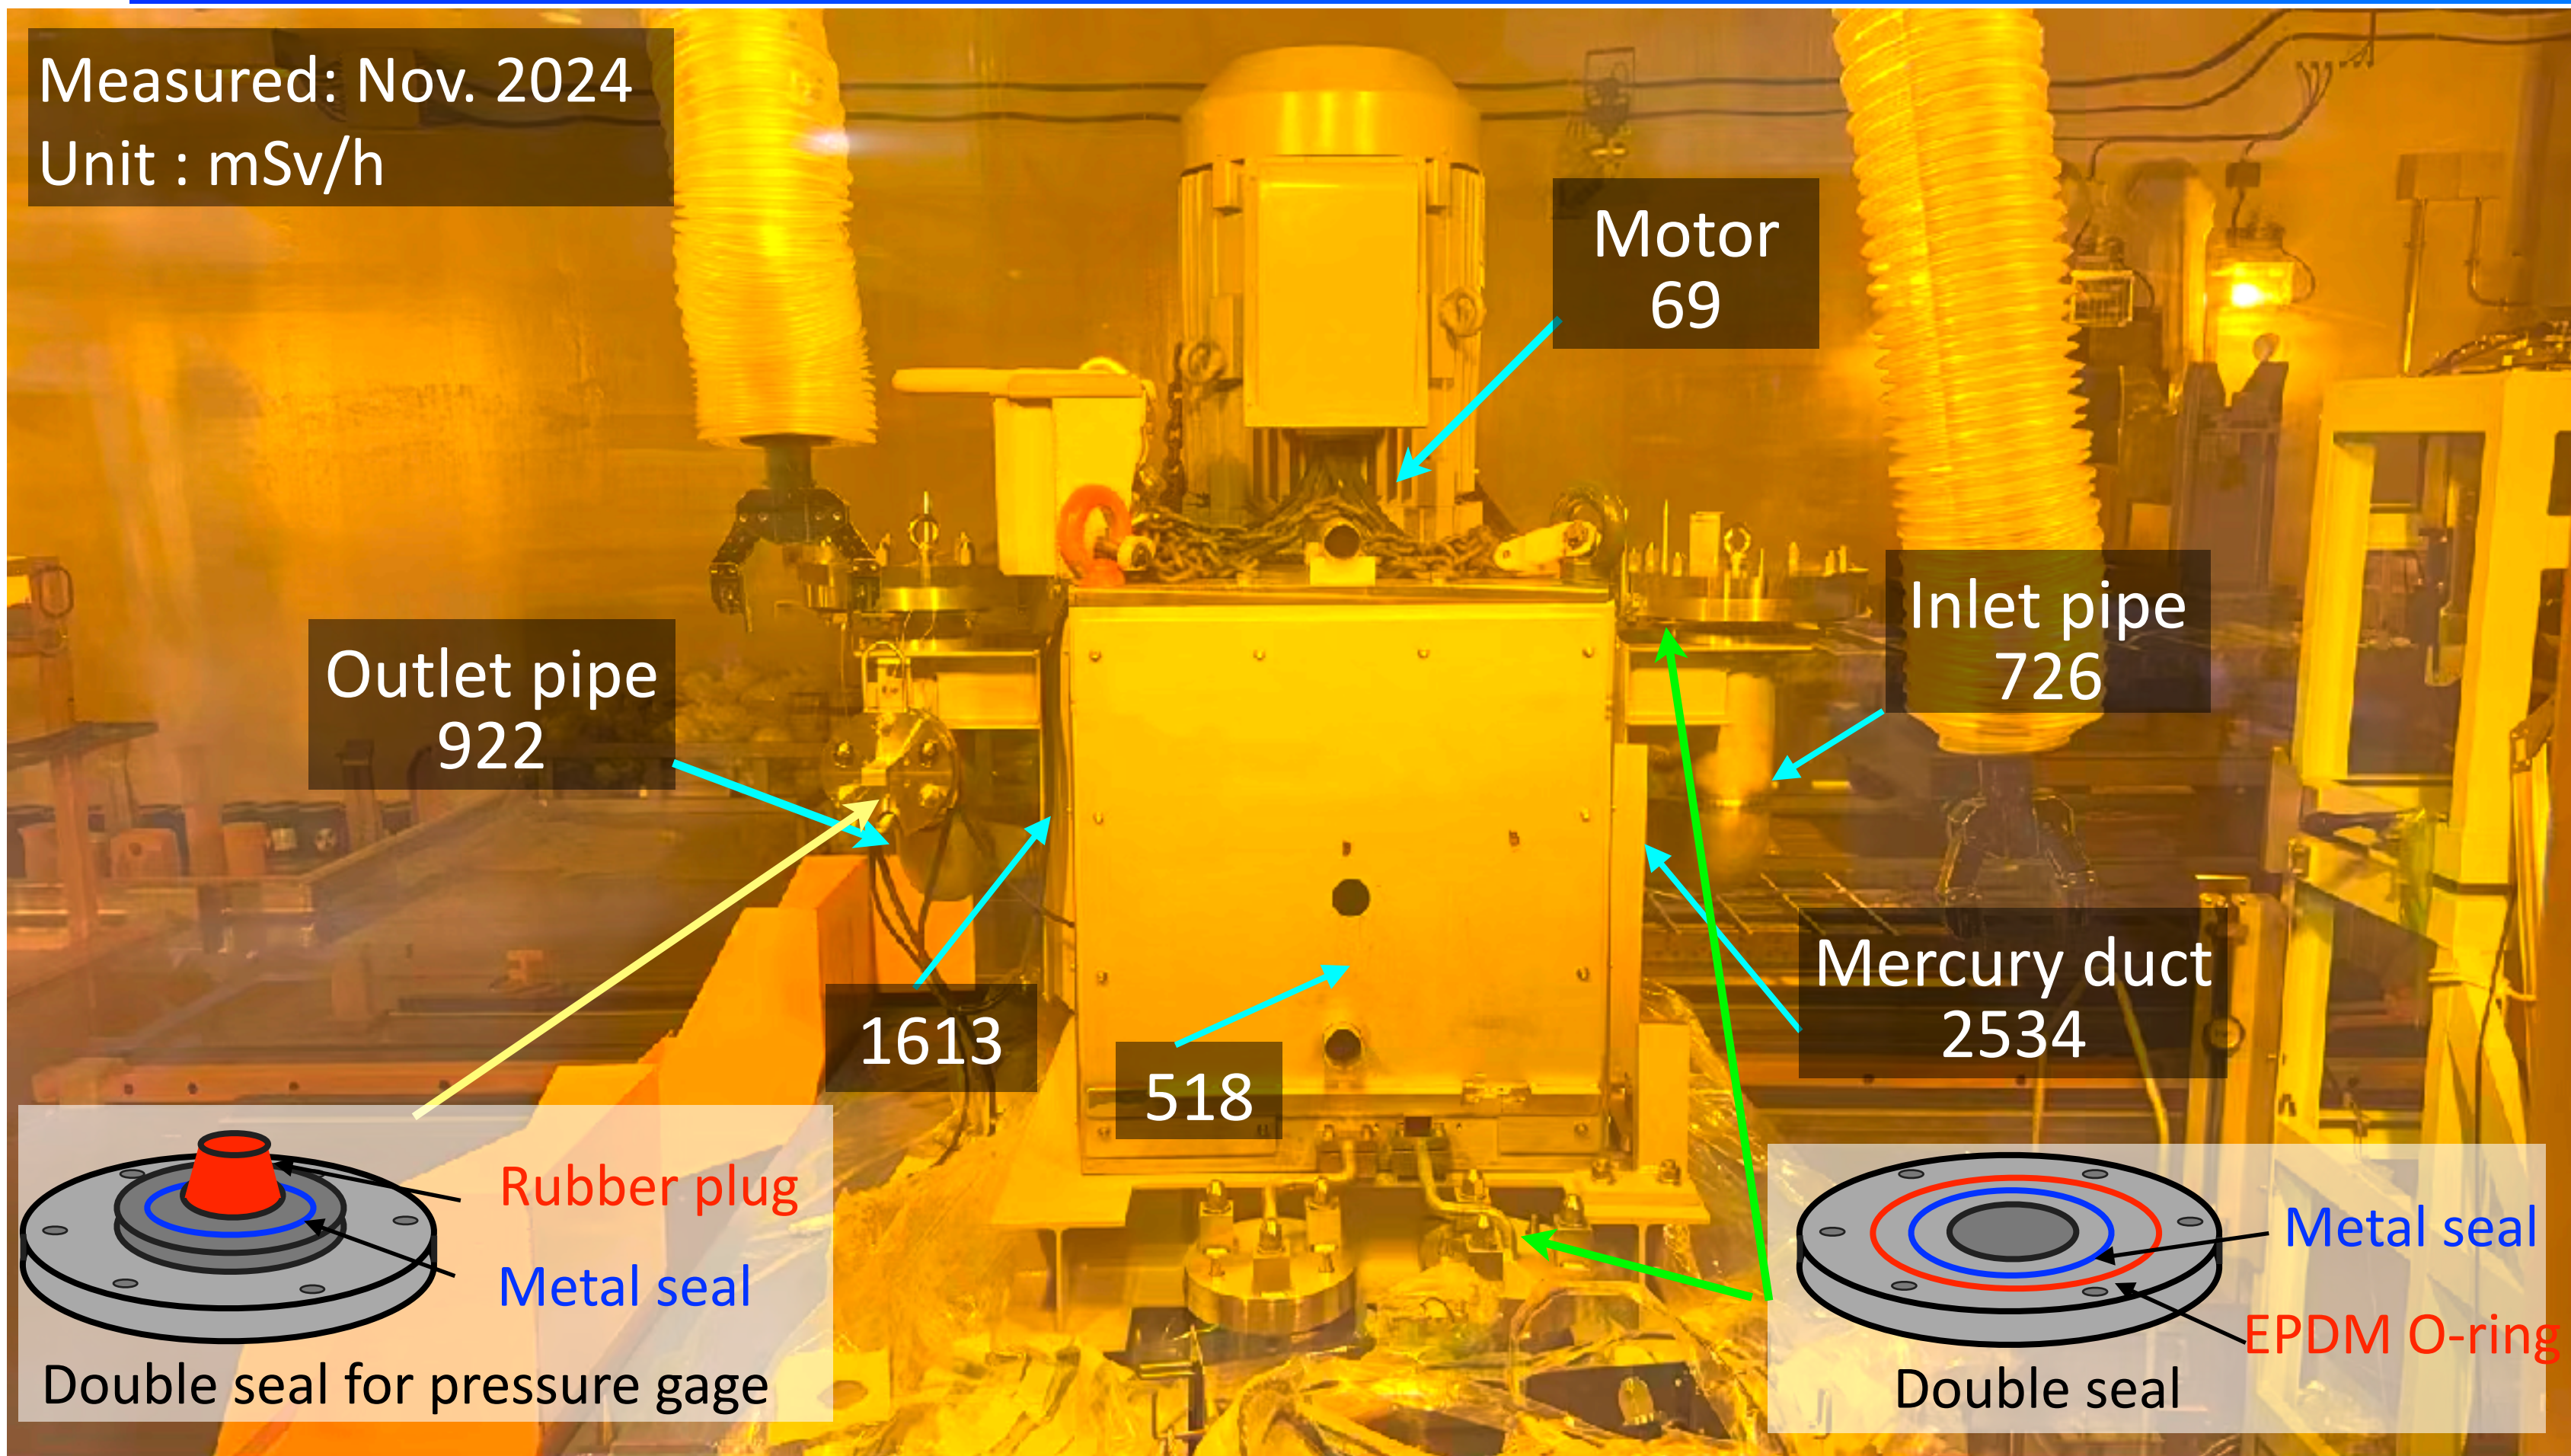
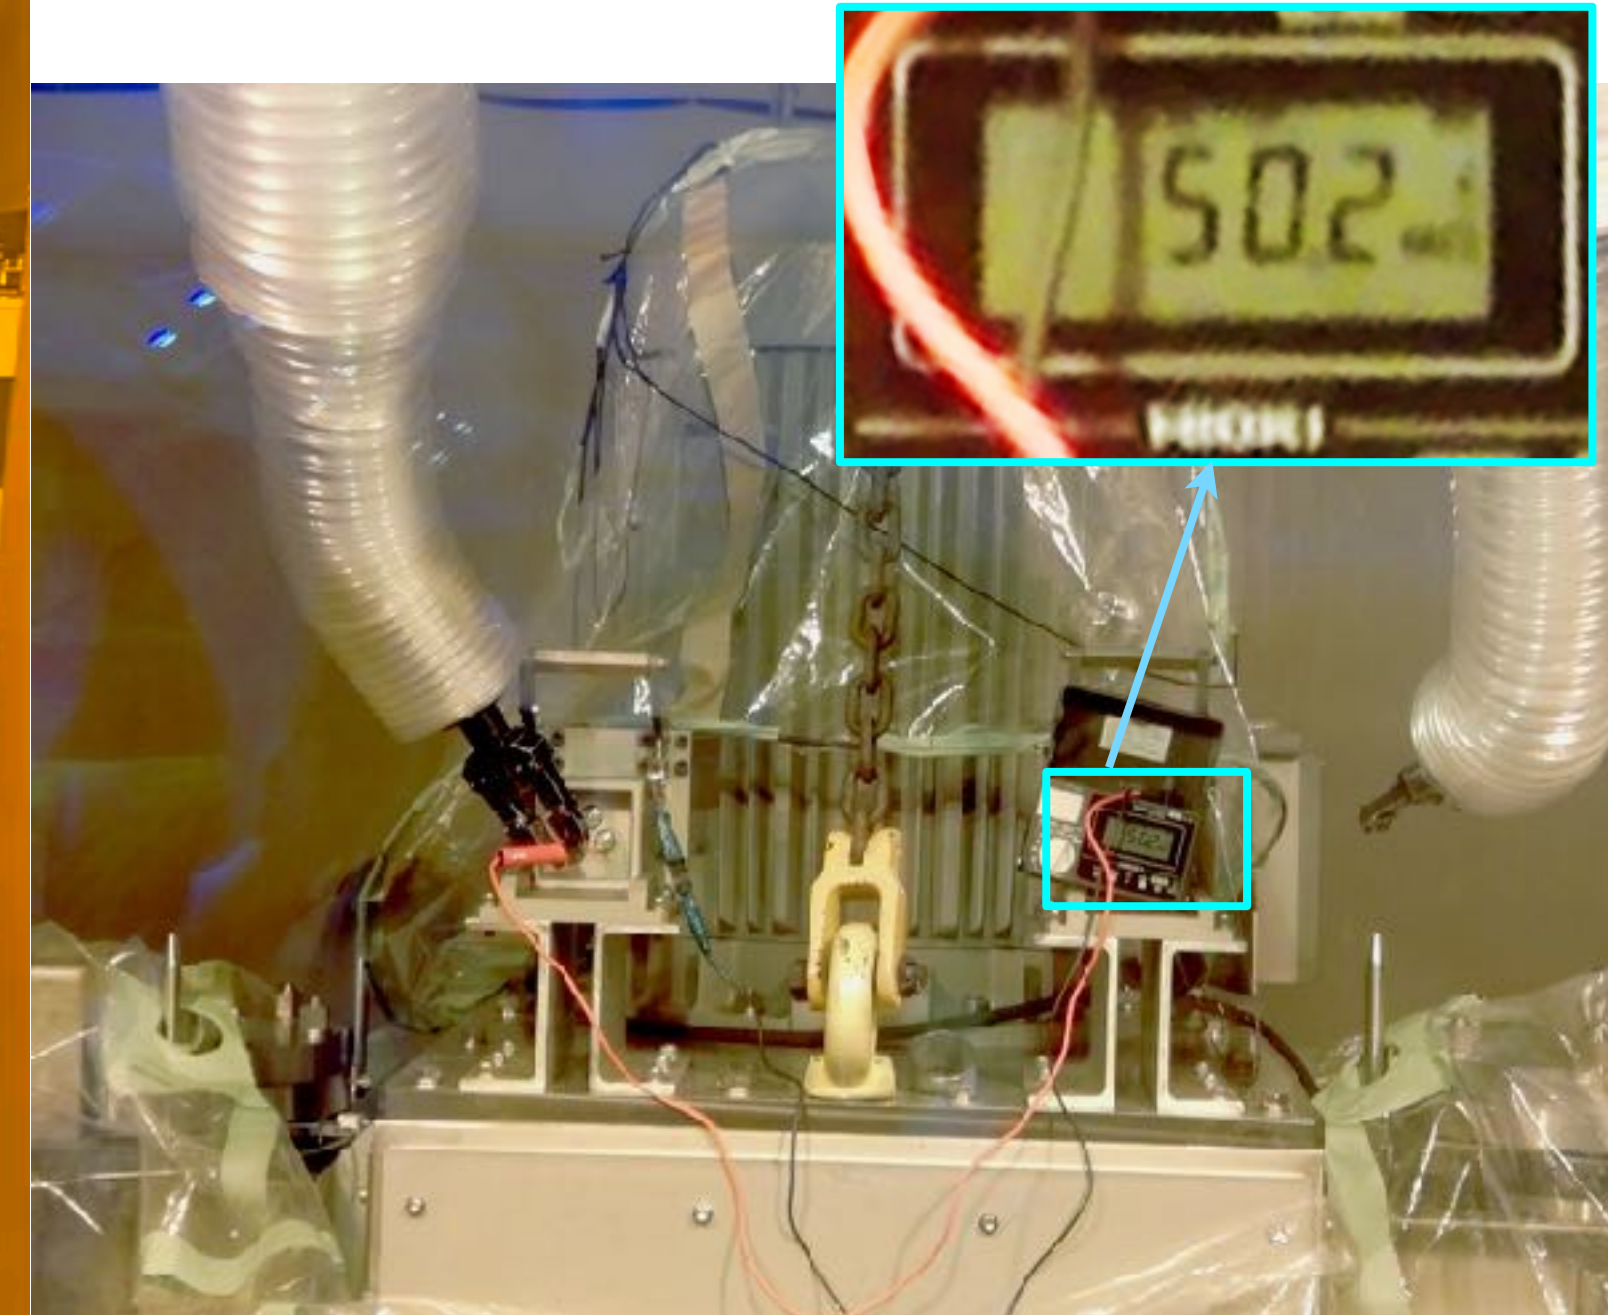
Storage and disposal for used pump issues

- Opening flanges were closed by blank flange with double seal, and temporarily stored in the storage room
- Using remote measurement tool developed after replacement, we confirmed that the pump has sufficient insulation resistance for use
- Due to the size of hatch to the storage room, pump can not stored in the cask and keep as a spare

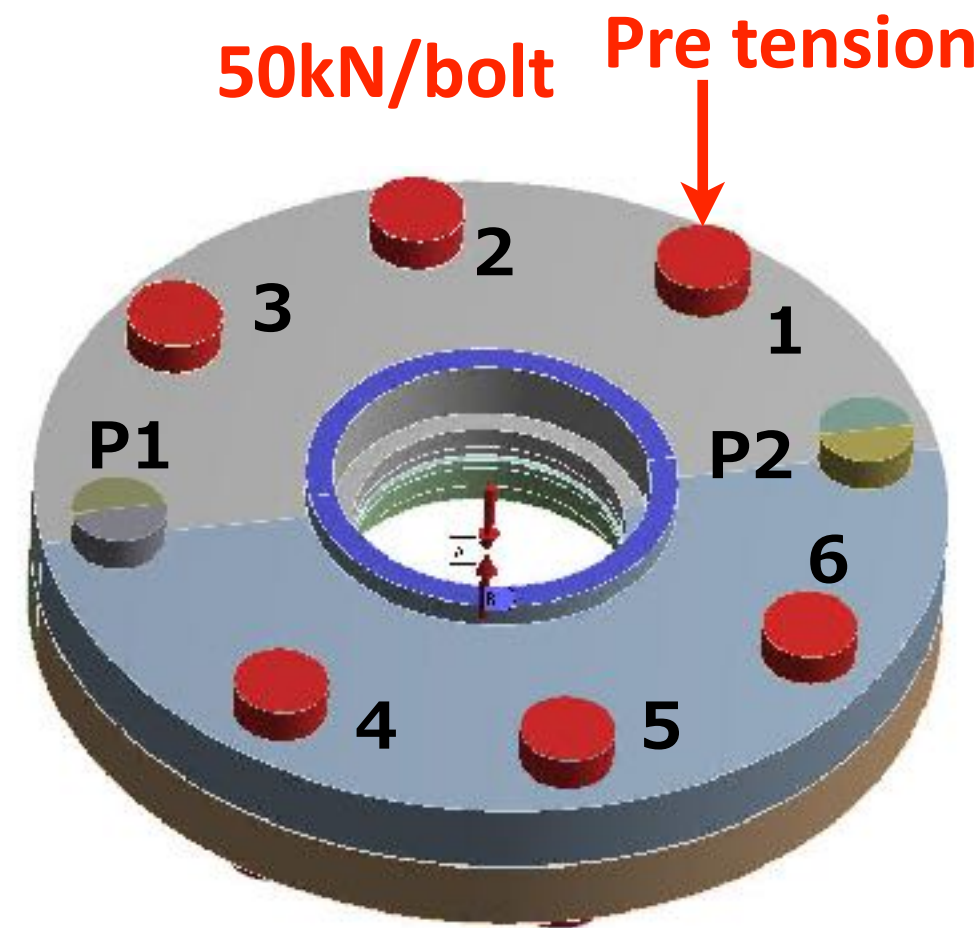
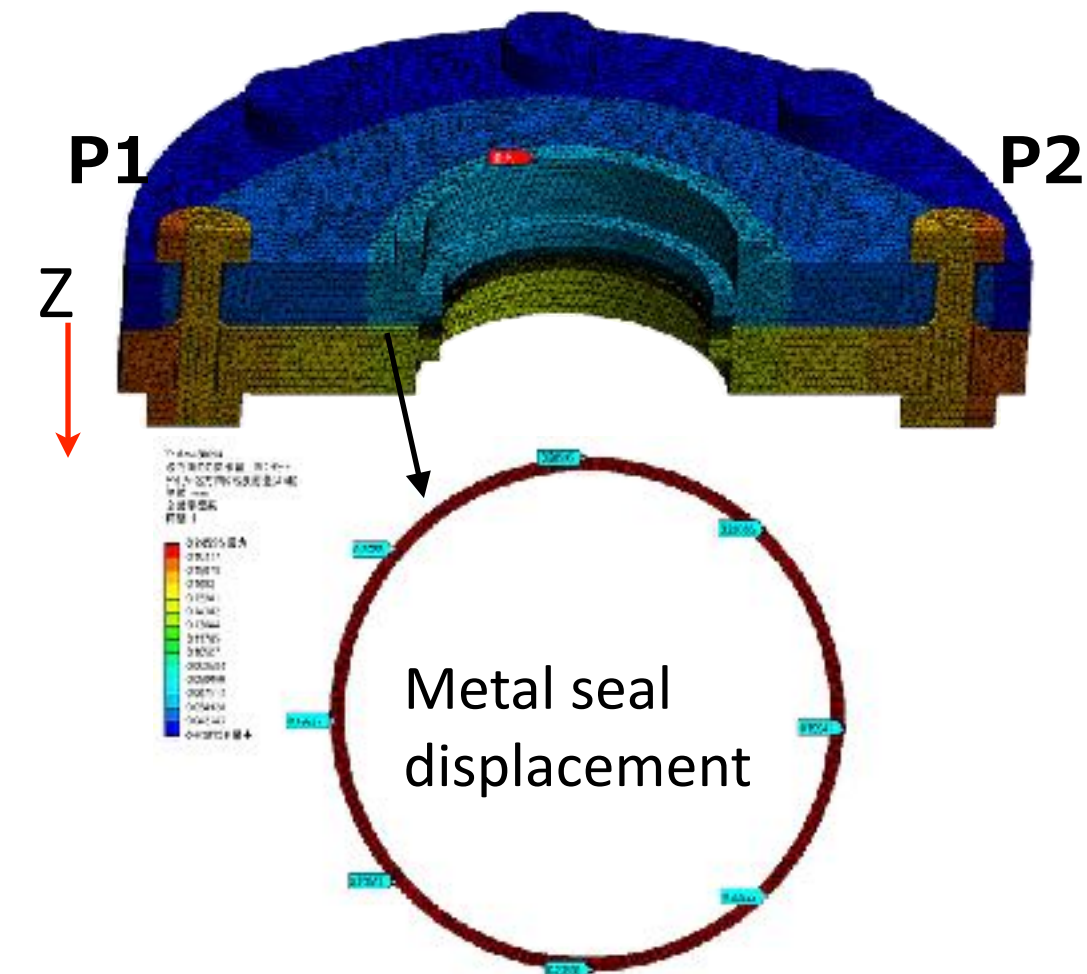
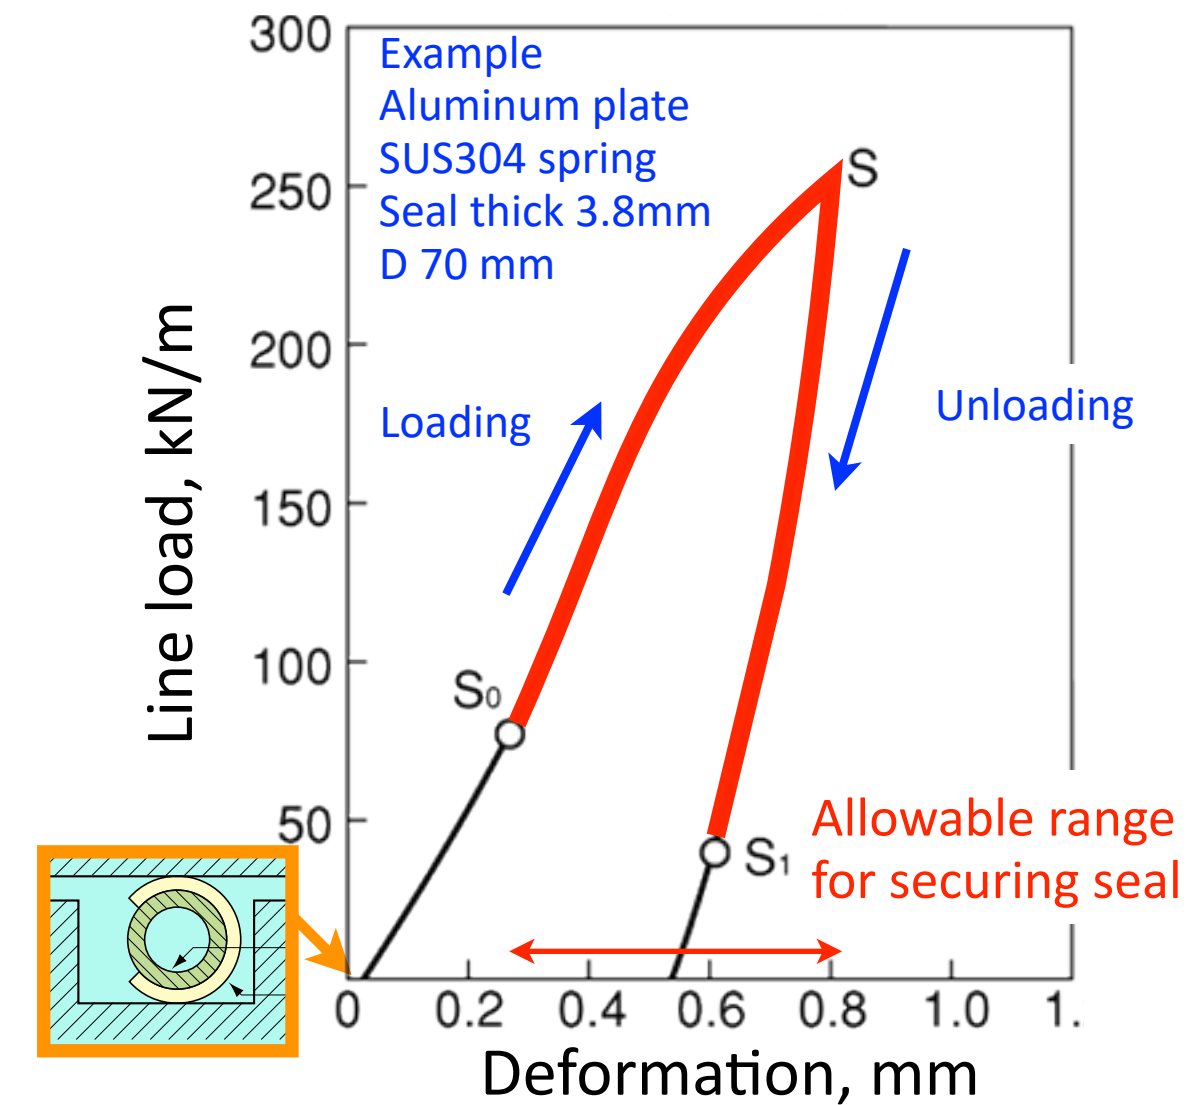
Numerical simulation for metal seal deformation

Bolts	Torque		Normalized seal deformation (Value / Max)							
	Nm	P1	1	2	3	P2	4	5	6	
6	200	0.97	0.98	1.00	0.98	0.97	0.98	1.00	0.98	
8	200	1.00	1.00	1.00	1.00	1.00	1.00	0.99	0.99

- From FEM simulation, current bolt number and layout is enough to deform the metal seal uniformly
- Difference between 6 bolts and 8 bolts are negligible small
