System Acceptance Review - Bifrost

Bifrost – NCRs and NITs
=ESS.NSS.H01.BIFRO

PRESENTED BY LIAM WHITELEGG

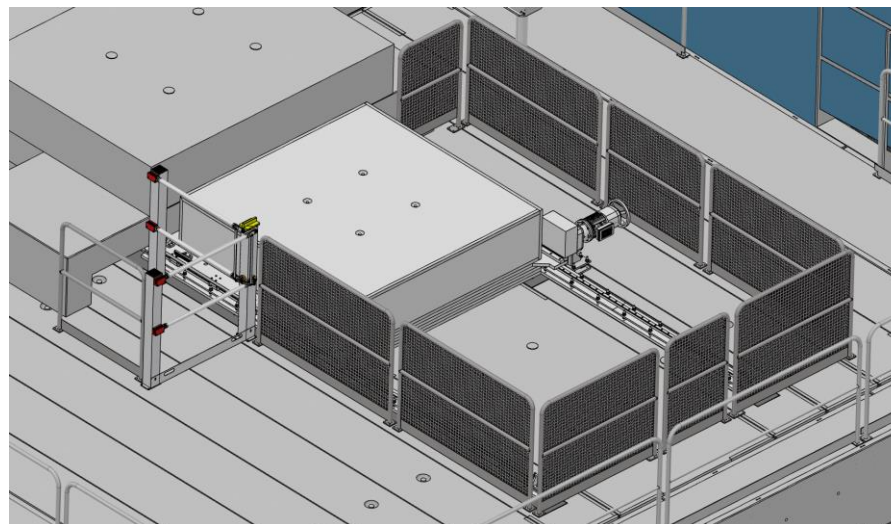
Summary	Issue key	To be resolved by	Notes
Bifrost Cave SAT - Roof Beam Gaps	NIT-226	ORR	To be highlighted as hotspot to RP
Bifrost Cave SAT - Roof Handrails	NIT-227	SAR	Most have arrived. Installation ongoing and awaiting final pieces
Bifrost Cave SAT - Lead Chimneys	NIT-228	SAR	One almost complete. One lead chimney to be built. One heavy concrete chimney ordered
Installation of Borated Poly Plug in Cave Wall	NIT-251	ORR	Ordered. Delivery Week 40
Bifrost False Floor North Completion	NIT-263	SRR	Awaiting access to bandsaw
Installation of borated lining in service feedthroughs	NIT-264	SAR	Material on site. Awaiting installation
Enlarge Radius on Beam Stop Borated Aluminium Sheet	NIT-303	SAR	Ordered. Delivery Week 40
Change thrust screw to non-magnetic - Bifrost	NIT-21	ORR	Small screws were labelled non-magnetic but clearly aren't
Bifrost BM4 - Magnetism	NIT-82	ORR	Multiple items on BM4 are magnetic. Some have changed, others need further investigation

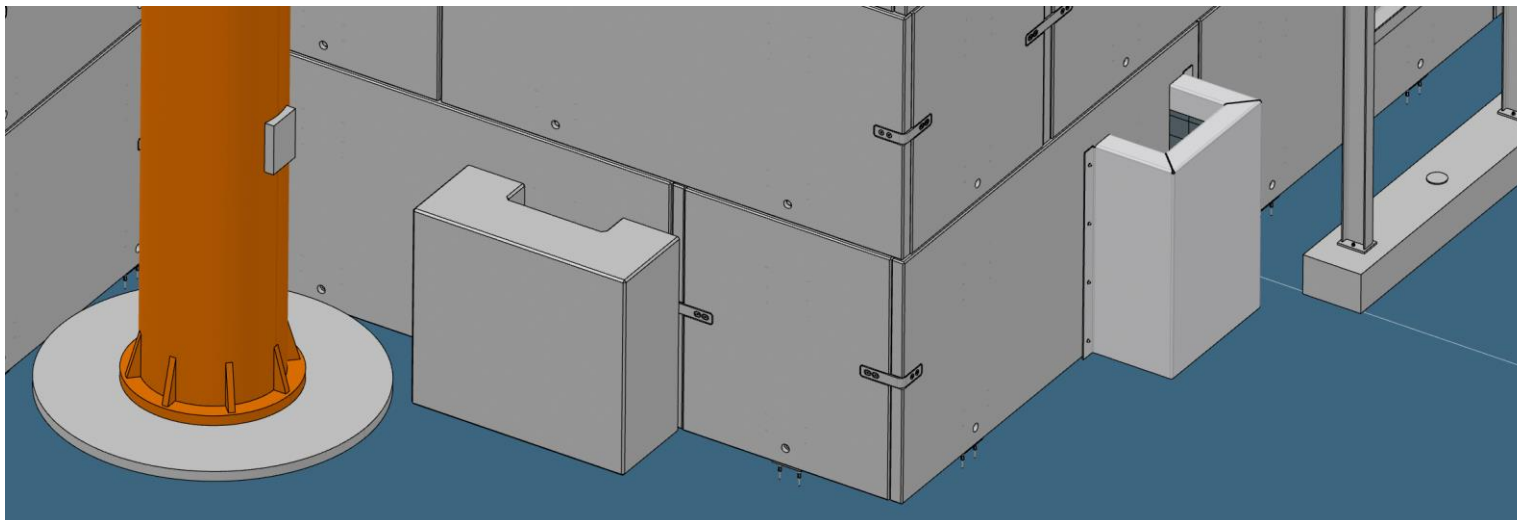
Summary	Issue key	To be resolved by	Notes
Bifrost Cave SAT - Roof Beam Gaps	NIT-226	ORR	To be highlighted as hotspot to RP
Bifrost Cave SAT - Roof Handrails	NIT-227	SAR	Arrived. Installation ongoing and awaiting final pieces
Bifrost Cave SAT - Lead Chimneys	NIT-228	SAR	One almost complete. One lead chimney to be built. One heavy concrete chimney ordered
Installation of Borated Poly Plug in Cave Wall	NIT-251	ORR	Ordered. Delivery Week 40
Bifrost False Floor North Completion	NIT-263	SRR	Awaiting access to bandsaw
Installation of borated lining in service feedthroughs	NIT-264	SAR	Material on site. Awaiting installation
Enlarge Radius on Beam Stop Borated Aluminium Sheet	NIT-303	SAR	Ordered. Delivery Week 40
Change thrust screw to non-magnetic - Bifrost	NIT-21	ORR	Small screws were labelled non-magnetic but clearly are
Bifrost BM4 - Magnetism	NIT-82	ORR	Multiple items on BM4 are magnetic. Some have changed, others need further investigation

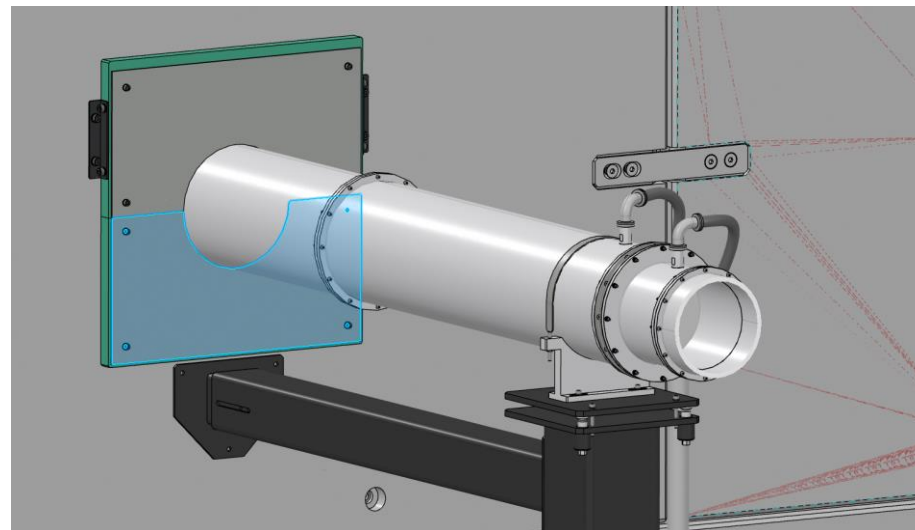
Summary	Issue key	To be resolved by	Notes
Bifrost Cave SAT - Roof Beam Gaps	NIT-226	ORR	To be highlighted as hotspot to RP
Bifrost Cave SAT - Roof Handrails	NIT-227	SAR	Arrived. Installation ongoing and awaiting final pieces
Bifrost Cave SAT - Lead Chimneys	NIT-228	SAR	One almost complete. One lead chimney to be built. One heavy concrete chimney ordered
Installation of Borated Poly Plug in Cave Wall	NIT-251	ORR	Ordered. Delivery Week 40
Bifrost False Floor North Completion	NIT-263	SRR	Awaiting access to bandsaw
Installation of borated lining in service feedthroughs	NIT-264	SAR	Material on site. Awaiting installation
Enlarge Radius on Beam Stop Borated Aluminium Sheet	NIT-303	SAR	Ordered. Delivery Week 40
Change thrust screw to non-magnetic - Bifrost	NIT-21	ORR	Small screws were labelled non-magnetic but clearly are
Bifrost BM4 - Magnetism	NIT-82	ORR	Multiple items on BM4 are magnetic. Some have changed, others need further investigation

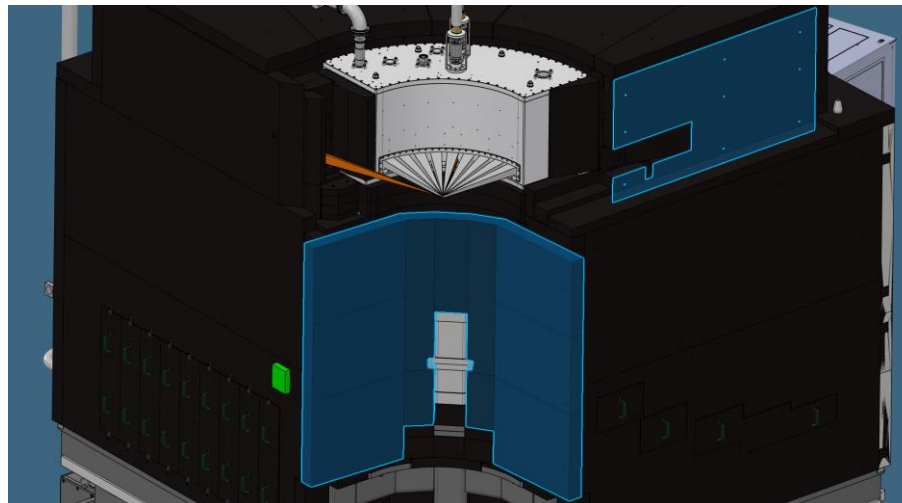
Summary	Issue key	To be resolved by	Notes
Bifrost Analyser - Performance Check	NIT-224	ORR	NIT used to highlight a potential future weakness
Bifrost Spectrometer Polyethylene	NIT-230	SAR	Material ordered. Delivery Week 40
Modify hard stop on the Bifrost tank	NIT-252	SAR	Changed during commissioning. Design ongoing.
Stainless steel parts on BE filter	NIT-29	ORR	Only problematic when/if polarisation upgrade comes in
Bifrost - Beryllium Filter Adjustment System Amendments	NIT-231	ORR	At high end of adjustment range. Harder to align than necessary.
BIFROST - implement warning in NICOS for low LN2 level in filter	NIT-254	SAR	ECDC – Unable to finalise tests due to concurrent work
BIFROST - implement NICOS warning beryllium filter temperature	NIT-255	SAR	ECDC – Unable to finalise tests due to concurrent work
BIFROST - Integrate tank vacuum pressure gauge level in NICOS	NIT-256	SAR	ECDC – Unable to finalise tests due to concurrent work

BIFROST - Integrate filter vacuum gauge level in NICOS	NIT-257	SAR	ECDC – Unable to finalise tests due to concurrent work
Creation of NICOS warnings for filter vacuum	NIT-306	SAR	ECDC – Need to discuss, implement and test alarm

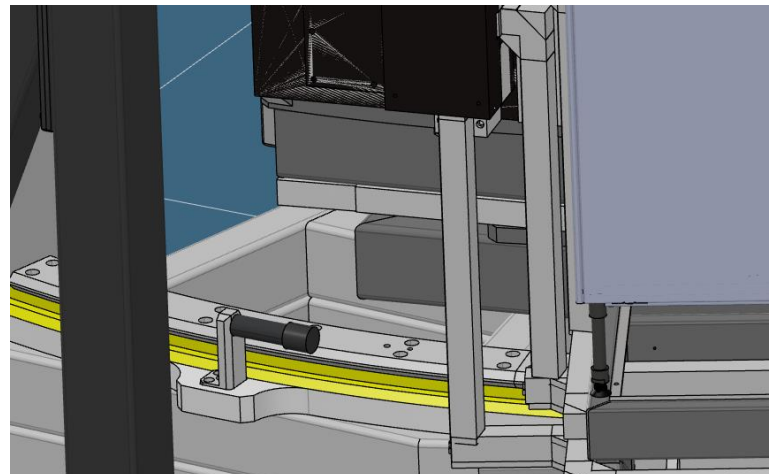
Summary	Issue key	To be resolved by	Notes
Bifrost Analyser - Performance Check	NIT-224	ORR	NIT used to highlight a potential future weakness
Bifrost Spectrometer Polyethylene	NIT-230	SAR	Material ordered. Delivery Week 40
Modify hard stop on the Bifrost tank	NIT-252	SAR	Changed during commissioning. Design ongoing.
Stainless steel parts on BE filter	NIT-29	ORR	Only problematic when/if polarisation upgrade comes in
Bifrost - Beryllium Filter Adjustment System Amendments	NIT-231	ORR	At high end of adjustment range. Harder to align than necessary.
BIFROST - implement warning in NICOS for low LN2 level in filter	NIT-254	SAR	ECDC – Unable to finalise tests due to concurrent work
BIFROST - implement NICOS warning beryllium filter temperature	NIT-255	SAR	ECDC – Unable to finalise tests due to concurrent work
BIFROST - Integrate tank vacuum pressure gauge level in NICOS	NIT-256	SAR	ECDC – Unable to finalise tests due to concurrent work

BIFROST - Integrate filter vacuum gauge level in NICOS	NIT-257	SAR	ECDC – Unable to finalise tests due to concurrent work
Creation of NICOS warnings for filter vacuum	NIT-306	SAR	ECDC – Need to discuss, implement and test alarm. Meeting next week

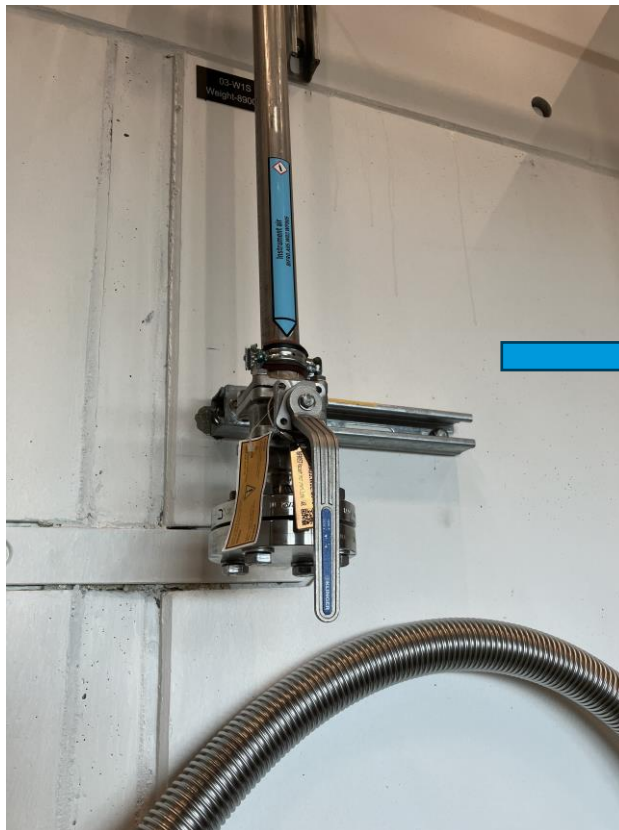
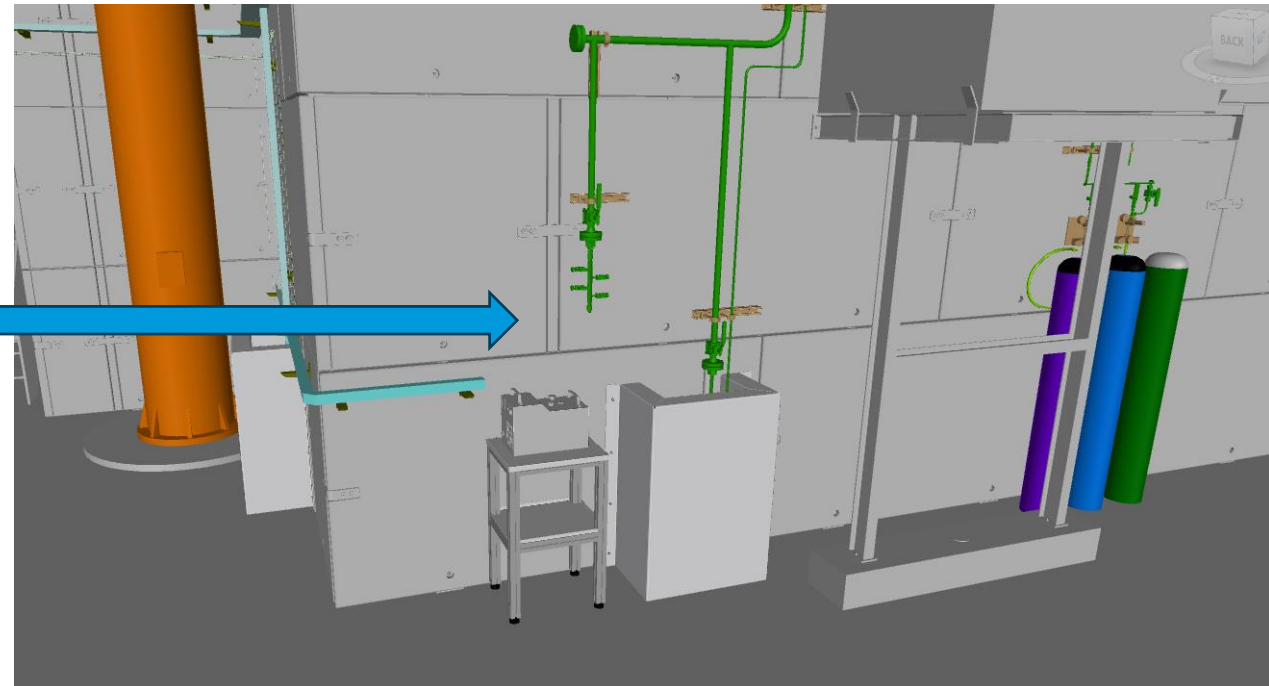
Summary	Issue key	To be resolved by	Notes
CUP Installation of IA Manifold	NIT-232	SAR	Wrong interface installed initially for one pump. New part arrives in October
BM1 Patch Panel and RH	NIT-320	SAR	Potential improvement to the RH accessibility in the bunker
Pipework over Bifrost FOC1	NIT-328	SAR	Pipelines obstructing removal of FOC-1

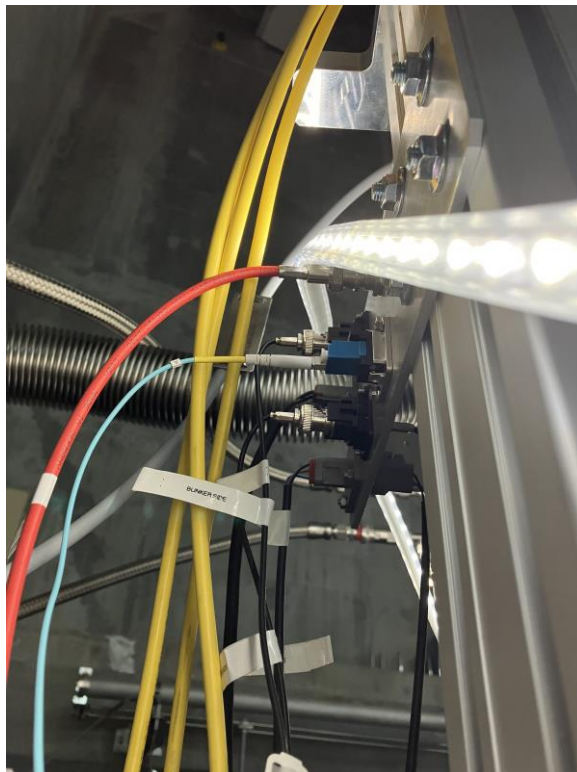
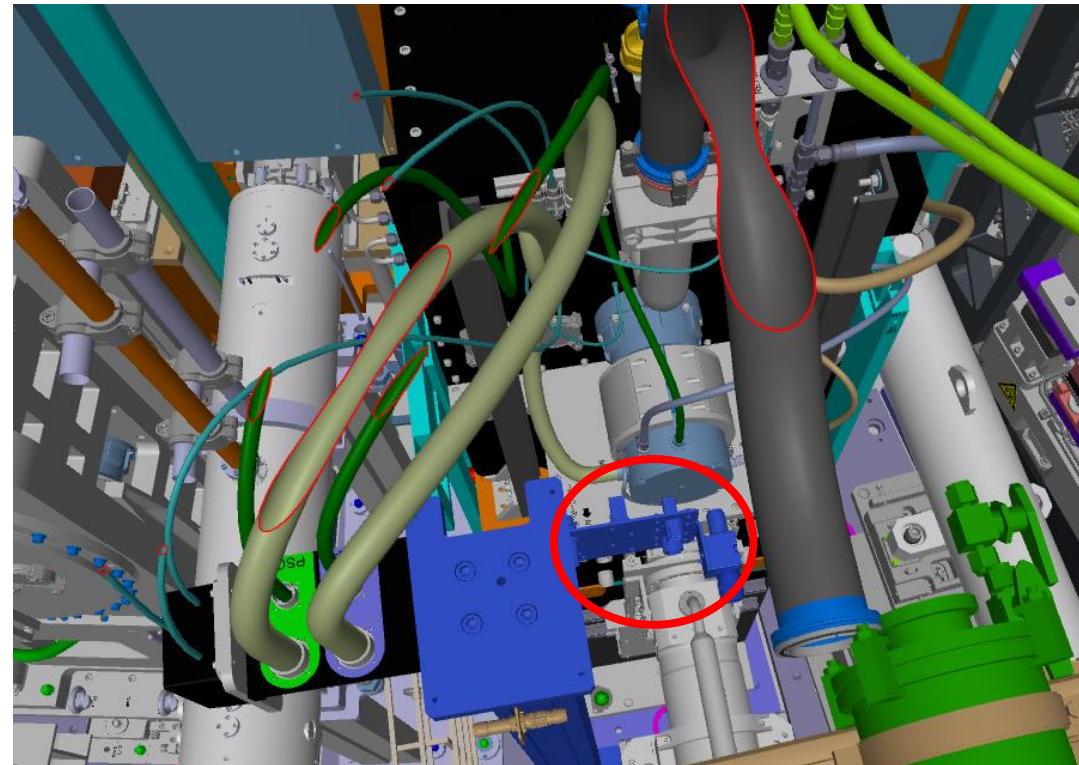
Summary	Issue key	To be resolved by	Notes
CUP Installation of IA Manifold	NIT-232	SAR	Wrong interface installed initially for one pump. New part arrives in October
BM1 Patch Panel and RH	NIT-320	SAR	Potential improvement to the RH accessibility in the bunker
Pipework over Bifrost FOC1	NIT-328	SAR	Pipelines obstructing removal of FOC-1

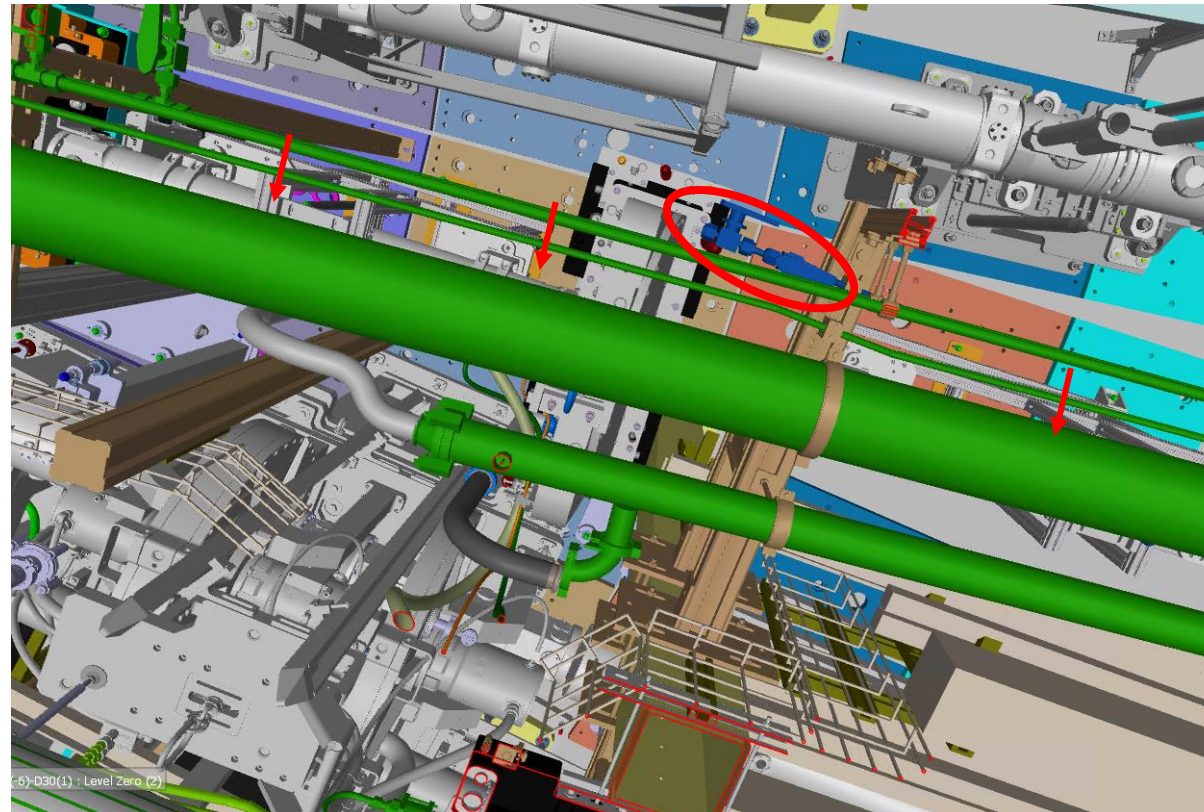
Summary	Issue key	To be resolved by	Notes
CUP Installation of IA Manifold	NIT-232	SAR	Wrong interface installed initially for one pump. New part arrives in October
BM1 Patch Panel and RH	NIT-320	SAR	Potential improvement to the RH accessibility in the bunker
Pipework over Bifrost FOC1	NIT-328	SAR	Pipelines obstructing removal of FOC-1

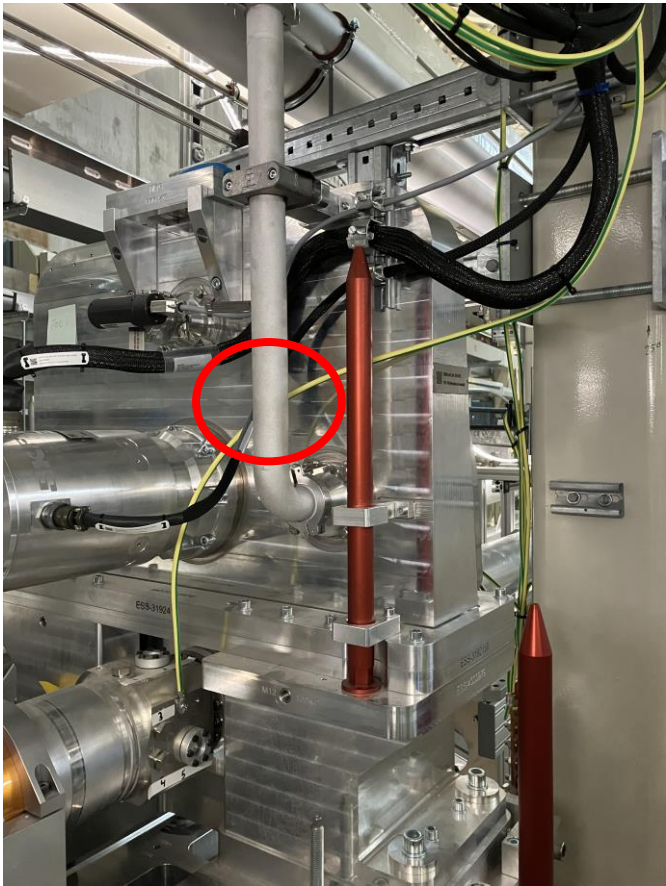
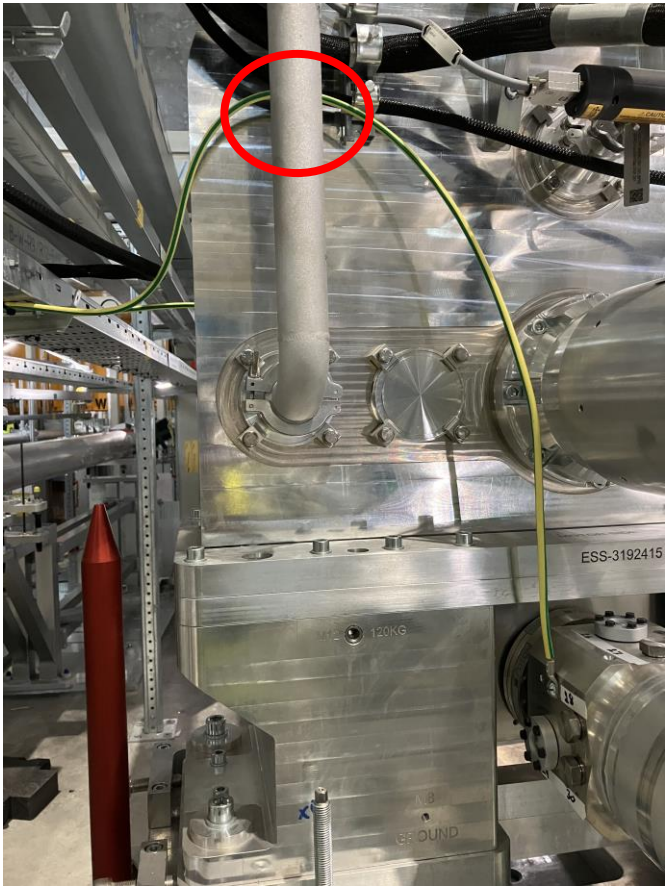
Summary	Issue key	To be resolved by	Notes
Grounding of Components in the Bunker	NIT-241	SAR	Installation Ongoing. Needs amendments
BIFROST Instrument Earthing System	NIT-31	SAR	Below

The BIFROST instrument earthing system is designed to have all components in the instrument zone isolated from the building. These components are connected to the Earth bar in the BIFROST distribution board, which is then connected to the transformer's star point. But during the Detector front-end energization, it was discovered that some racks were not electrically isolated from the building, despite being installed on spacers.

A brief examination was conducted to identify the source of the issue. It was found that the racks were getting connected to the building through the BIFROST distribution board, where all the earth connections meet at the earth bar.

While the low-resistance connection to the building provides a safe equipotential connection to the ground, its potential impact on sensitive equipment such as detectors or beam monitors should be assessed during commissioning.

To find the fault location, CEP should disconnect all earth connections to the distribution board one by one, checking for impact on the isolation of the racks from the building.

- Future steps
 - Run detectors and investigate potential sources of noise
 - Unplug cables within front end cabinet and re-check isolation of modules
 - Run tests with relevant technology groups within cave area
