System Acceptance Review meeting for LoKI

LoKI Neutron Detector System & Detector Electronics
=ESS.NSS.H01.LOKI.B01.B01 & ESS.NSS.H01.LOKI.B01.C01

2025-09-15

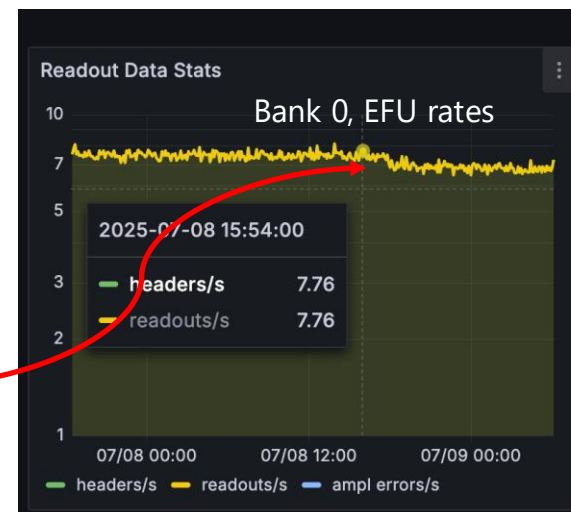
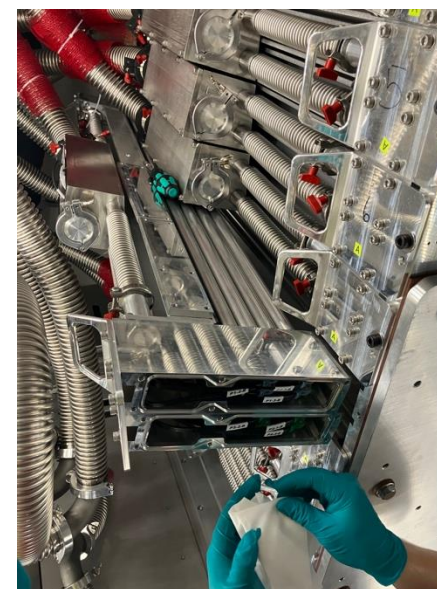
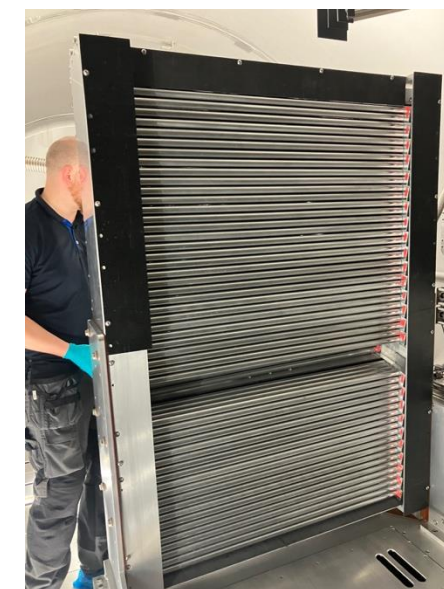
- The tank was closed on July 3 and pumping down started around lunch time.
- Module 9 in Bank 0 switched off by itself on July 8. Any attempt to power it up again failed as the measured leakage current raised above the maximum allowed value for safe operation ($40\text{ }\mu\text{A}$).
- Tank vented a few days later. Module 9 was fully operational at the nominal value of 1.1 kV → we concluded that the module has a vacuum leak.
- All 5 O-rings that ensure the vacuum tightness of the detector module were changed by the Vacuum team on July 15. The problem persisted.

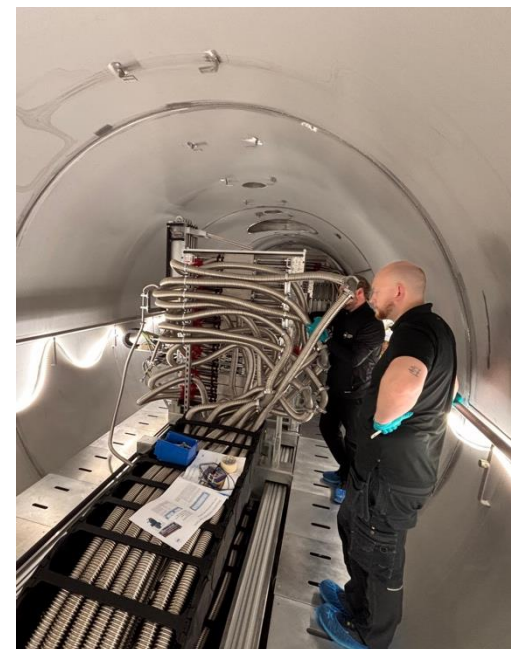
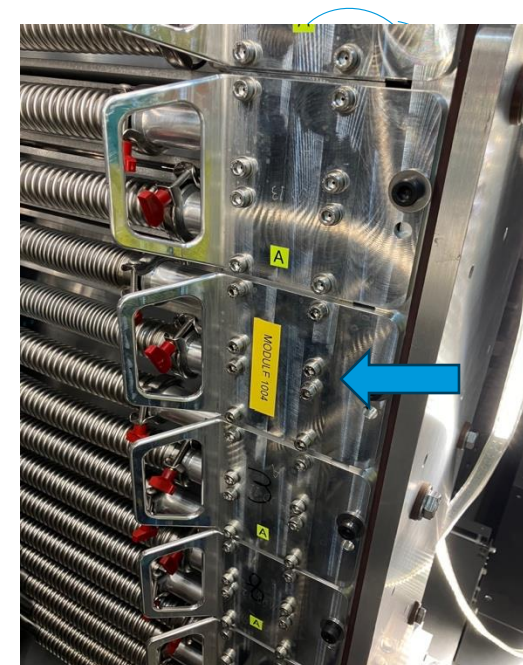
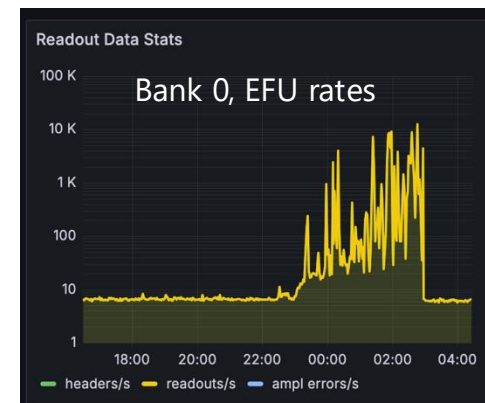
(Grafana rates)

- Since the replacement of the O-rings did not solve the problem, the clamps connecting the cables hoses to the detectors were suspected of leaking, but the vacuum team could not detect any.
- On August 14, Module 9 was replaced with Module 1004 (ISIS ID), one of the modules delivered to ESS this summer to complete the Loki detector Full-Scope.

- Module 6 in Bank 0 tripped on August 28. Symptoms were similar to those observed for Module 0 → vacuum leak.

We suspect that the observed vacuum leaks are caused by the routing, movement and attachment of the long and heavy cable hoses to the detector modules.

Loki detector modules are not ready for hot-commissioning – the cause for the vacuum leaks of the modules must be understood.
