# System Acceptance Review meeting for DREAM

**DREAM Neutron Detector System & Detector Electronics**

ESS.NSS.H01.DREAM.B01.B01 & ESS.NSS.H01.DREAM.B01.C01

2026-03-26

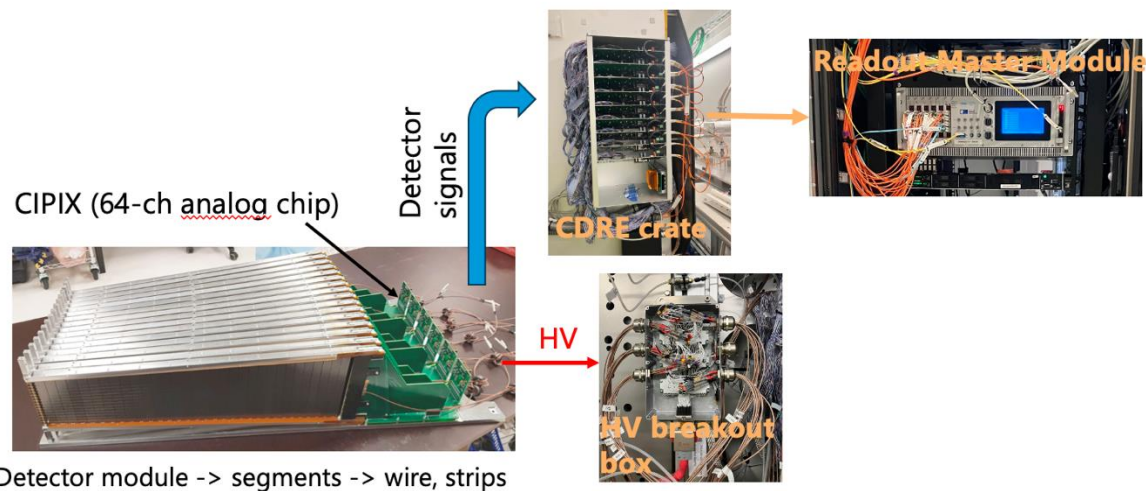
Failed test cases	NIT	Comments
2	<p><b>Inspections (hardware)</b></p> <p>Failed test 2.11: All detector modules are operational.</p>	<p><a href="#">NIT-651</a> - CIPIX error, SUMO5, Ring 1 / FEN1 (EndCap BW, Sector 9)</p> <p>CIPIX – the analogue 64-ch chip performing preamplification and discrimination of the raw signals from the detector.</p> <p><a href="#">NIT-632</a> - CDRE boards are overheating.</p> <p><a href="#">NIT-627</a> - HV issues for the detectors (6 cuboids, 1x SUMO4, 1 Mantle segment).</p> <p><a href="#">NIT-625</a> - Spurious signals (EM interference) observed in the EndCap detector modules.</p>	<p>The manufacturer (CDT) suspects issues in the I2C communication protocol between the chip and the readout board. Suggested a modification of the CDT part of the firmware.</p> <p>Installed active cooling (fans) on the covers of the crates hosting the boards.</p> <p>The manufacturer is informed. Discussions with the instrument team ongoing.</p> <p>The manufacturer installed a RC-filter (low-pass filter) in the HV breakout boxes.</p>

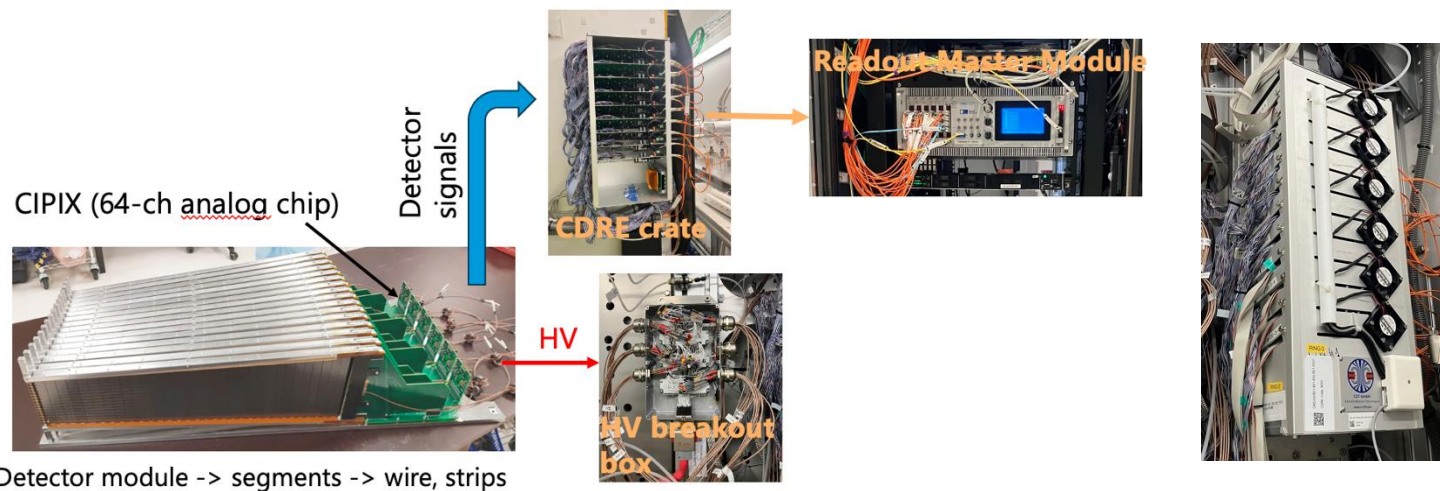
Failed test cases	NIT	Comments
2	<p><b>Inspections (hardware)</b></p> <p>Failed test 2.11: All detector modules are operational.</p>	<p><a href="#">NIT-651</a> - CIPIX error, SUMO5, Ring 1 / FEN1 (EndCap BW, Sector 9)</p> <p>CIPIX – the analogue 64-ch chip performing preamplification and discrimination of the raw signals from the detector.</p> <p><a href="#">NIT-632</a> - CDRE boards are overheating.</p> <p><a href="#">NIT-627</a> - HV issues for the detectors (6 cuboids, 1x SUMO4, 1 Mantle segment).</p> <p><a href="#">NIT-625</a> - Spurious signals (EM interference) observed in the EndCap detector modules.</p>	<p>The manufacturer (CDT) suspects issues in the I2C communication protocol between the chip and the readout board. Suggested a modification of the CDT part of the firmware.</p> <p>Installed active cooling (fans) on the covers of the crates hosting the boards.</p> <p>The manufacturer is informed. Discussions with the instrument team ongoing.</p> <p>The manufacturer installed a RC-filter (low-pass filter) in the HV breakout boxes.</p>

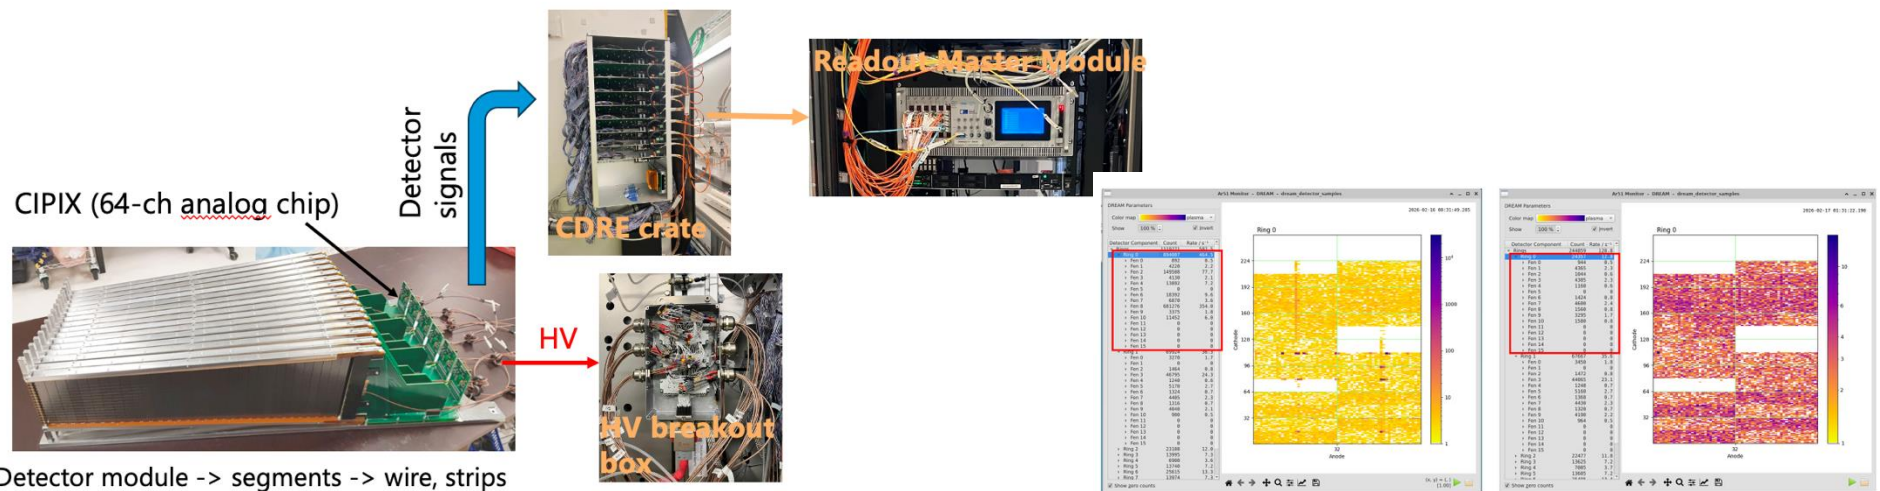
Failed test cases		NIT	Comments
2	<b>Inspections (hardware)</b>  Failed test 2.11: All detector modules are operational.	<a href="#">NIT-651</a> - CIPIX error, SUMO5, Ring 1 / FEN1 (EndCap BW, Sector 9)  CIPIX – the analogue 64-ch chip performing preamplification and discrimination of the raw signals from the detector.	The manufacturer (CDT) suspects issues in the I2C communication protocol between the chip and the readout board. Suggested a modification of the CDT part of the firmware.
		<a href="#">NIT-632</a> - CDRE boards are overheating.	Installed active cooling (fans) on the covers of the crates hosting the boards.
		<a href="#">NIT-627</a> - HV issues for the detectors (6 cuboids, 1x SUMO4, 1 Mantle segment).	The manufacturer is informed. Discussions with the instrument team ongoing.
		<a href="#">NIT-625</a> - Spurious signals (EM interference) observed in the EndCap detector modules.	The manufacturer installed a RC-filter (low-pass filter) in the HV breakout boxes.
