**EUROPEAN
SPALLATION
SOURCE**

Integrated Tests results

ESTIA

2026-06-17

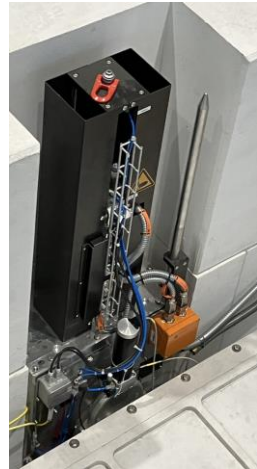
ESTIA instrument shutter - ESS-5949115

- Total 47 tests into 4 different test cases
- 0 failed test cases
- 1 NITs generated:

Following a design change to the air pipe system, [NIT-782](#) trace the retesting. Should the shutter performance change, the report will be revised accordingly.

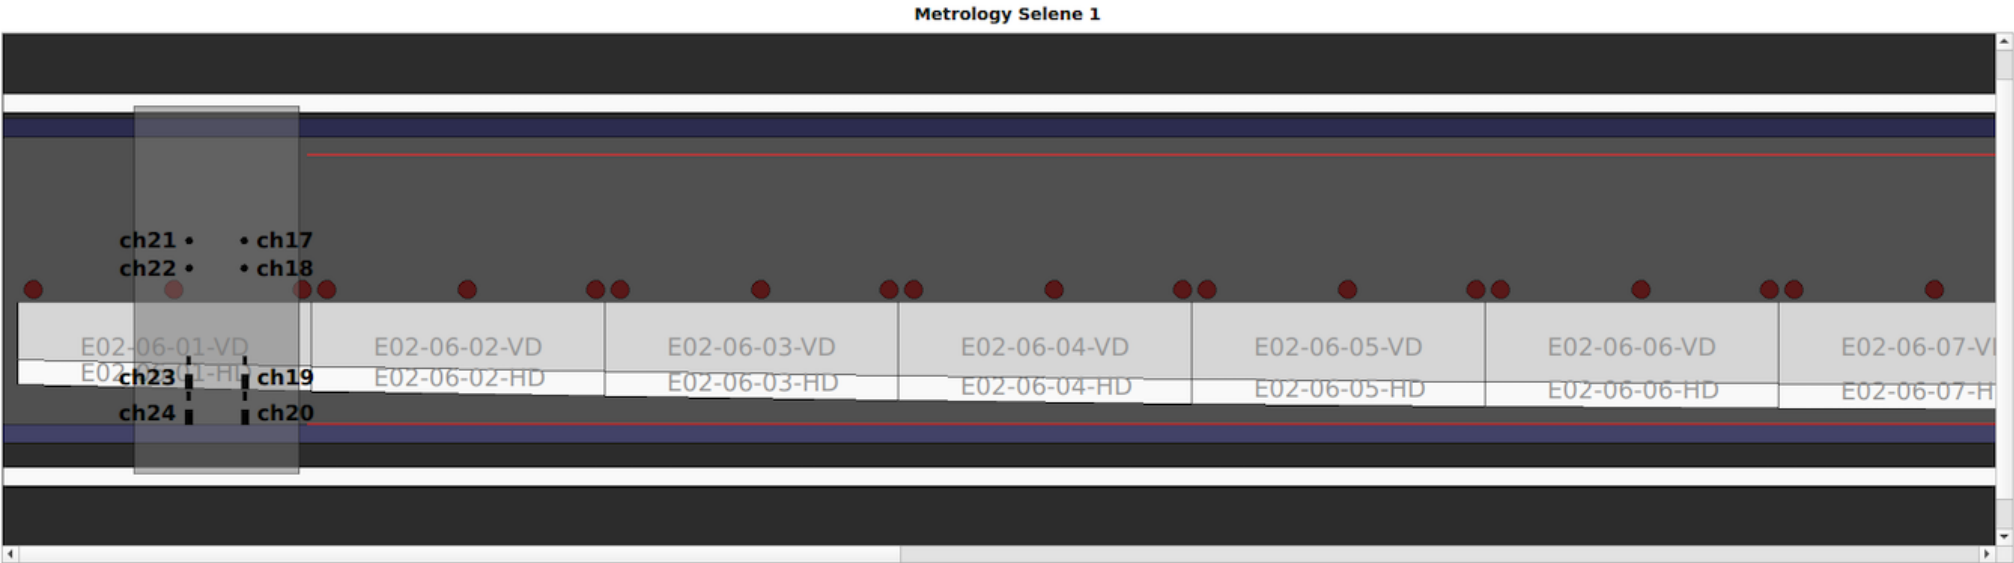
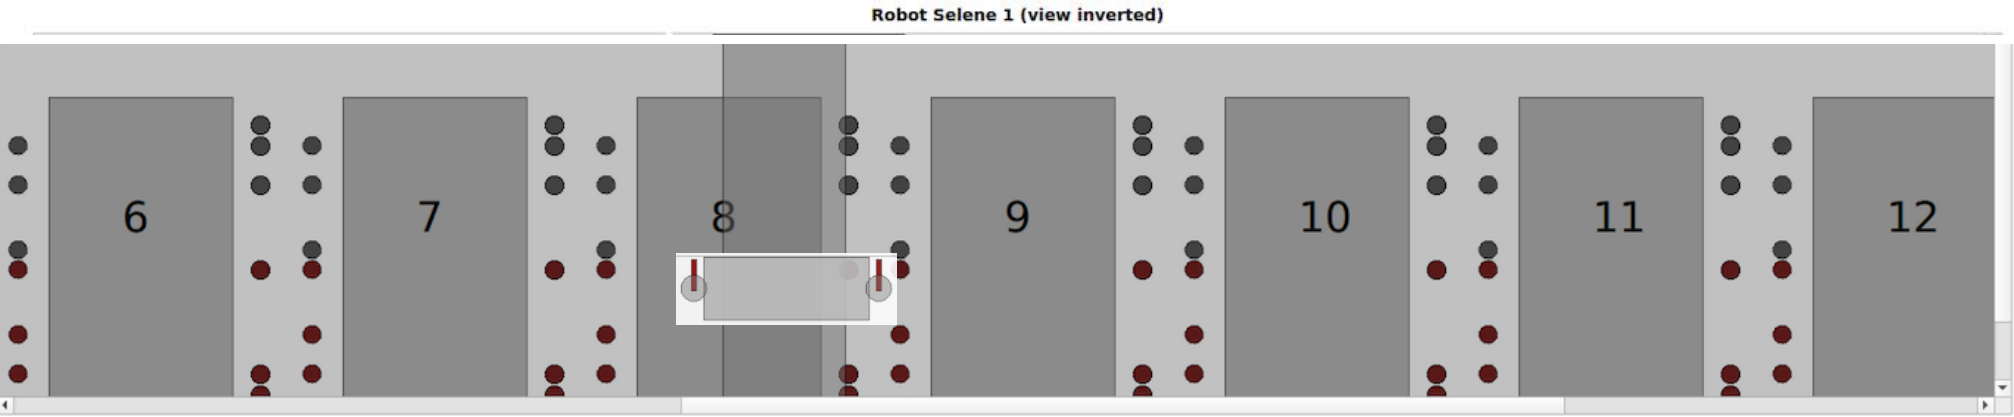
Selene Guides – Graphical User Interface - GUI

- Total 82 test into 4 different test cases
- 8 failed tests
- 1 NIT generated [NIT-817](#):
- All failed tests were due to interferometer not working:

Shut down for 2 years, when we tried to restart a module was not powering on.

- We made progress and managed to update the firmware as required by the manufacturer, which powered the module back on.
- Further problems
