**EUROPEAN
SPALLATION
SOURCE**

Integrated Tests results

ESTIA

2026-06-17

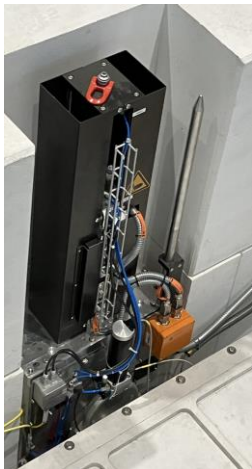
- Total 47 tests into 4 different test cases
- 0 failed test cases
- 1 NITs generated:

Following a design change to the air pipe system, [NIT-782](#) trace the retesting. Should the shutter performance change, the report will be revised accordingly.

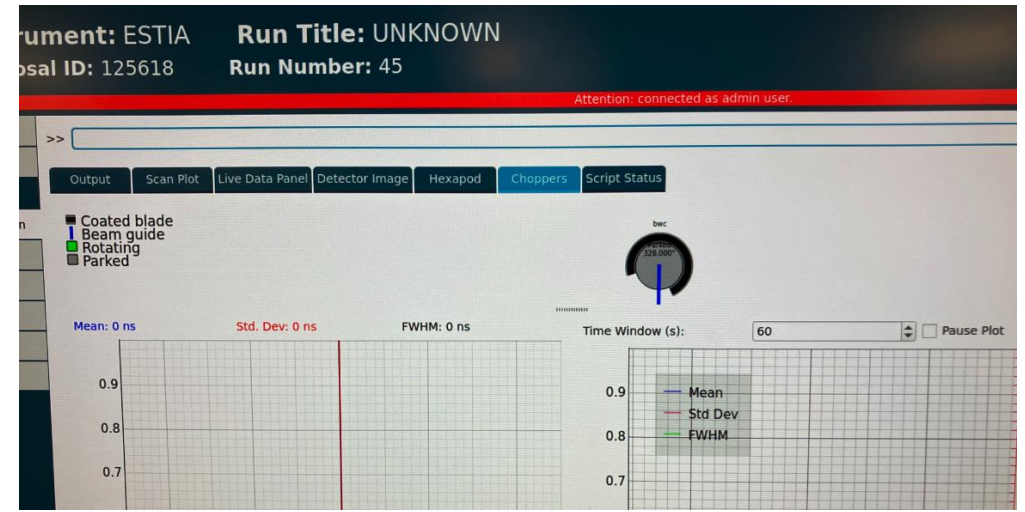
- Total 13 tests into 2 different test cases
- 0 failed test cases
- 3 NITs generated:
 - NeXUs file ([NIT-683](#)) - RESOLVED ✓
 - Fastest way to confirm the phase change ([NIT-681](#)) **for all instruments** - RESOLVED ✓
 - Frequency change causes the phasing to be lost **for all instruments** – ([NIT-682](#)) – **ECDC developing the chopper abstraction layer**
