TECHNICAL REPORT

“Assessment of tungsten bricks (intended for the target of the ESS) according to a technical selection protocol agreed with ESS-Bilbao.

Stage 2 results of tests of three batches selected after Stage 1”

Document Code: MT / 120033-2 / 15 / R 02

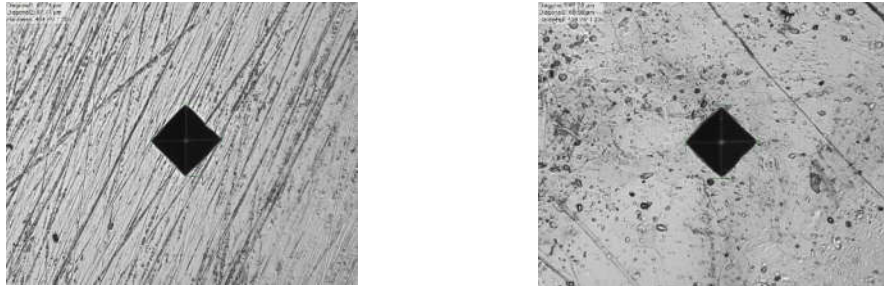
The surface of the new batch under the optical microscope of the hardness tester is manifestly smoother than the surface of the previous batch 5, fig. 1. The aspect of the surface does not allow for assessing the polishing method used; the total absence of scratch lines (confirmed in SEM observations too) points to a possible electro-polishing process.

Figure 1. Example of indentations on the rolling surface of brick 5; stage 1 (left), stage 2 (right).

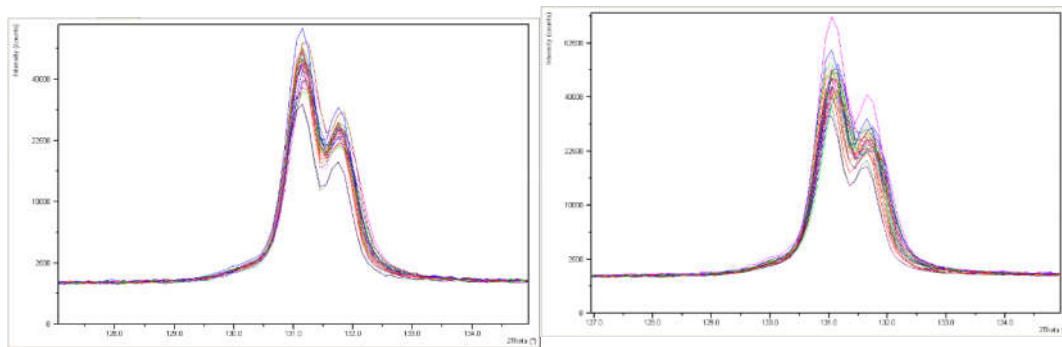
The {321} X-rays diffraction peak results used for measuring the residual stresses in the as-received surface of the polished (St.2) or ground (St.1) brick 5 is given below, fig. 2 (the measurement procedure and analysis was the same in both cases). Qualitatively, the diffraction spectrum after polishing is similar to the spectrum measured before. Quantitatively, the biaxial residual stress state remains compressive but the absolute value of the two stress components is reduced after polishing, Table 2, as it could be expected.

The relatively narrow double peak of fig. 2, ground or polished brick 5, is very different from the surface diffraction peaks of the other bricks, as was noted in the report of the Stage 1 tests. In figure 3 the surface diffraction peak of batch 2 is shown for comparison, the peaks of the other bricks were qualitatively similar. Such broad peak is associated to a deformed structure, the double peak of brick 5 corresponds to a nearly undeformed material. Indeed, the OM and EBSD observations show that the structure of bricks 5 is recrystallized and very different from the structure of bricks 2 or 6, as explained below in this report.

Figure 2. Diffraction spectra from surfaces of brick 5N, polished, left and 5, ground (?), right.

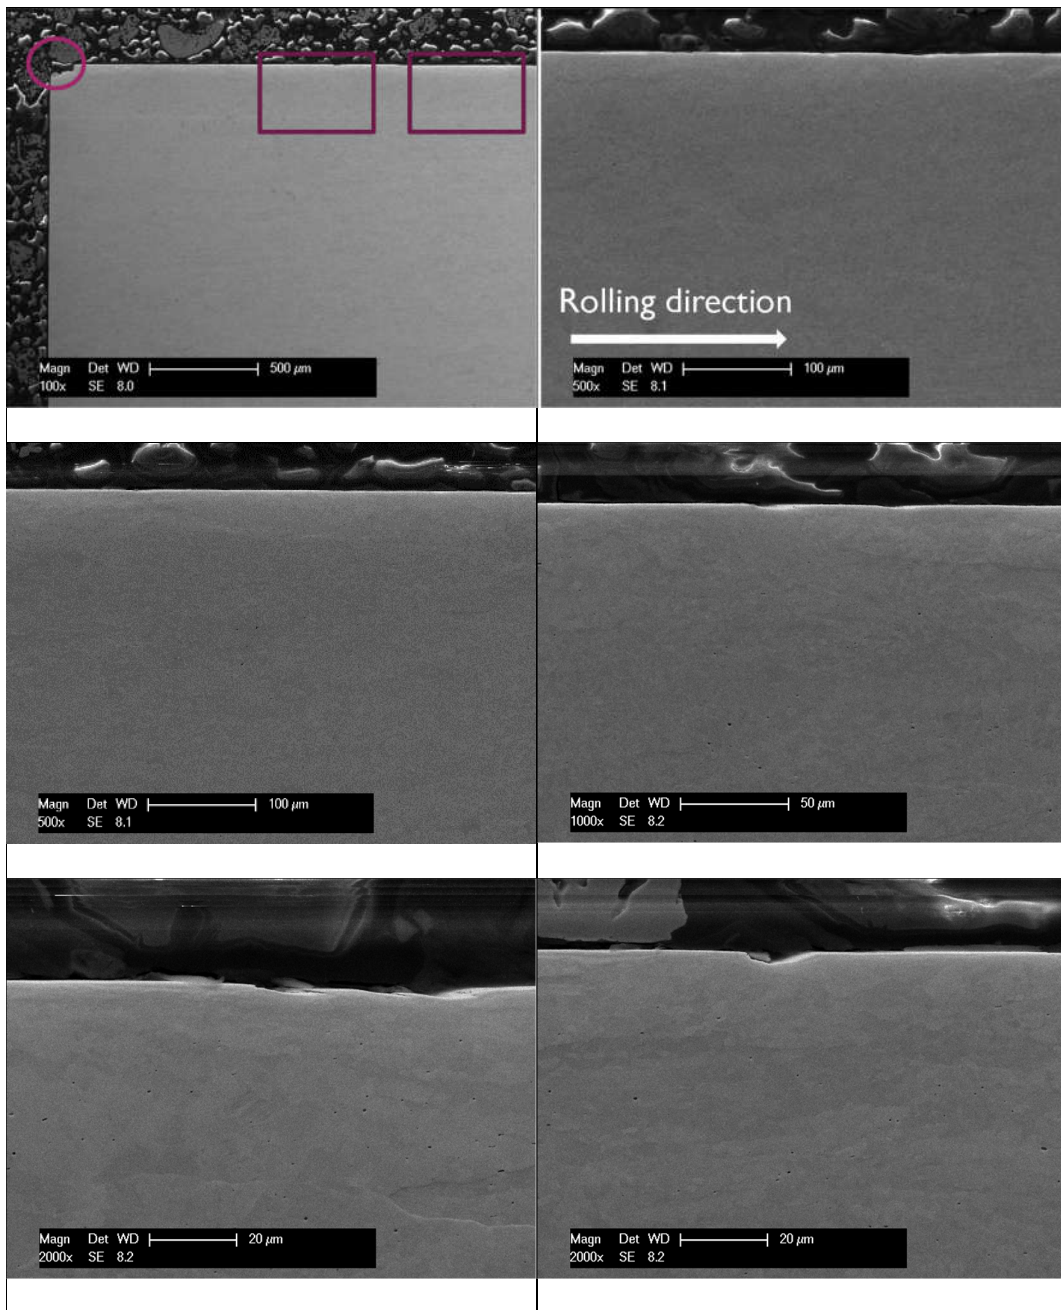
The edges of the LN and NT cross sections have been explored for microcracks or other surface-nucleated defects; the interior, for porosity. Examples of such observations are presented in figures 7-12. The superiority of the surface state (in terms of smoothness and absence of geometrical defects) of brick 5 (polished) is evident. At the surface of brick 6 some folding of the ground subsurface have been detected; again, a more detailed and quantitative characterization should be undertaken for differentiating bricks 2 and 6 with respect to the population of such type of defects. More porosity is detected in brick 2.

Figure 7. Brick 2, unetched, LN section, SEM secondary electrons images. Encircled in the corner of the first image, damage induced by cutting the sample. The edge is free from microcracks, some shallow defects probably associated with the grinding relief observed in fig. 4. Nanoporosity can be seen at high magnification (the two figures at the bottom).

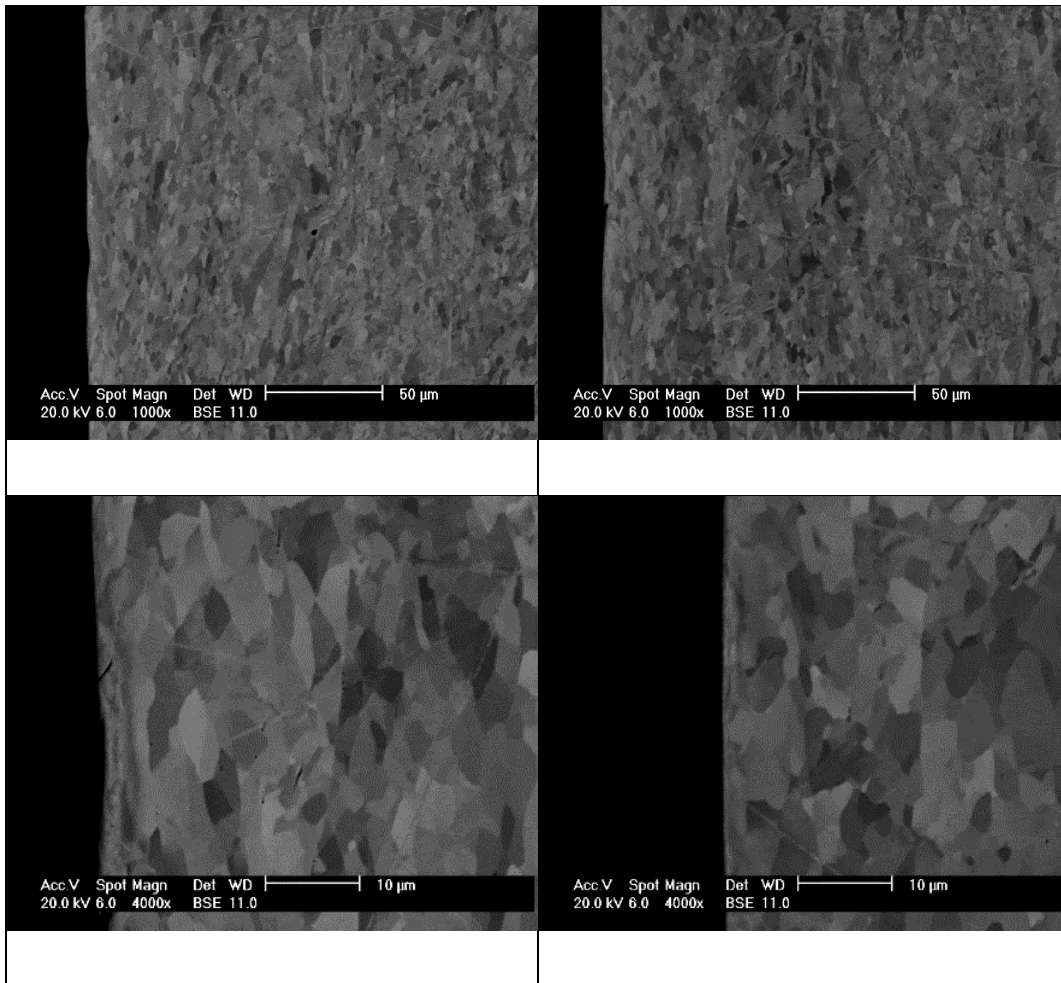
The contrast in SEM images using back-scattered (primary) electrons reveal the grain structure. For instance, they show a very thin sub-surface zone affected by the machining (grinding) deformation in brick no. 6, fig. 16a. In figure 16b, the grain distribution in brick no. 5 is bimodal, with the fraction of fine grains being of micrometric size (about 3 μm).

Figure 16a. BS-SEM images of the edge zone of brick 6, LN section. A heavily affected surface layer of about 3 μm is evident: severely deformed and with some (unfrequent) microcracks (of less than 2 μm).

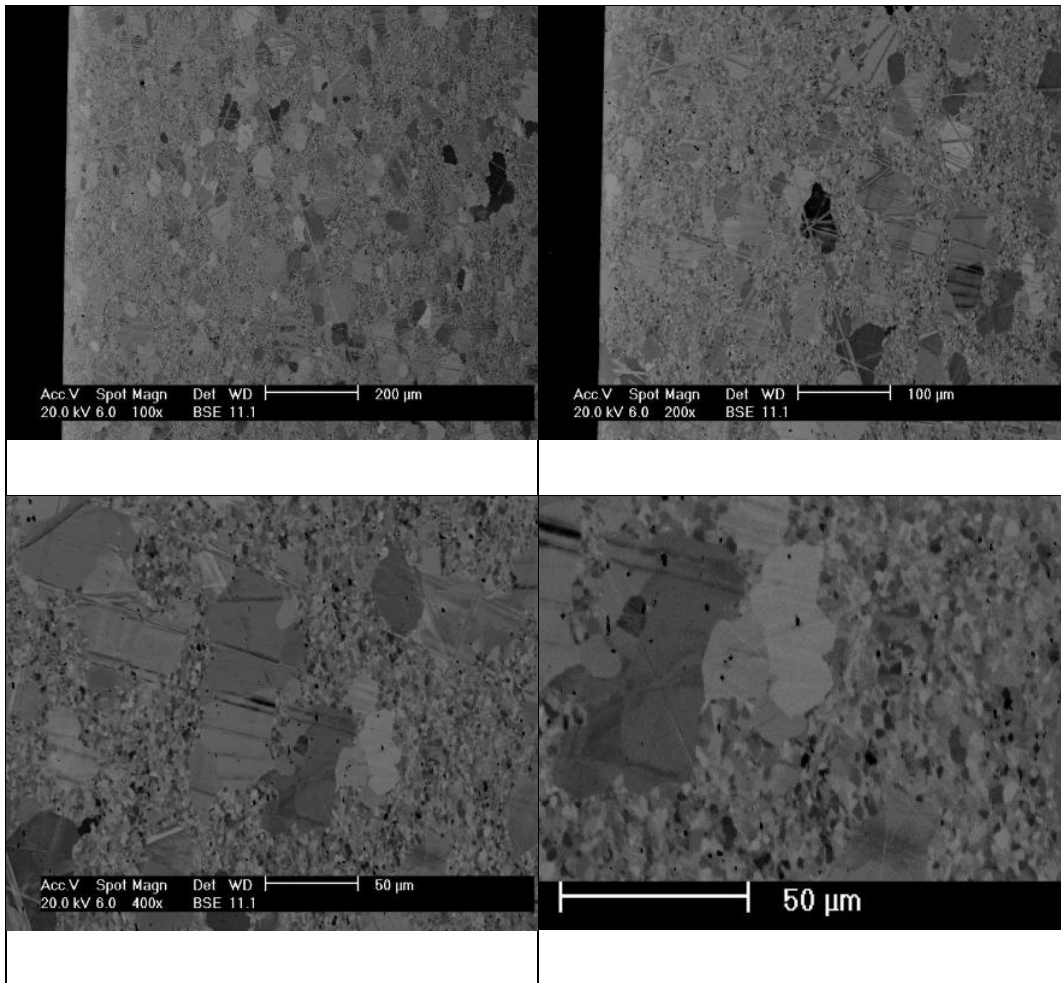
Figure 16b. BS-SEM images of the edge zone of brick 5N, LN section. No evidence of heavily deformed surface layer. Bimodal structure of grains free from substructure. The grain size of the fine fraction is very small.

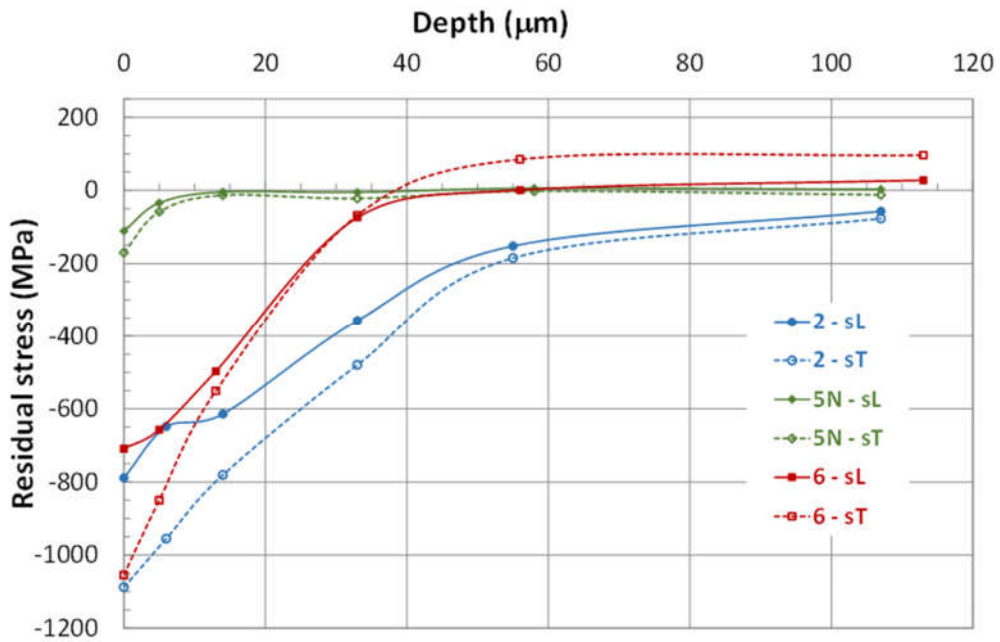
The stress state is near-balanced biaxial in all cases but clear quantitative differences are evident between the three bricks. In ref. 5N, the double, narrow peak at any depth indicates a recrystallized structure. The other two bricks show wide single peaks near the surface that narrow and become double as depth below the surface increases; they are still wider than the peak of brick 5N even below $100 \mu\text{m}$, an indication of their deformed structural state (as SEM-EBSD observations confirm). **The stress state at the free surface is compressive in all cases, but the absolute value of the stresses is very weak for brick 5N and maximum for brick 2.**

The compressive stress state disappears at depths 15, 40 and $> 100 \mu\text{m}$ for respectively bricks 5N, 6 and 2.

Figure 23a. Residual stresses measured in longitudinal and transverse directions on the rolling plane of the three bricks as a function of the sub-surface depth.

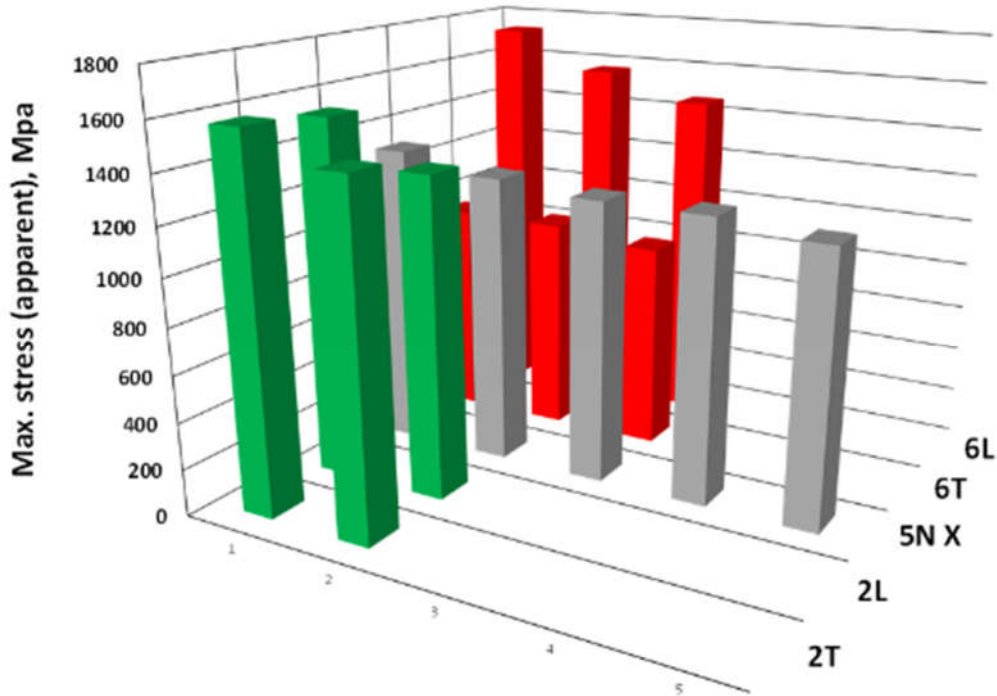
Bending tests in air at 400°C were performed as described in the technical report of Stage I of this study. Unfortunately, the same error in the position of the samples, described in section 2 (above, this report) was made for all the bending tests at 400°C. We thus have not tested the as-received surface in bending, as intended, but the EDM machined surface. The results are comparable among them and correspond to a “worst case” behavior: in air at 400°C with tension applied in the rough, heavily damaged surface obtained by electro-discharge (EDM) machining. Despite that, **in all cases but for orientation T of brick 6, the behavior is above the DBT temperature**, with considerable plastic deformation before fracture, although fracture itself occurs by brittle mechanisms (mixture of intragranular cleavage and intergranular decohesion).

Figure 25. Maximum (apparent) tensile stress, three-point bending tests at 400 °C in air, samples machined (EDM) from the surface of bricks 2, 5N and 6. Tensile stresses applied in longitudinal (L) or transverse (T) orientation, electro-discharge machined surface.

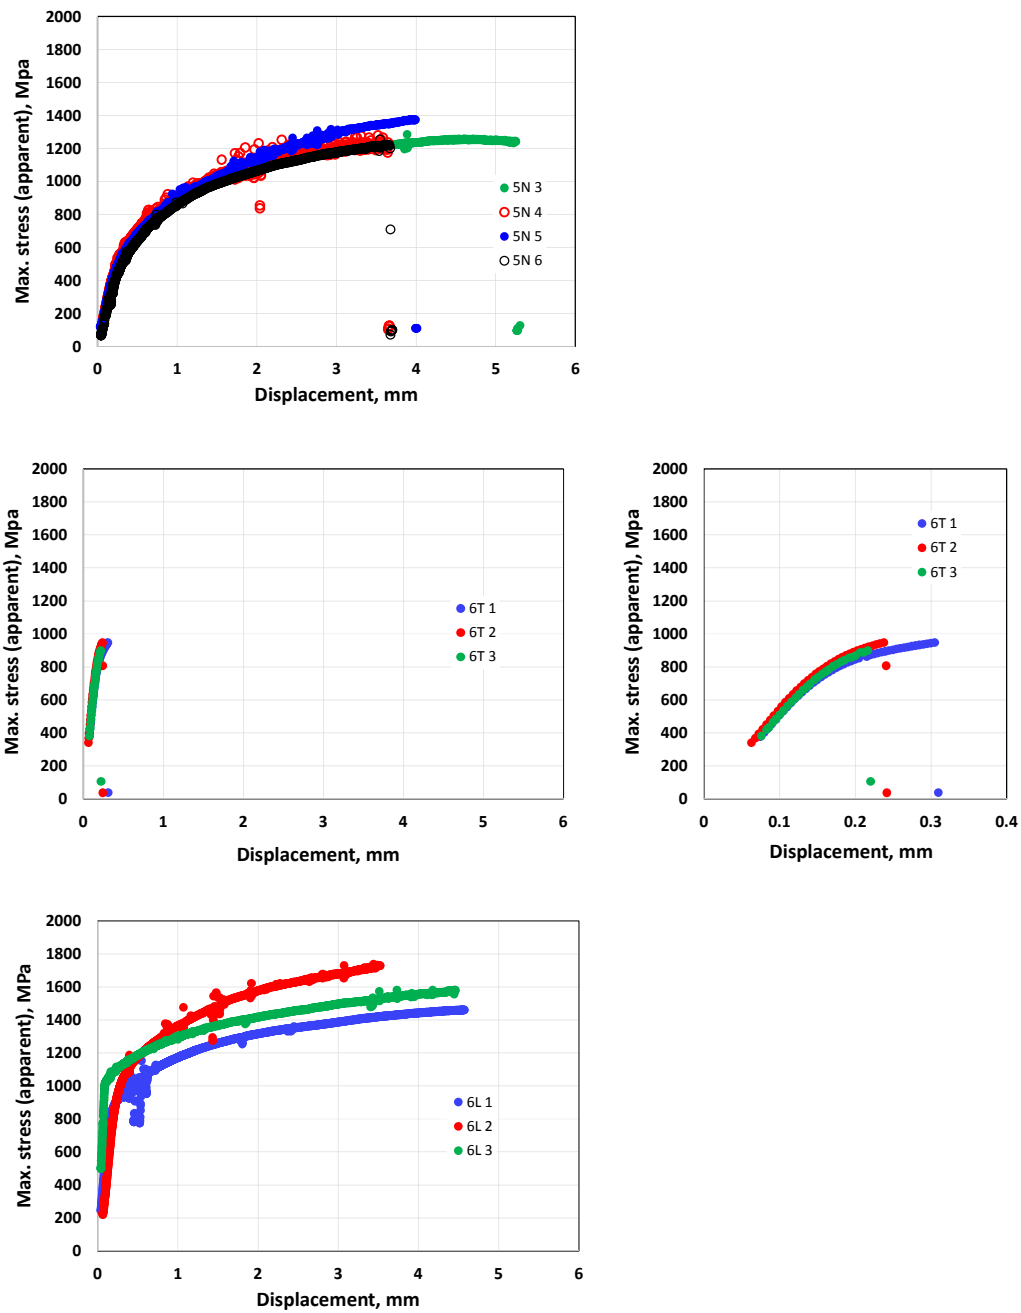
The apparent stress-strain behavior of bricks 5N and 6 is shown in figure 26¹. The yield stresses (elastic limit) are about 600 MPa, 800 MPa and 1000 MPa for, respectively, samples 5N (mixed orientation L or T), 6L and 6T. The tensile strength levels are not much above the limit strength expected from perfect plasticity (eq. 2).

Figure 26. Apparent stress-strain behavior of bricks 5N and 6 at 400°C in air. Elastoplastic behavior and final brittle fracture. The zoom of the response of brick 6L shows that its behavior is elastoplastic too despite its small ductility.

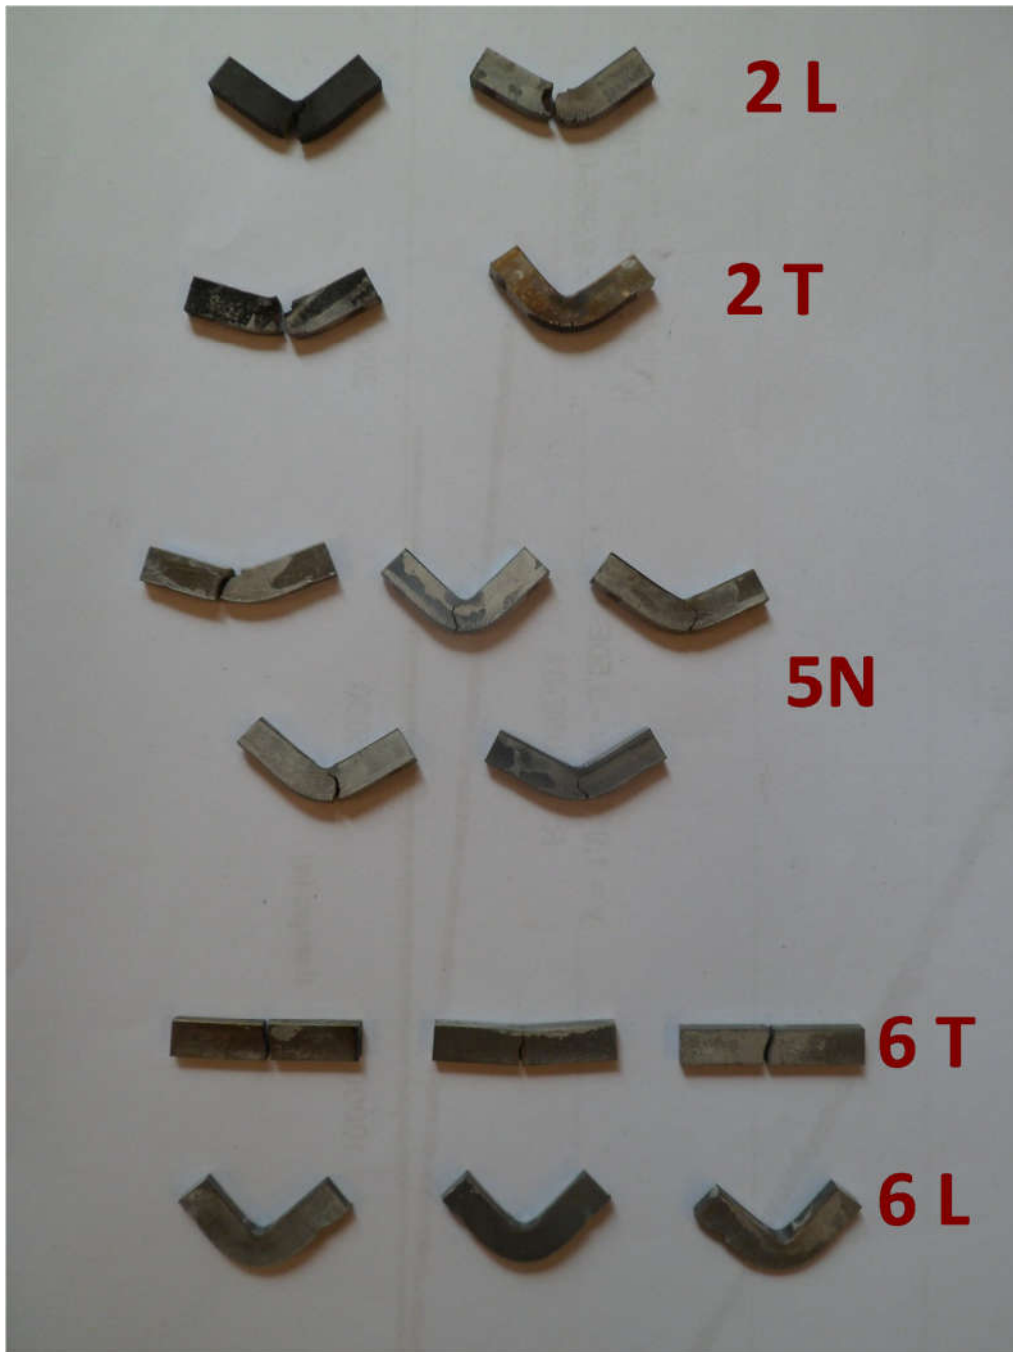
Pictures of the broken bent specimens are shown in fig. 27. The poor ductility of bricks 6T relative to bricks 2 or 5 of any orientation is evident. Such relative poor ductility is not related with the surface state; the anisotropy of the fracture stress is rather similar in the tests performed at room temperature: the ratio of the failure stresses L/T is 2.3 at room temperature (original surface of the bricks) and 1.7 at 400°C (EDM surface).

Figure 27. Bending tests, 400°C in air, broken specimens. The samples had been sprayed prior to testing with BN for protection and lubrication.

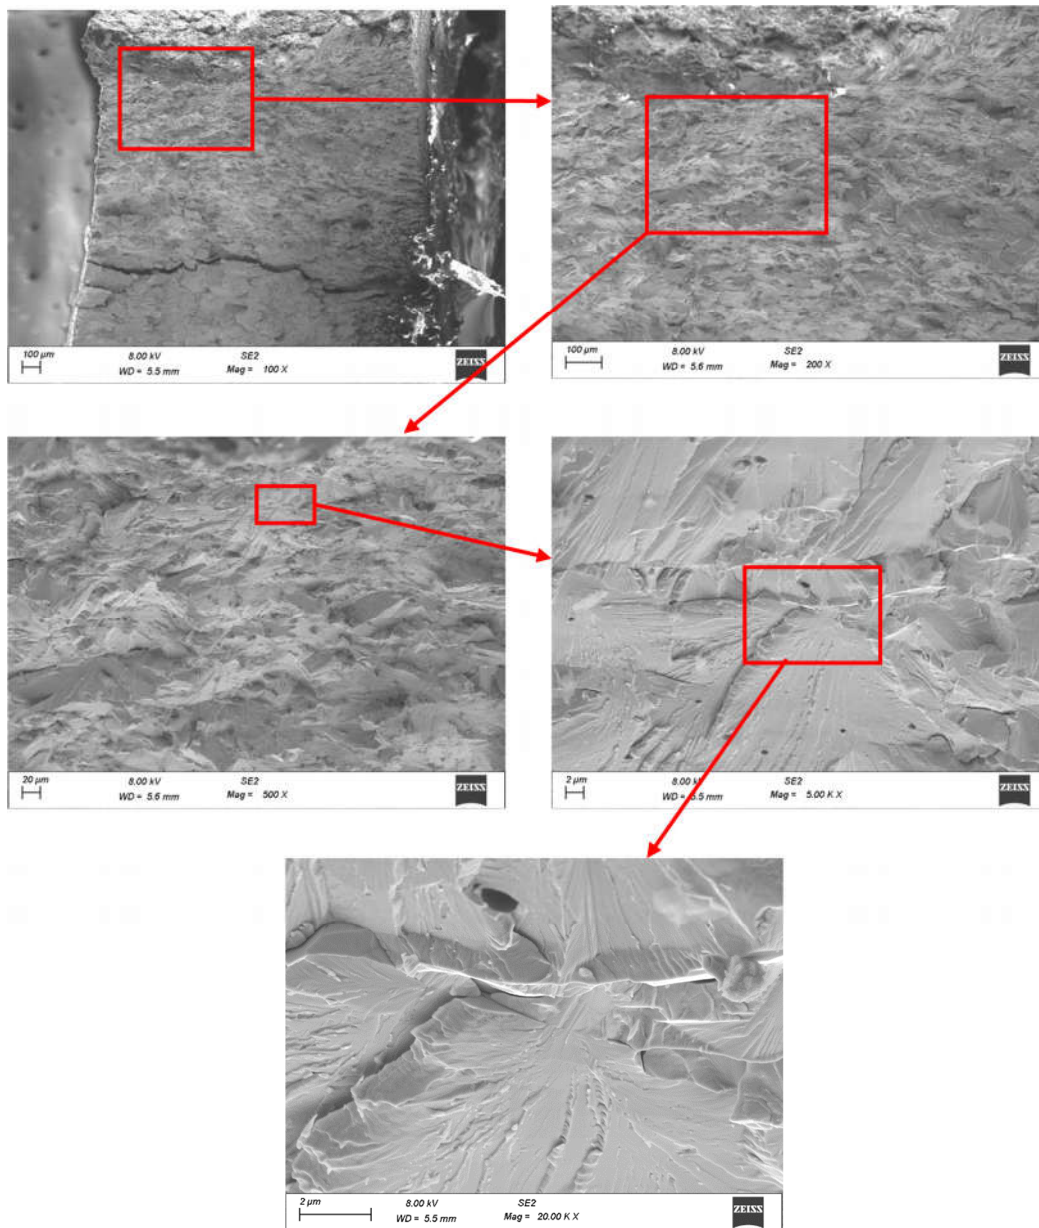
The fractography of different samples is displayed in figs. 28-33. Testing in air at 400°C has produced some surface oxidation. Qualitatively, it seems that the fraction of intergranular decohesion is the smaller for sample 2, where cleavage prevails and the fracture surface is rougher.

Figure 28. Fracture surface of sample 2 L (1). Direction T horizontal. Mainly distorted cleavage facets, small intergranular fracture surface fraction. Submicrometric pores.

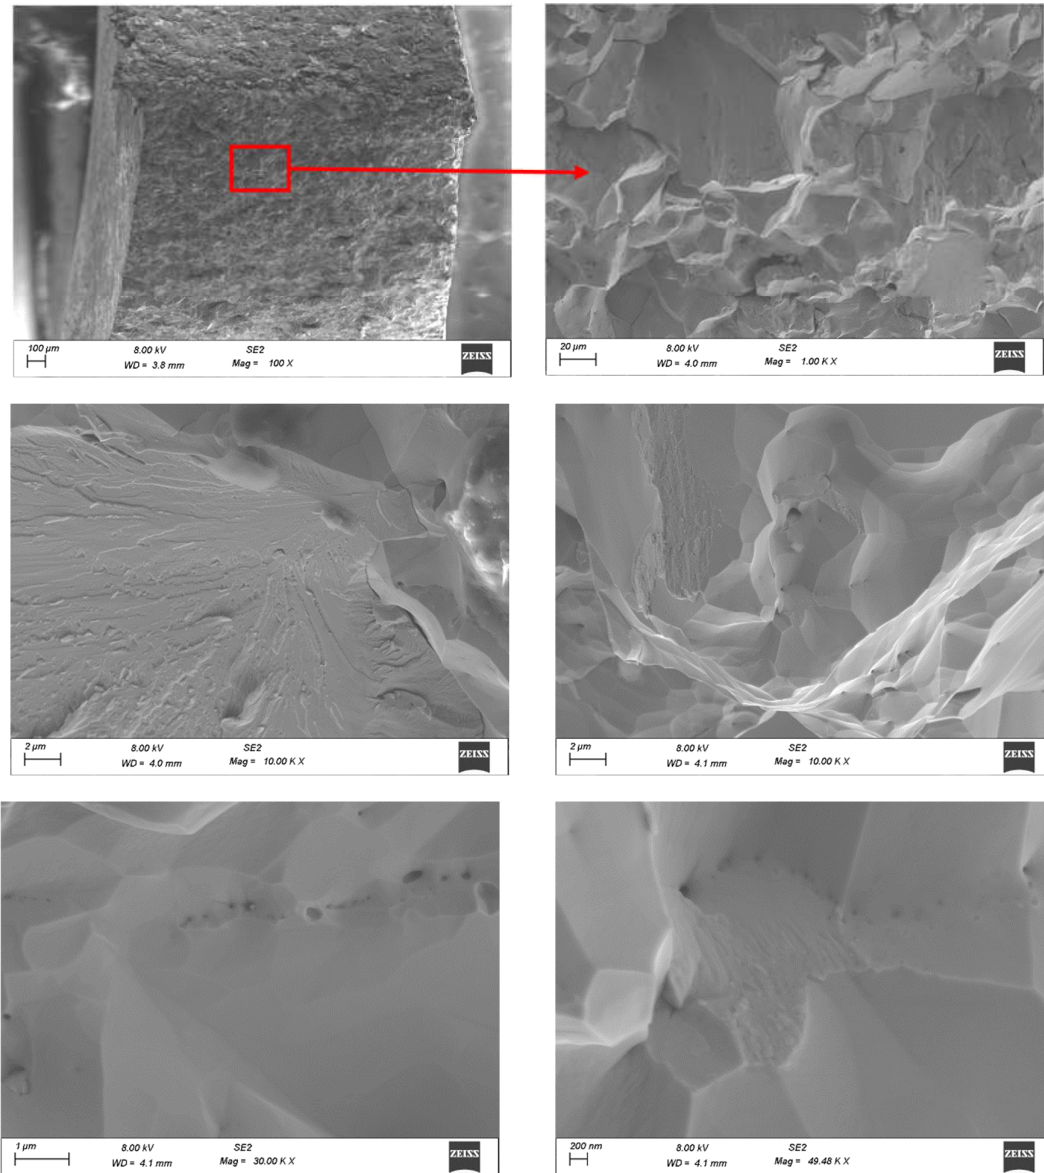
Figure 29. Fracture surface of sample 5N (probably T, L horizontal in the picture: some horizontal rows of pores). Large cleavage facets and regions of intergranular decohesion (fine grains).

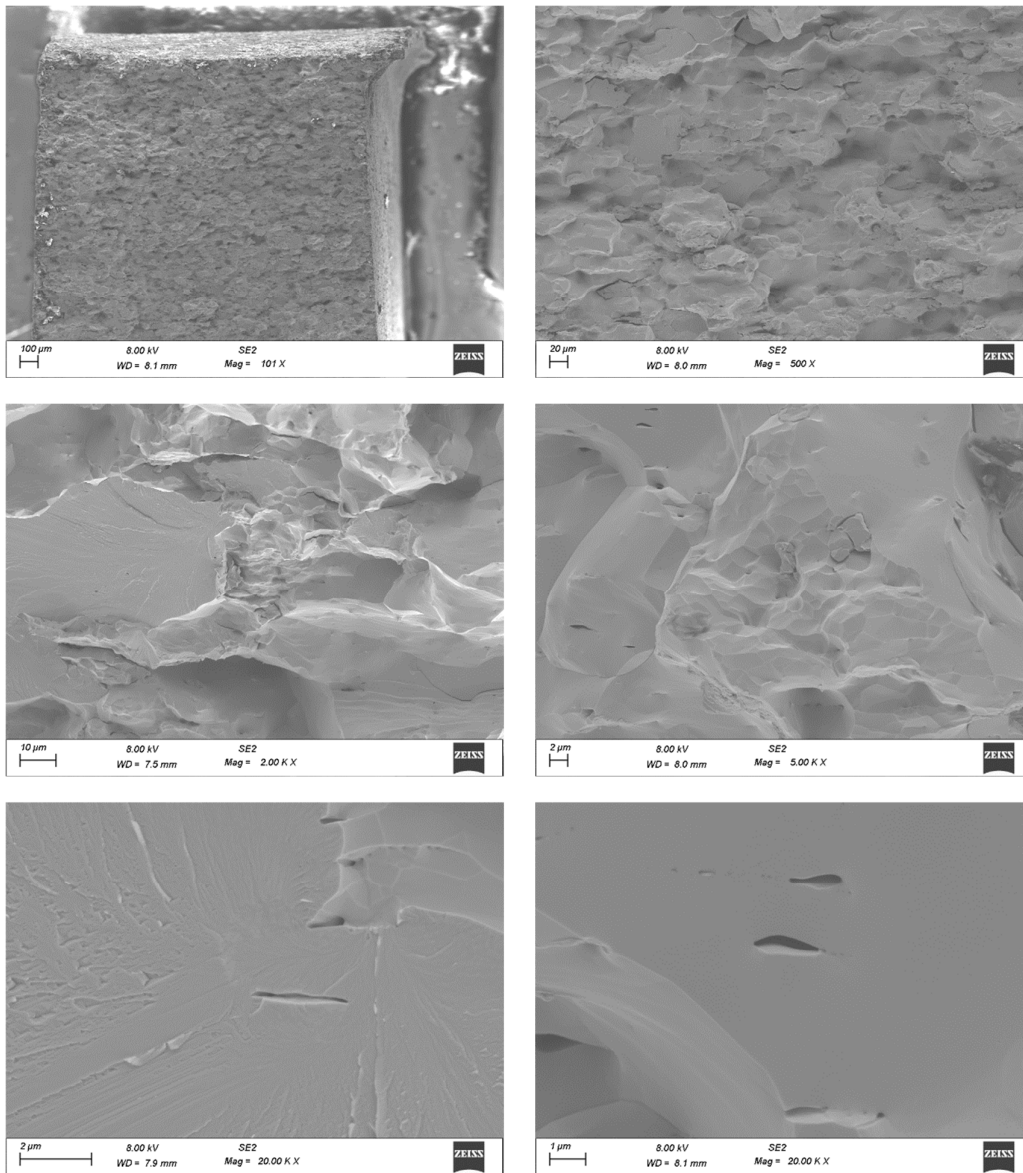
Figure 30. Fracture surface of sample 5N (probably direction T, L horizontal in the picture: some horizontal elongated pores). Large cleavage facets and regions of intergranular decohesion (fine grains).

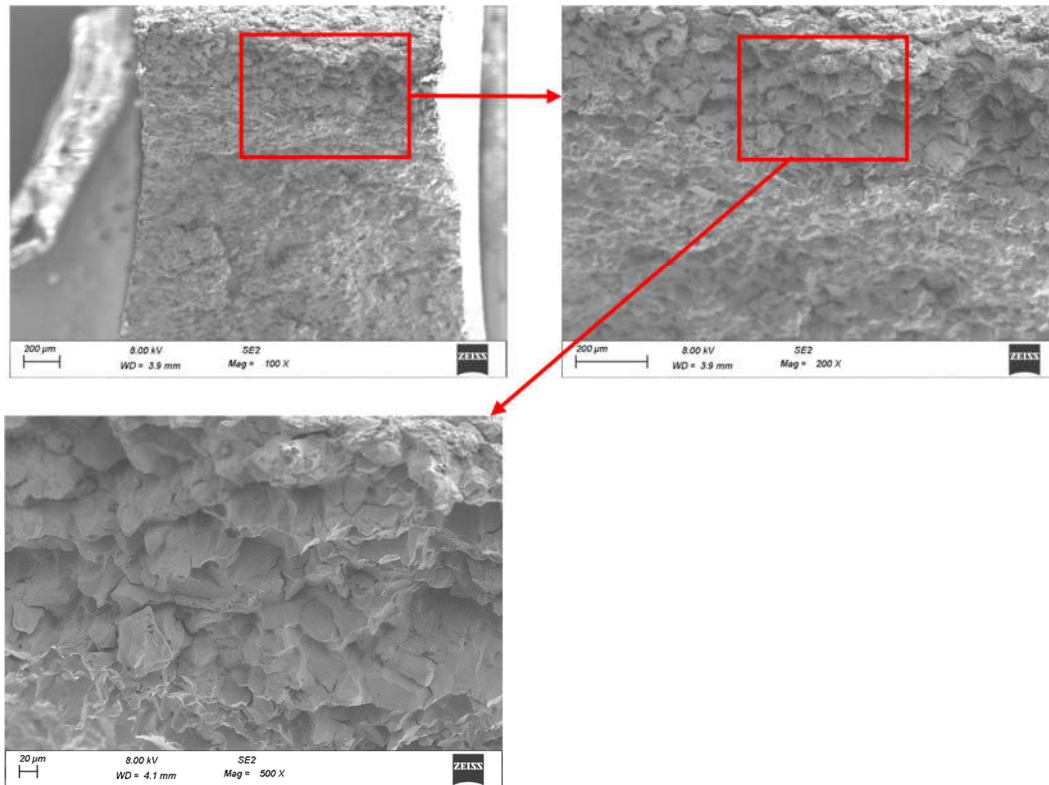
Figure 31a. Fracture surface of sample 6 T. Fracture initiation from the surface layer, (oxidized surface?, distorted cleavage?)

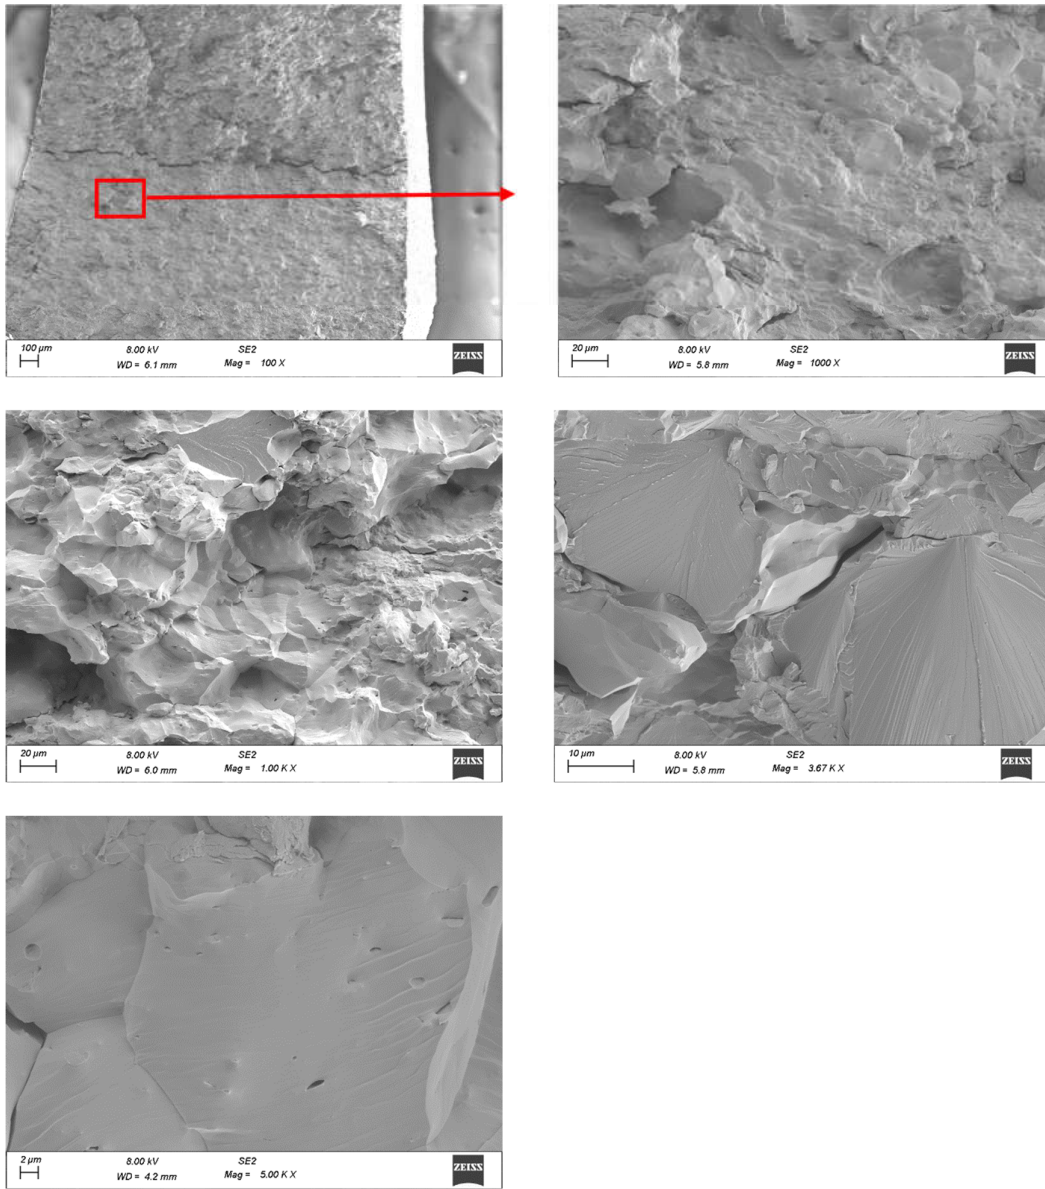
Figure 31b. Fracture surface of sample 6 T, away from the surface; L is horizontal; mixture of cleavage and intergranular decohesion.

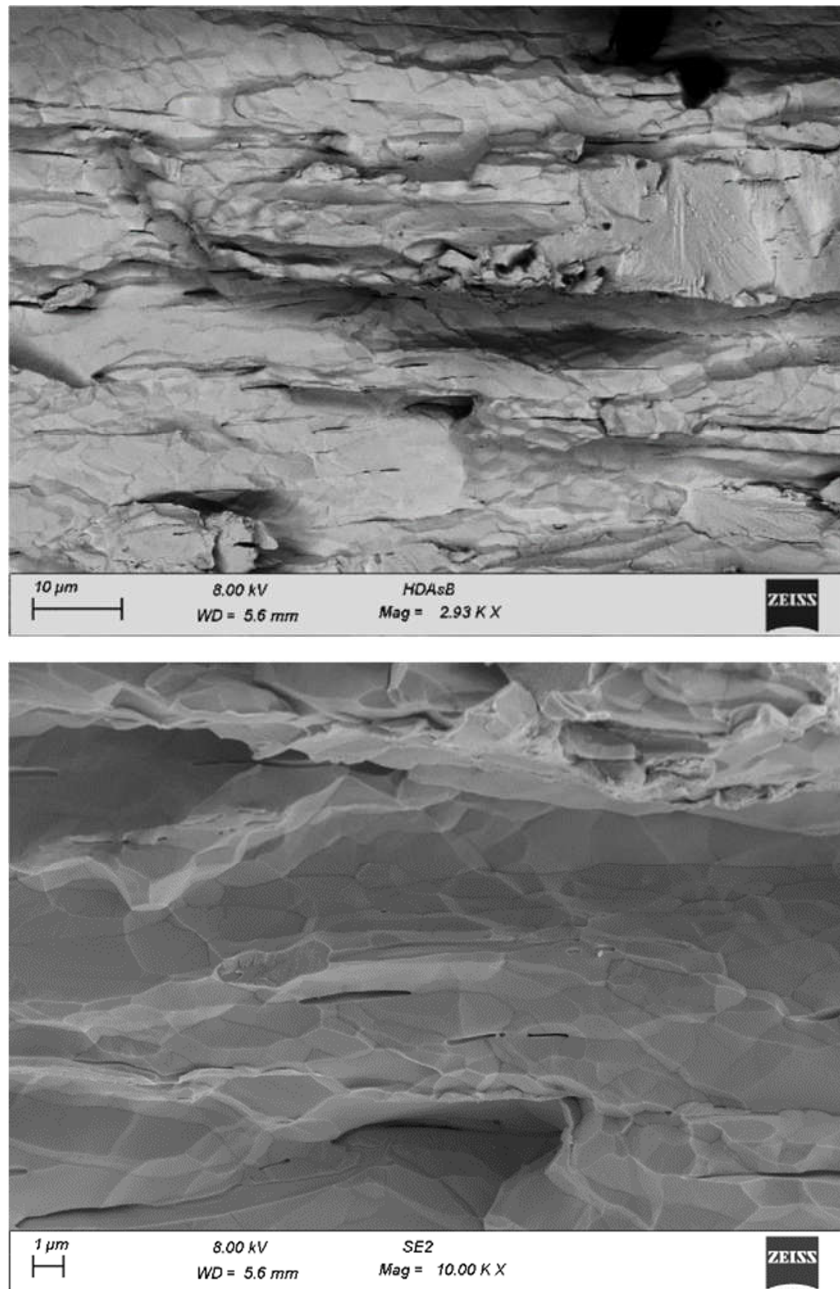
Figure 32. Fracture surface, sample 6 L. Distorted cleavage and intergranular decohesion.

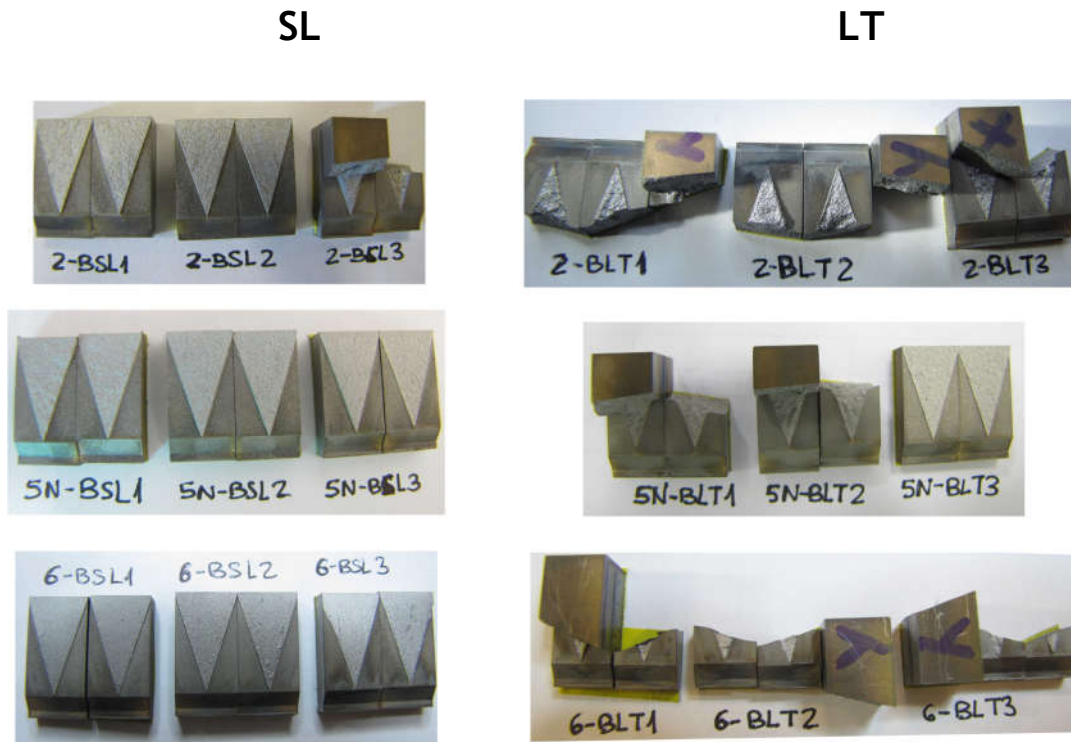
Pictures of the broken fracture toughness samples are presented in fig. 38. The orientation influence on the type of fracture is evident:

- all specimens with SL orientation but one (2 SL 3) fail by planar fracture guided by the notch, without any deviation.
- by contrast, all LT specimens by one (5N LT 3) fail by arm fracture deflection;

Arm fracture occurs after considerable propagation in the notch plane and only when the load surpasses 1 kN. Consequently, it is related to a high resistance to crack propagation.

This is also true when crack deflection occurs in specimen 2 SL 3. In this specimen crack deviation only takes place when the crack front is larger than B/3, i.e., its toughness value is valid according to ASTM E1304. The same is true for 2 LT and 5N LT specimens, but not for 6 LT ones, they fail by arm cracking before their crack front reaches B/3 width, their apparent toughness values being thus invalid, as indicated in Table 7.

The early arm fracture of specimens 6 LT indicates an easy fracture path in TL orientation relative to specimens 2 LT and 5 LT; such relative weakness is coherent with the results of bending at room temperature, fig 5 of report of Stage 1 of this study. It could be related with differences in crystallographic texture (there is a weak maximum of {001} cleavage planes in T direction in the midplane of bricks 6 that is not present in their L direction, fig. 22; it is absent in bricks 2. It is present in bricks 5N, but their failure occurs mainly by intergranular decohesion).

Figure 38. Fractured chevron-notch specimens.
