**Target tungsten  
assembly prototype  
vibration tests**

**ESS**  
bilbao

Proc.: TRGT-REPORT

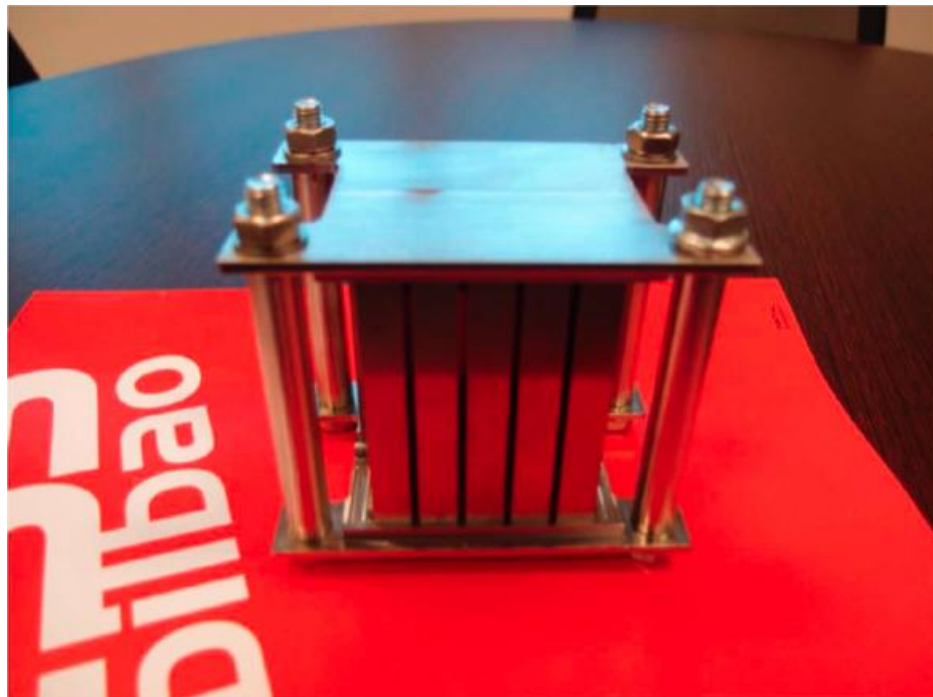
Figure 1. Assembly under test.

The assembly under test is composed by eleven tungsten bricks mounted in a stainless steel base and cover, as shown in Figure 1. The dimensions of every brick are 10 mm x 30 mm x 80 mm. Two bricks, coded BTW-5.4 and BTW-5.18, were selected for analysis.

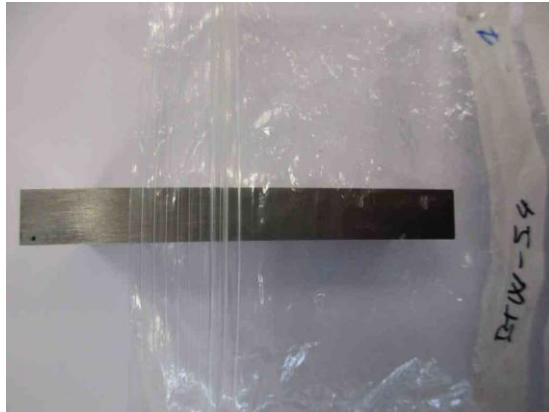
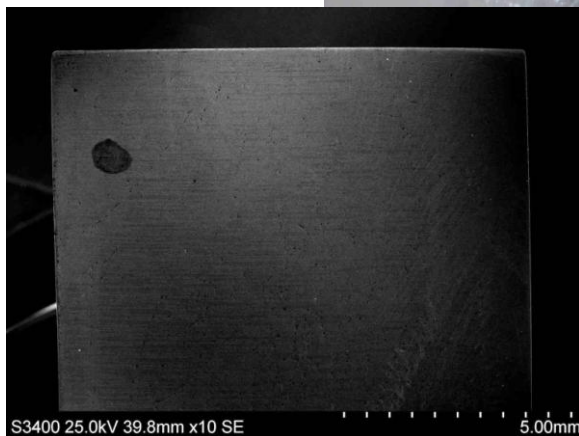
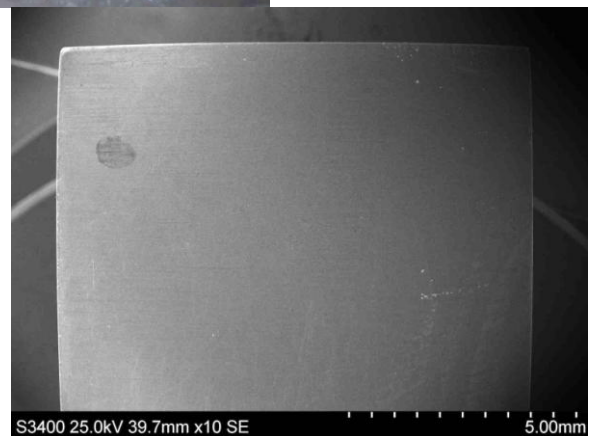
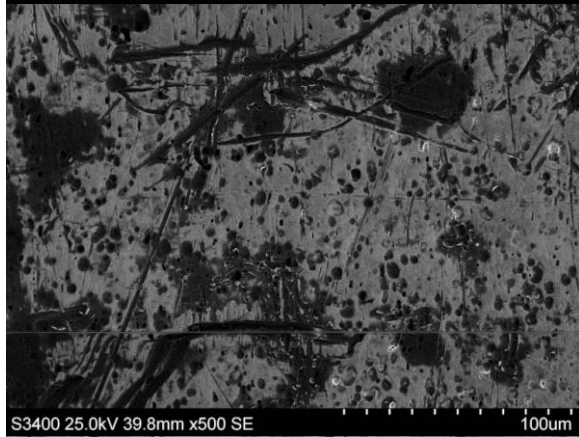
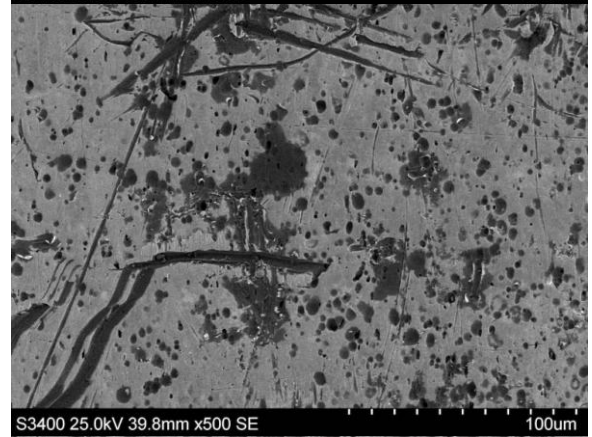
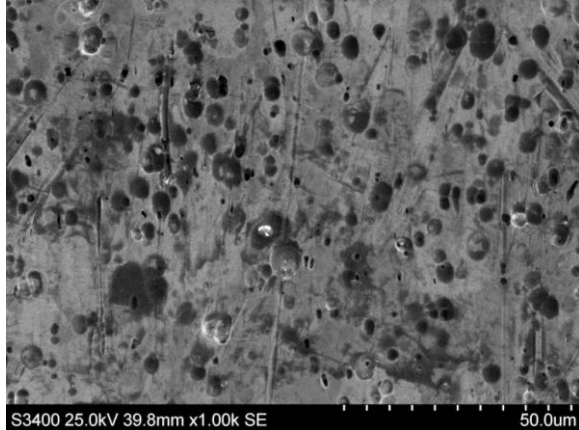
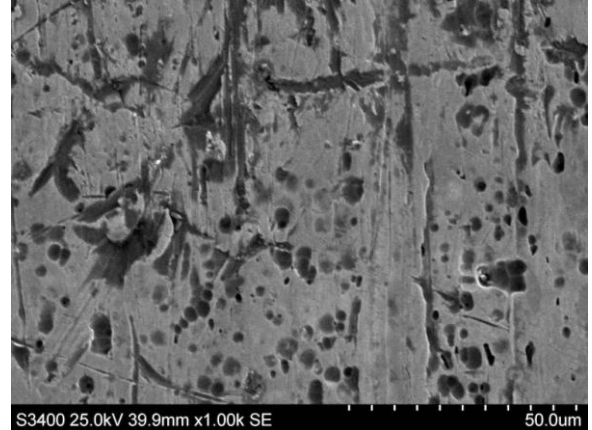
After the SEM analysis, the two bricks were placed in the assembly and the vibration test was conducted, as described in the test report V16001-INR-01. Next, the assembly was carefully demounted and the area of interest of the two selected bricks was imaged again by SEM. Images at the same magnification are shown in the right part of figures 2 and 3 for comparison. The main conclusion that can be drawn from the comparison of the pre- and post- test images is that there is no significant evidence of surface modification and/or degradation due to the vibration test.

Figure 2. Photo of the brick coded BTW-5.4 (upper part). SEM images taken prior- (left) and post- (right) the vibration test was conducted.

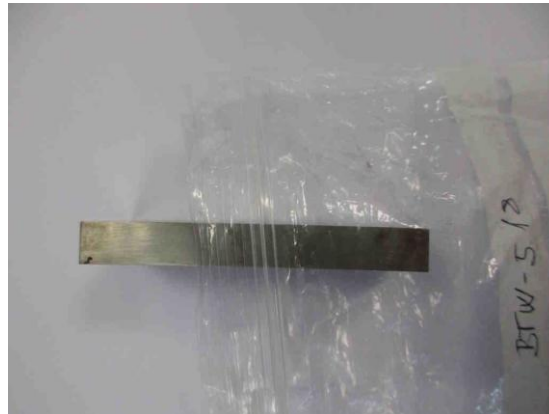
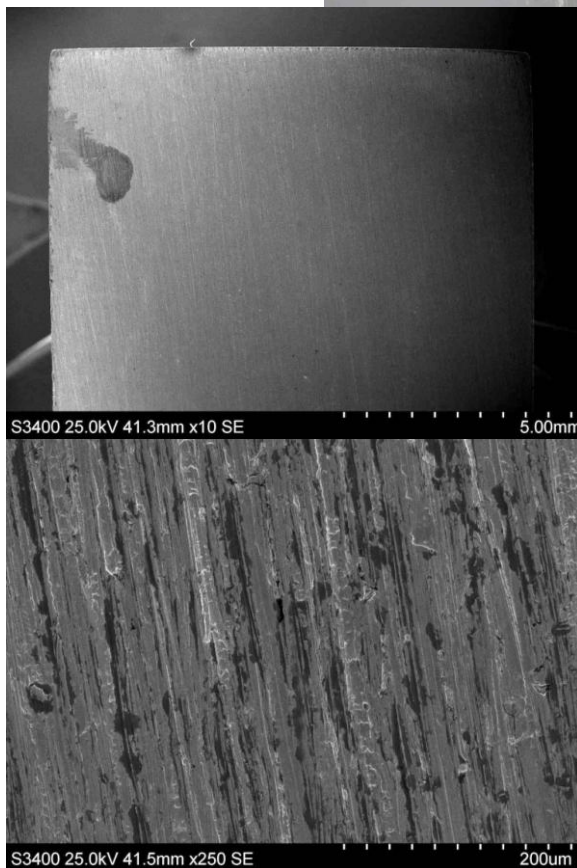
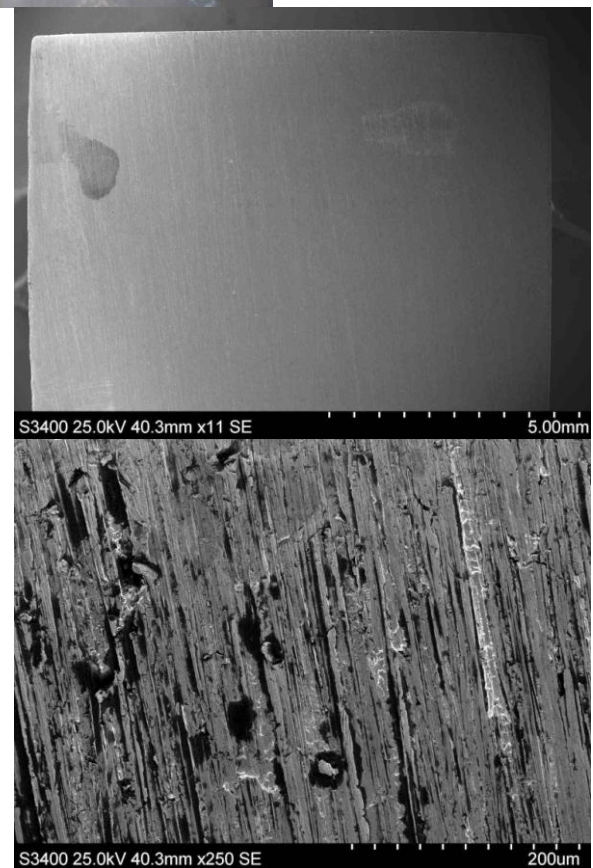
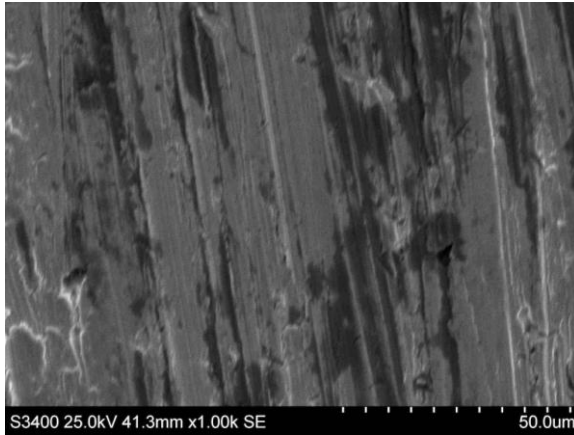
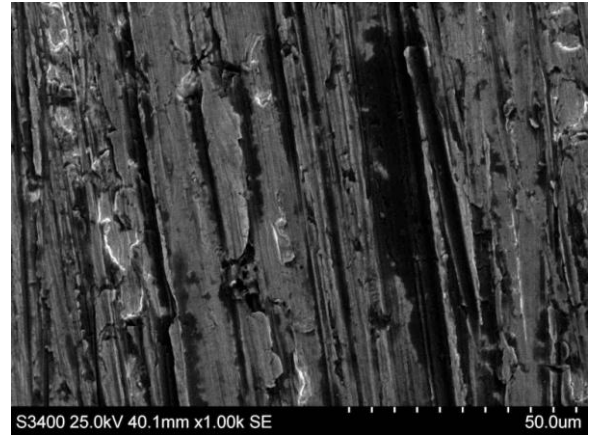
Figure 3. Photo of the brick coded BTW-5.18 (upper part). SEM images taken prior- (left) and post- (right) the vibration test was conducted.

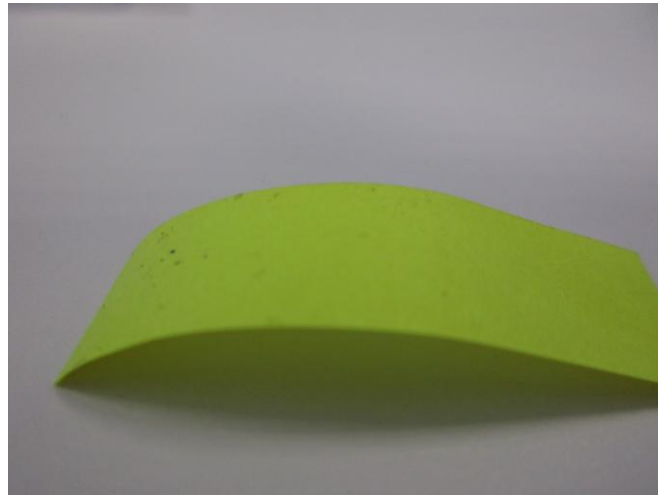
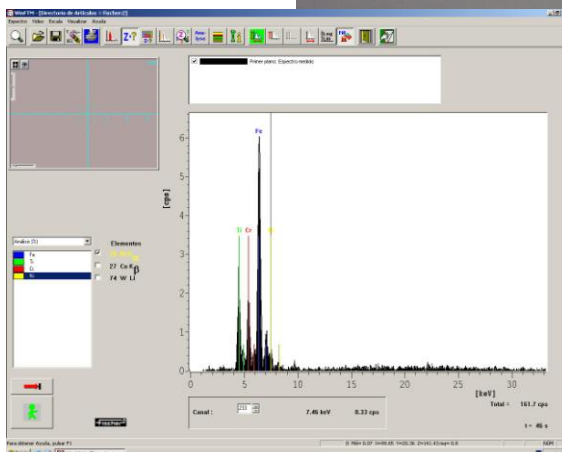
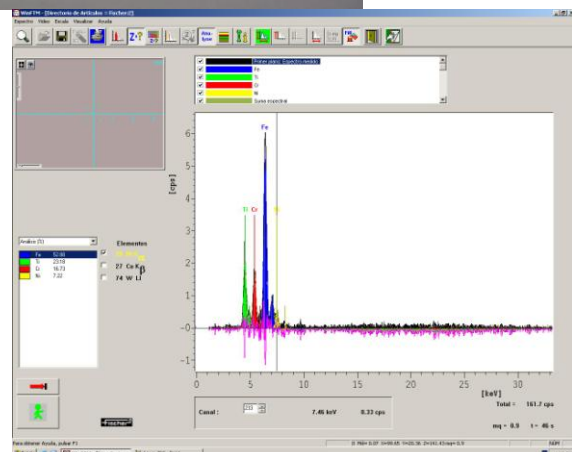
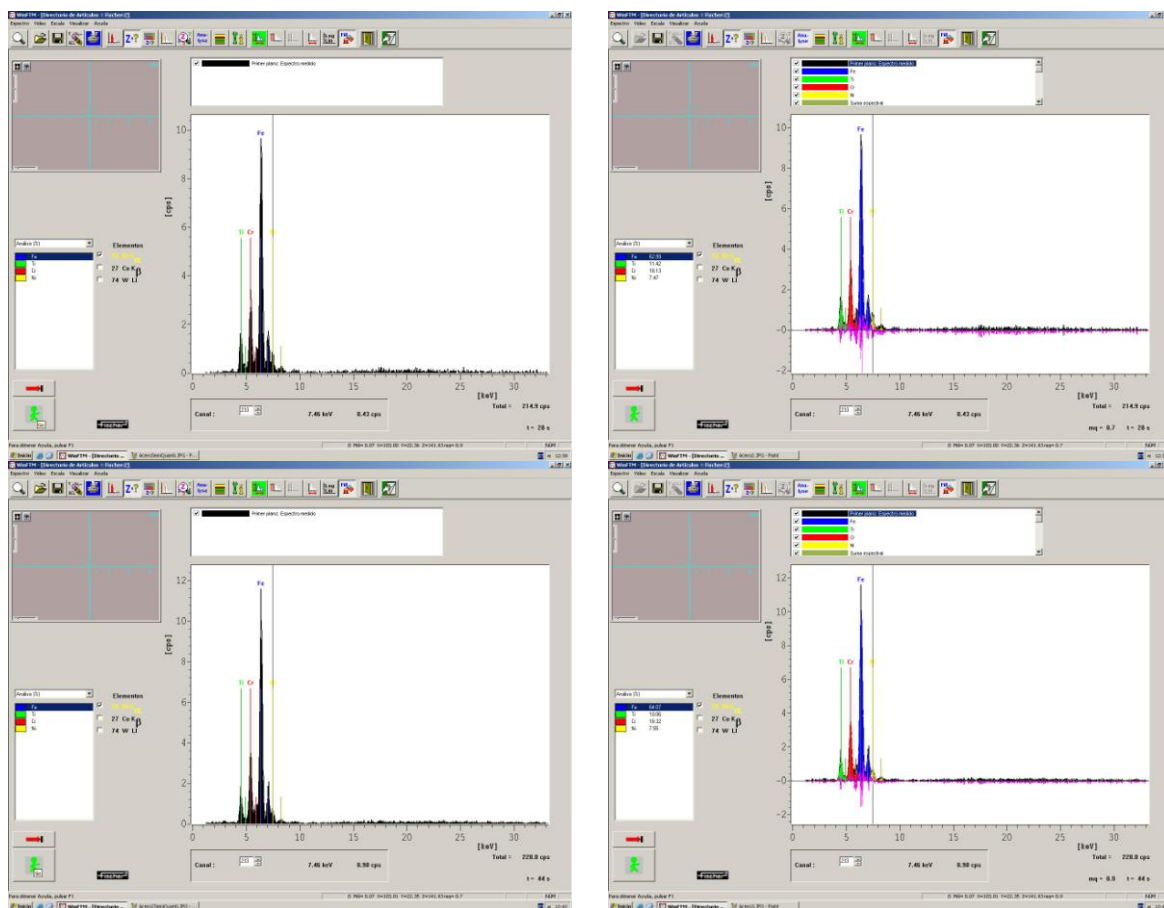
An elemental analysis of the grains was performed in order to elucidate if there were stainless steel grains from the base and cover or tungsten grains from the bricks. The analysis was conducted using an Energy Dispersive X-Ray Fluorescence (EDXRF) equipment (FISCHERSCOPE X-RAY SYSTEM XDAL) at the UPV/EHU SGIKER. This system is able to detect elements heavier than Ca and can give a semiquantitative analysis. The X-ray beam was focussed, by using a 100 $\mu$ m collimator, in three different small grains. The recorded spectra are presented in the left-hand side of Figure 4 and the results of the semiquantitative analysis on the right-hand side. Similar results were found for the three grains. The spectra show picks from Fe, Cr and Ni, as well as a Ti pick coming from the paper used as sample holder. The semiquantitative analysis is also similar for the three grains: >50% Fe, 20% Cr and 7% Ni. This elementary analysis indicates that all the analysed grains come from the steel base and cover. No W pick was found in the analysis.

Figure 4. Photo of the collected grains on a yellow paper used to hold them (upper part). EDXRF spectra (left) and semiquantitative analysis (right) performed on three different grains.
