# **BPM Manufacturing**

Zamudio, 12/07/17 Arturo Ortega, Igor Rueda

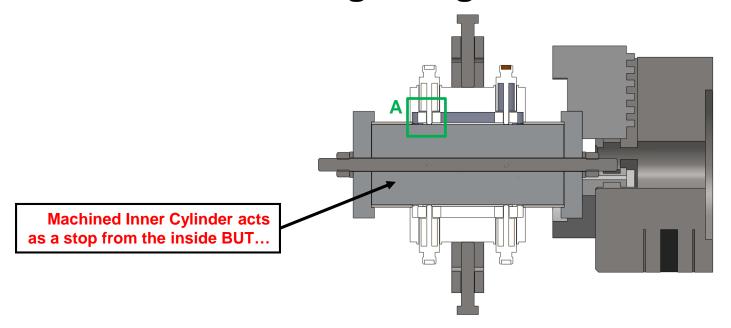
**Detail A**

#### Connectors broken after Weld #3

- After Welds #1&2, connectors were OK (all vacuum tests were successful)
- Weld #3 creates no stress to connectors (only box is welded, no constrains for connectors)

#### **CAUSE:** extraction of Inner Cylinder breaks connectors due to shear stresses:

- BPM Tube shrinks a bit during welding, leading to a tight grip between BPM Tube and Inner Cylinder
- A smooth extraction of Inner Cylinder after Weld #3 does not prevent the Connectors from breaking

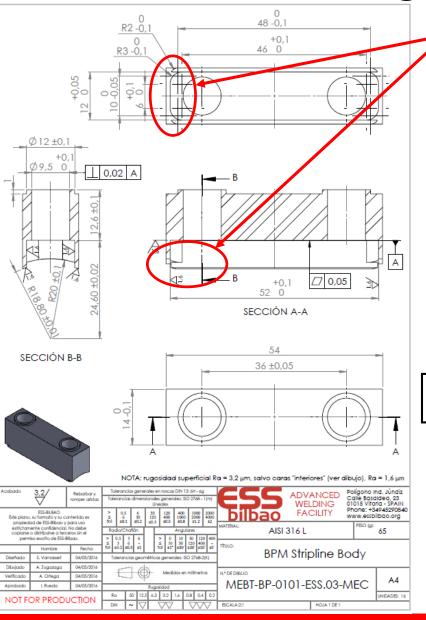
Tricky area to be machined

Manufacturer did not reproduce the area faithfully

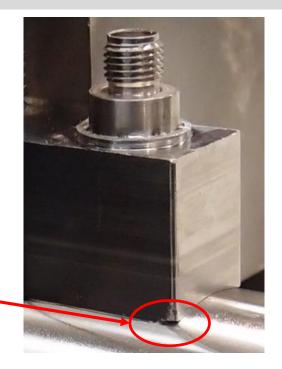
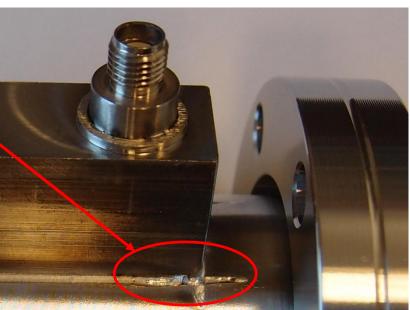
Many welds needed to close the gap

**Big distortions** in Final Part
