Target status at J-PARC

Hiroshi Takada
Neutron Source Section
Materials and Life Science Division
J-PARC Center

JSNS 1MW spallation neutron source

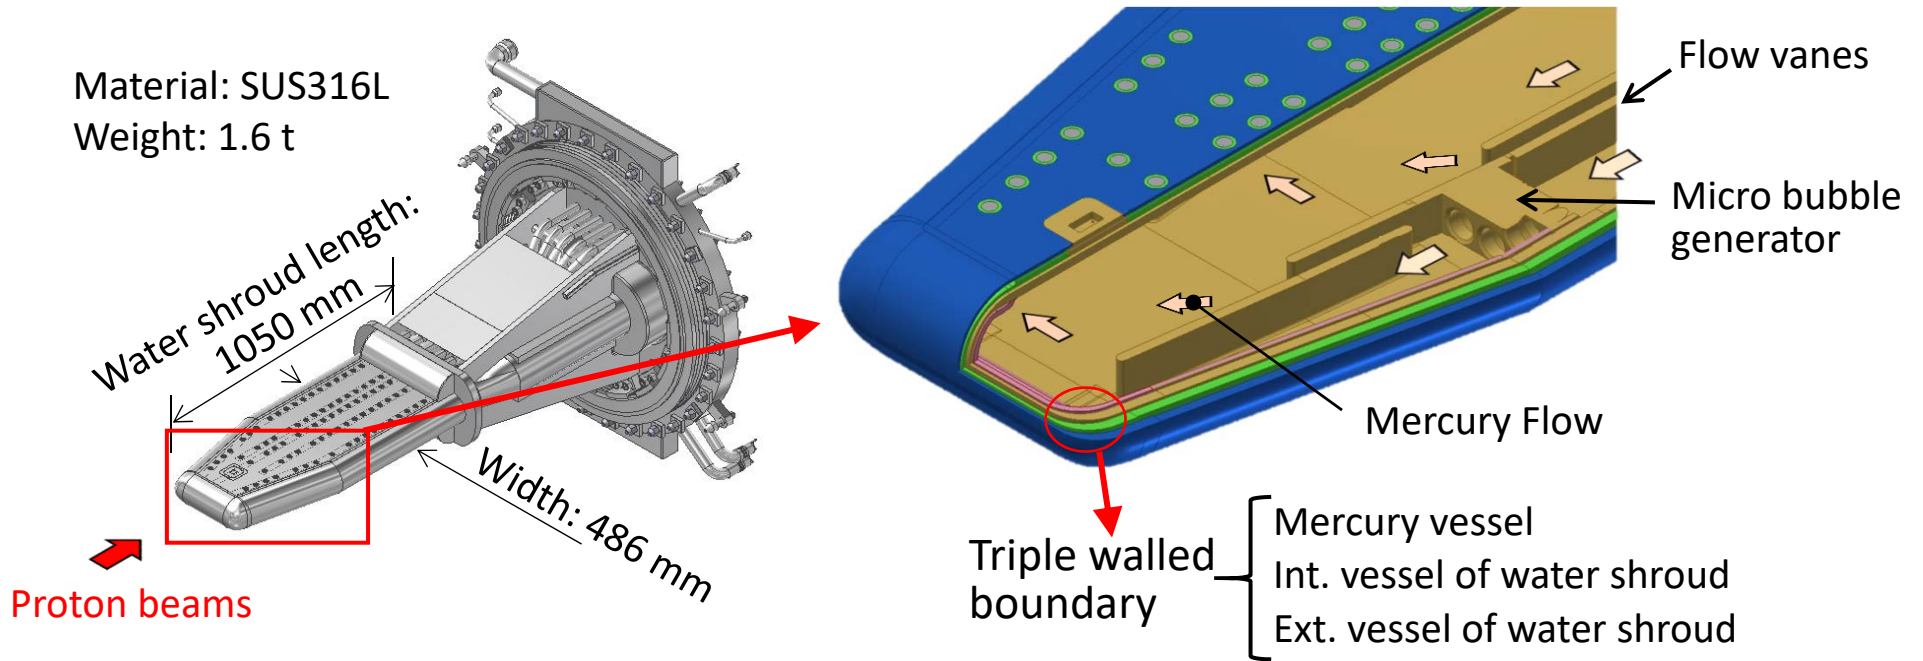
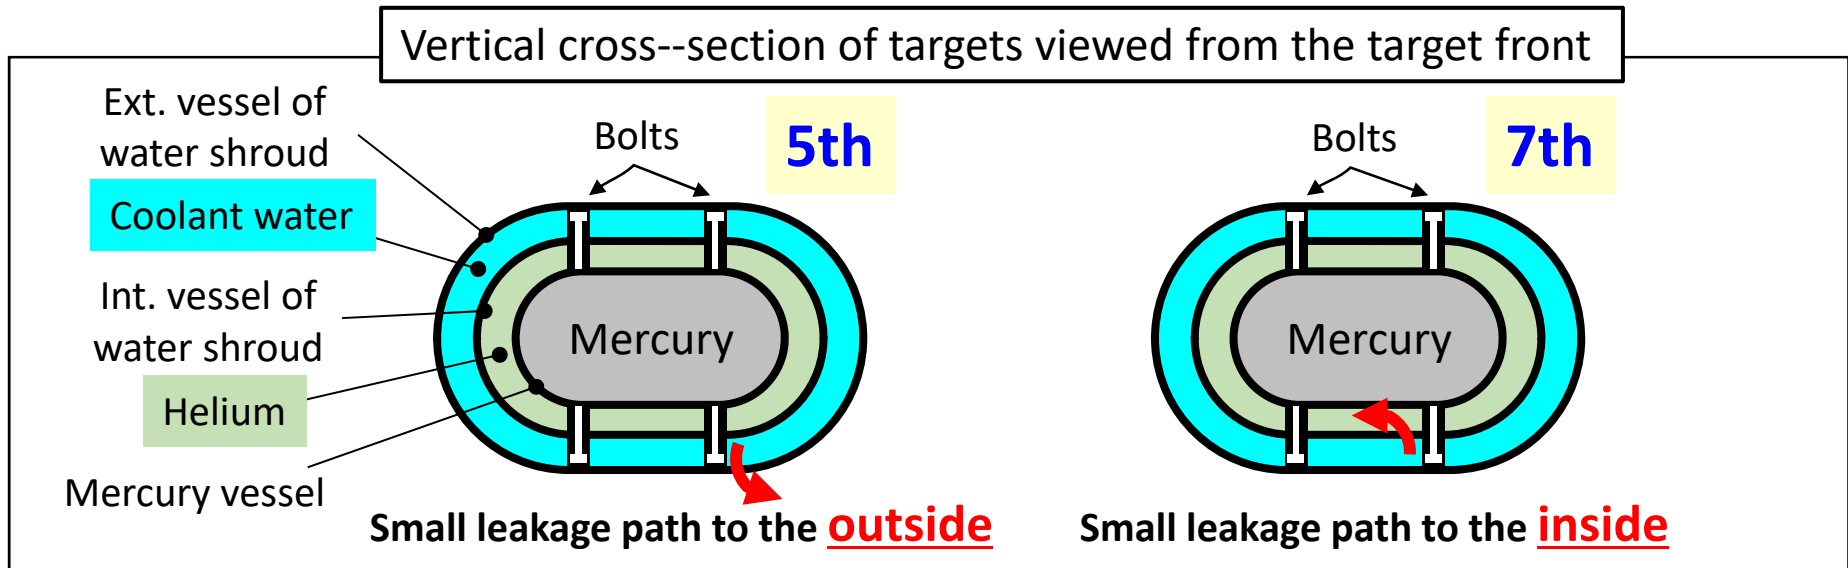
Target structure and failures occurred on water shroud in 2015

- Failures on water shroud at 500 kW operation in 2015
- Redesign of target vessel (#8) to have sufficient robustness and fabrication with improving welding inspection (from 2016 to 2017)
- Further target vessel design improvement with reducing thermal stress and welding. (in progress)
- Performance degradation of helium refrigerator of cryogenic hydrogen moderator system since 2015 and restoration in 2016
- Target vessel replacement to new one (#8) in last October
- Proton beam window replacement to 3rd one in last August.

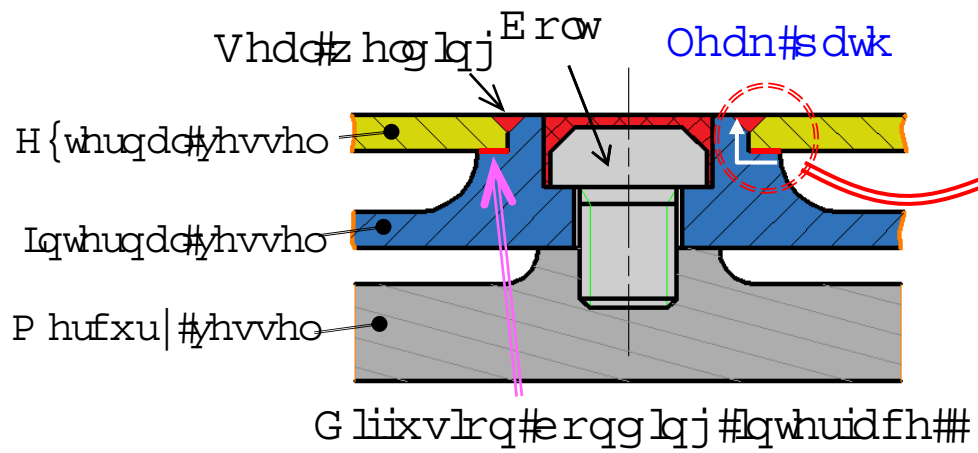
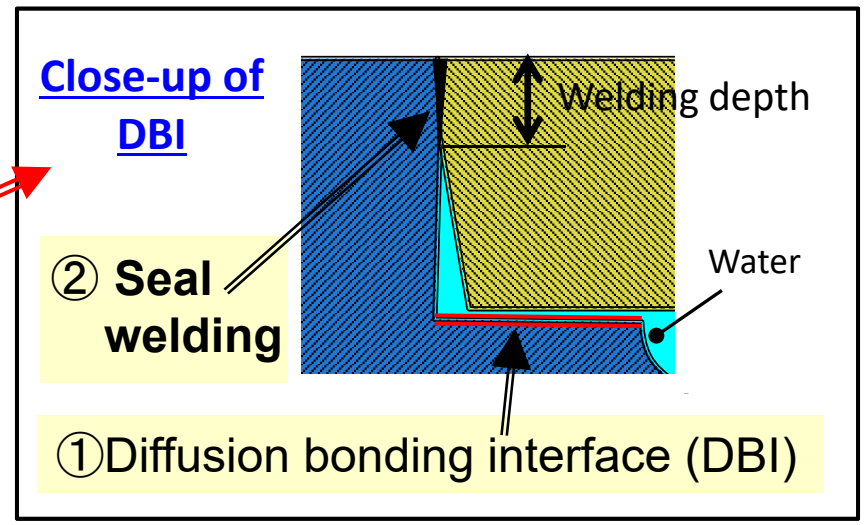
Failure Mechanisms in the 5th Target

Diffusion bonding of int. & ext. vessels

① DBI was detached due to welding thermal deformation.

② Seal welding failed by repeated thermal stress.

Outward Leak path was generated.

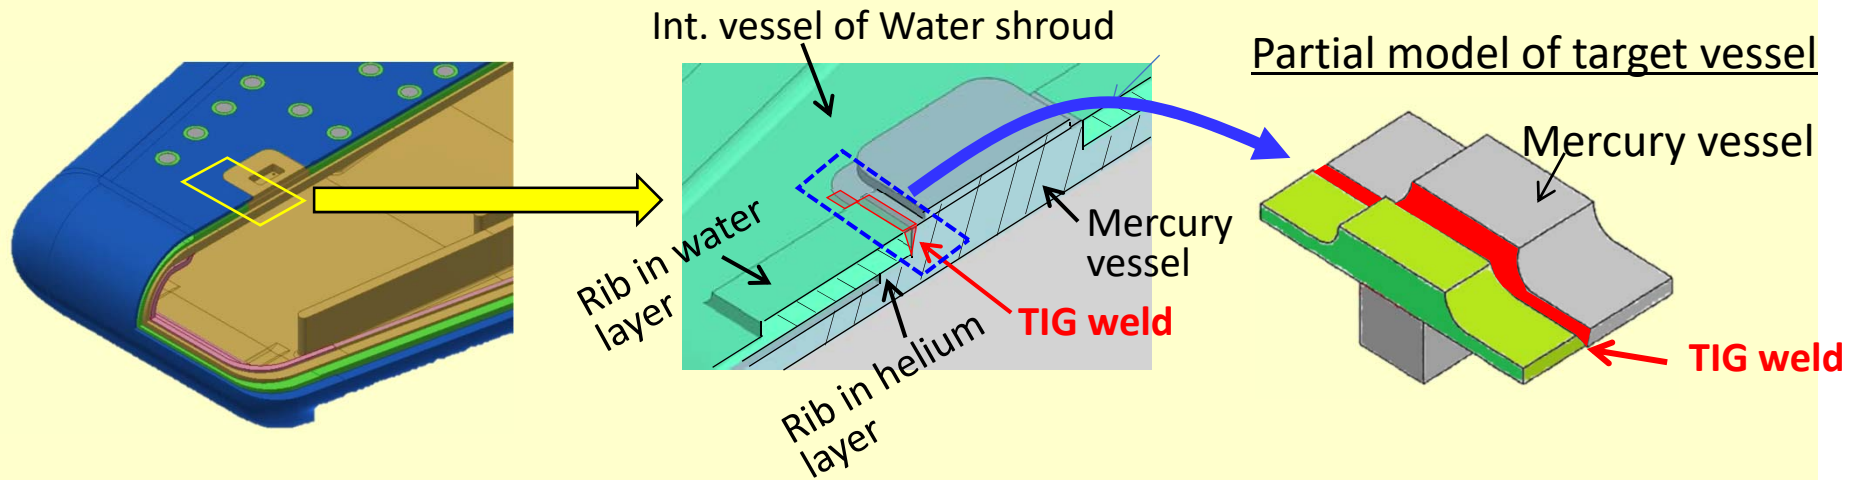
Cause investigations of failure on target #7 -Welding - ⁸

Possibility of incomplete welding at the portion where vessel wall becomes thicker

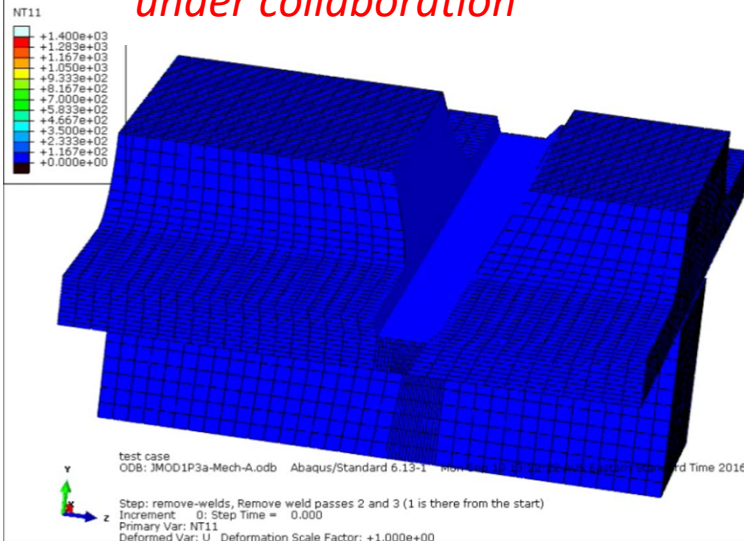
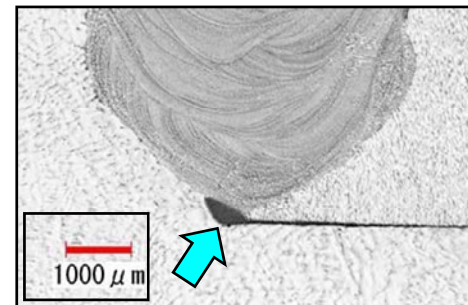
Simulation was done by ANSTO under collaboration

- The area over melting point is small at the center of the rib where the vessel wall becomes thick.
- This analytical result suggests the cause of the insufficient welding.

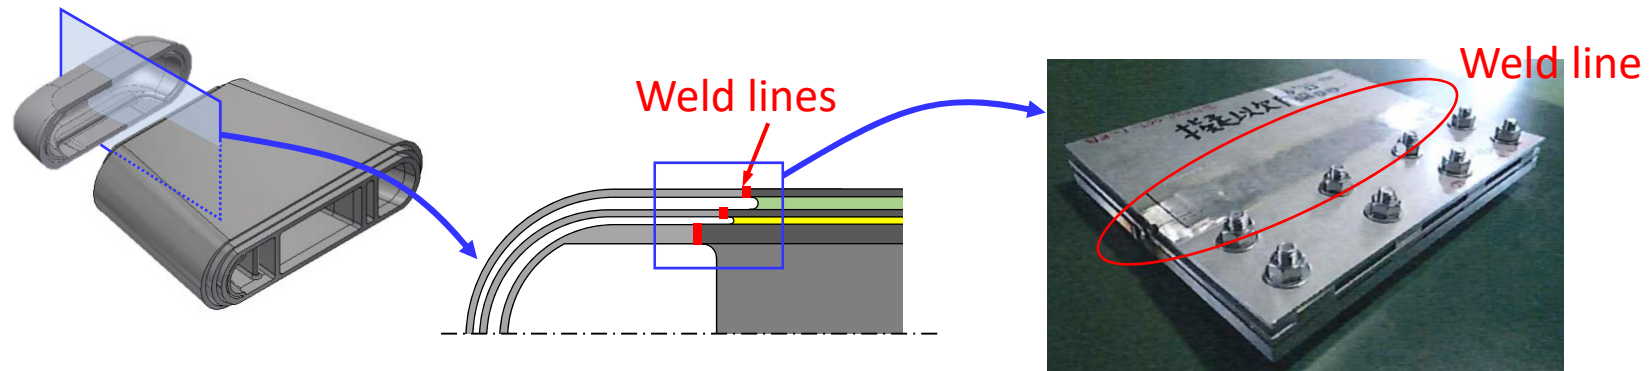
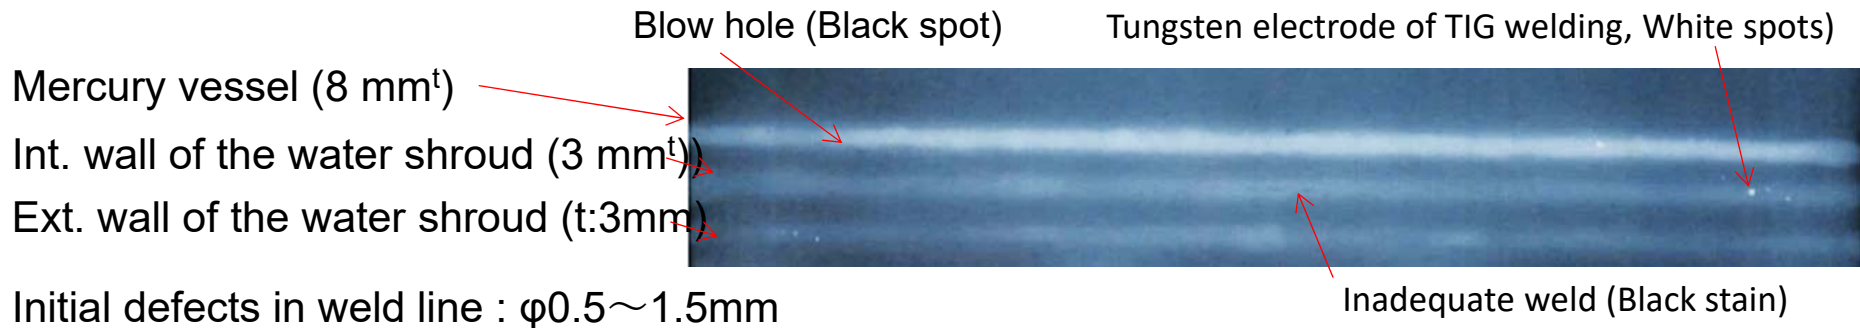
Radiographic Test using Multi-walled Mockup

- Defect detection performance for the multi-walled structure was examined .
- In the triple walled structure, radiographic picture became unclear and the detectable defect size became larger than the usual detection limit of ca.0.3 mm.
