FREIA Project Update

Reflectometry STAP

PRESENTED BY TOM ARNOLD

2023-09-18

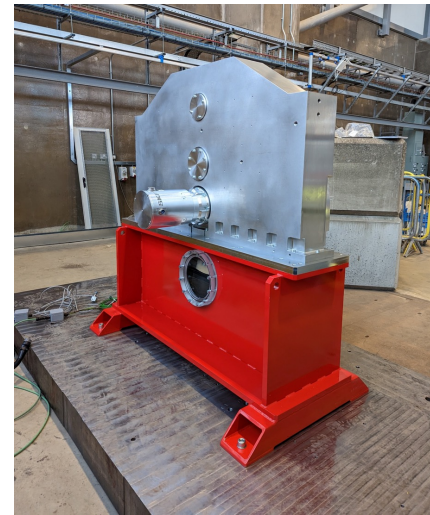
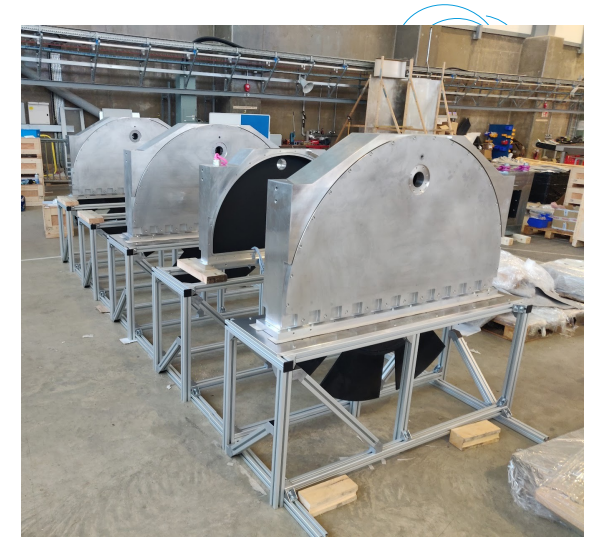
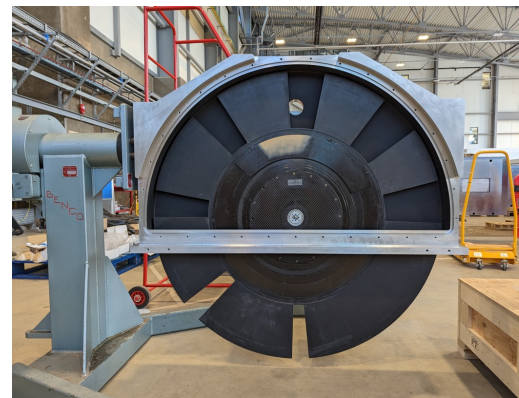
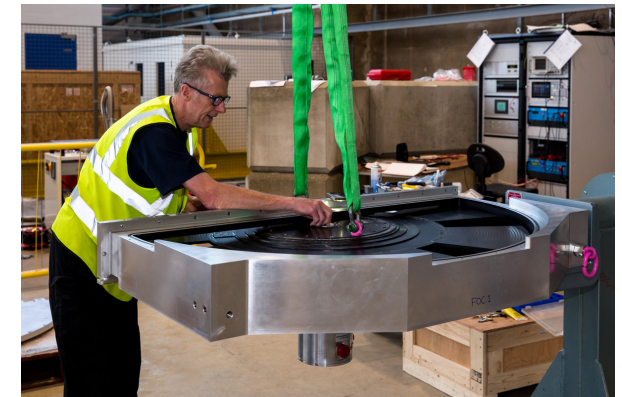
Chopper Commissioning

Initial testing of the three 56Hz chopper assemblies identified quality issues with both the Airbus carbon-fibre chopper discs, and SKF spindles.

It has been challenging to achieve a good balance on some discs, especially on discs where a substantial proportion of the balancing holes were already filled during manufacture. Additionally, one of the balancing inserts has become loose.

Excessive vibrations were observed near operating speed, which has been identified to be predominantly due to a poor fit between the discs and the SKF spindles causing a massive imbalance in the system. Metrology has confirmed that this is due to non-conformities in the spindle machining.

A further test using a well-matched showed resonances in the disc near to operating speed are also contributing.

The spindles have been returned to SKF for replacement shafts to be fitted. The 1.3m discs will be returned to Airbus for rework.

| | Status | Next steps |
|---|---|---|
| WFM1 (56Hz) | Estimated 54g of additional weight are needed to balance, but no balancing holes available. Operated to 20Hz, with a resonance at 16Hz | Return to Airbus. Re-balance using CF/epoxy to free up balancing holes. Check balancing insert bonding. |
| WFM2 (56Hz) | Fine balancing carried out. Operated at 56Hz, vibration borderline acceptable. Resonances at 16Hz & 53Hz. | Airbus/ISIS to check balancing insert bonding. |
| FOC1 (56Hz) | Balancing insert came loose. Hub/spindle fit out of tolerance. Operated to 20Hz, with a resonance at 15Hz. | Return to Airbus. Re-attach loose insert. Check bonding of other inserts. |

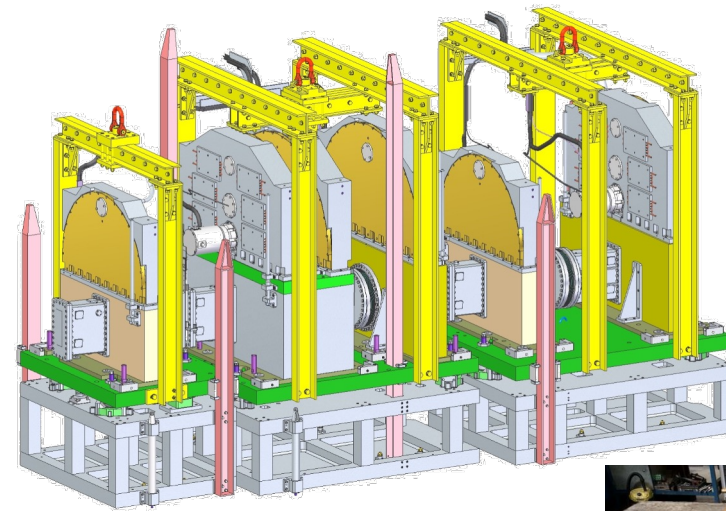
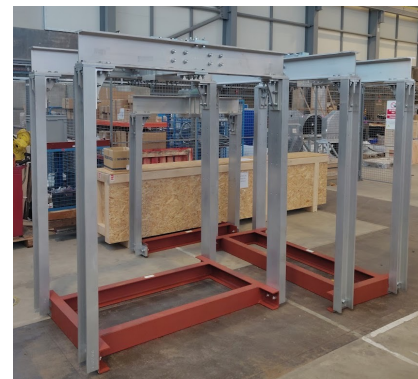
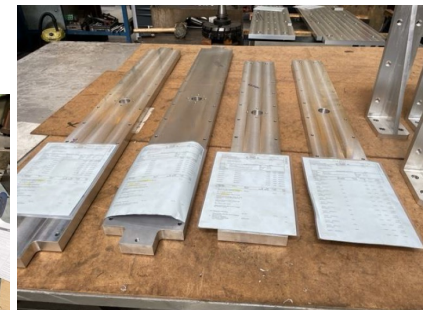
Module 1 Module 2 Module 3

Procurement of the bunker modules is being undertaken in a phased manner, with multiple tender exercises.

Components have been grouped according to size and manufacturing process in order to streamline the manufacture process.

The contract for the large vacuum housings has been awarded. Due to material size limits, knife-edge seals were re-evaluated using 5000 series Aluminium instead of 6000 series with acceptable test results.

The lifting frames have been tested and delivered to STFC ready for pre-building of the modules.

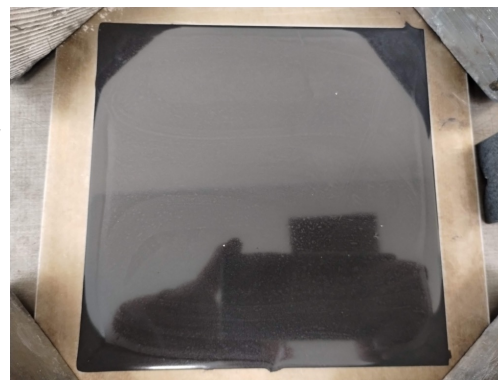
Aluminium WBC choppers have had issues with preparation of absorbing coatings - some distortion of the test plate due to shrinkage.

A range of preparation methods have been tested including with the addition of carbon fibre to stabilise the coating. None of these methods have successfully removed the distortions

Cost to change over to carbon-fibre discs has been evaluated – this is not feasible due to very long lead times.

Last remaining solution is to cast coatings separately and to glue these to the choppers.

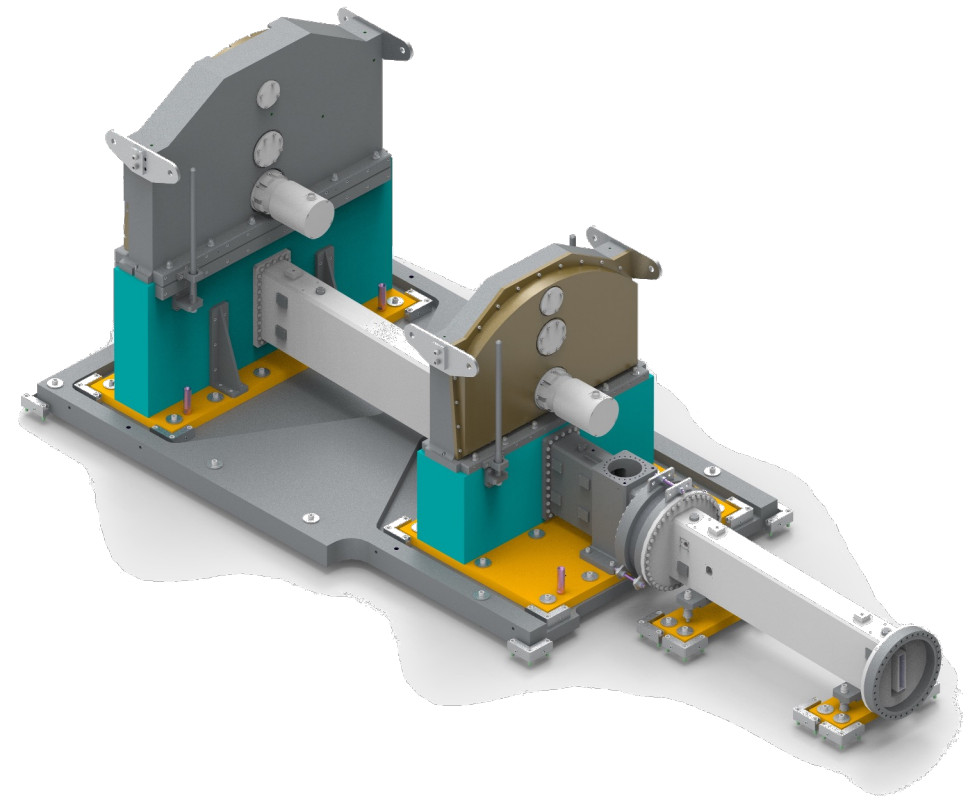
Module design is now complete and TG3.5c is scheduled in September.

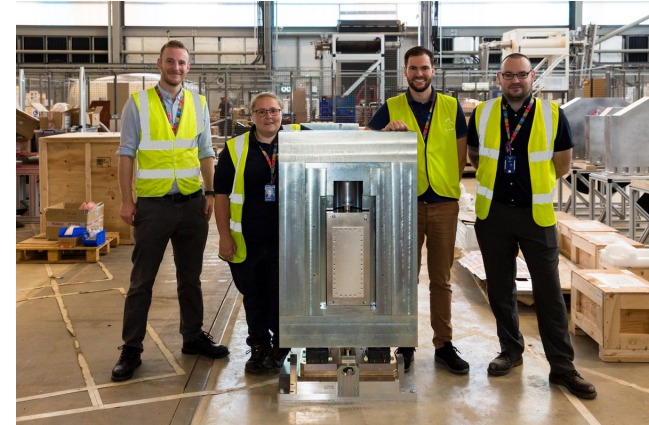
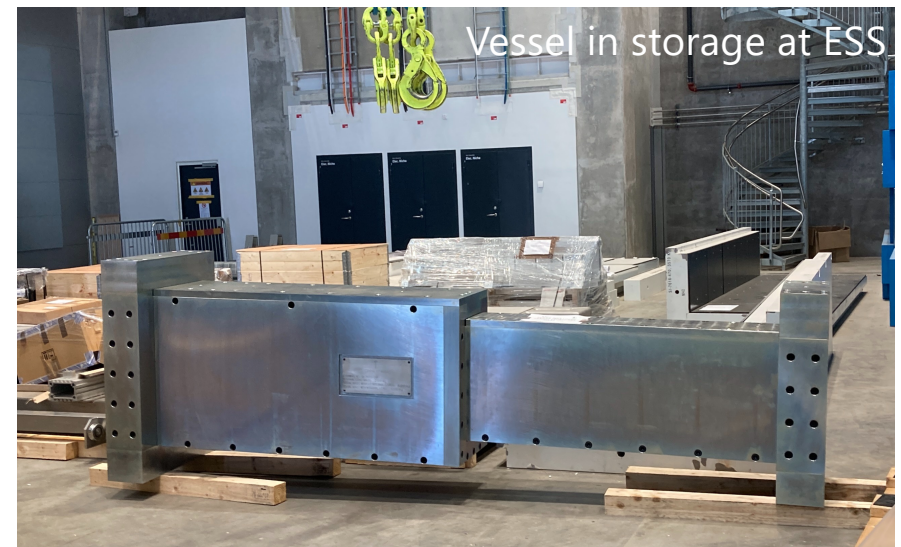
Bunker Wall Feedthrough

The bunker wall feedthrough comprises:

- Alignment bases (STFC)

- Shielding insert (PureNetwork)

- Vacuum vessel & guide (Swiss Neutronics)

Integration tests were successfully completed at STFC during June.

The vessel is now back with Swiss Neutronics for guide integration. Delivery to ESS is planned for October.

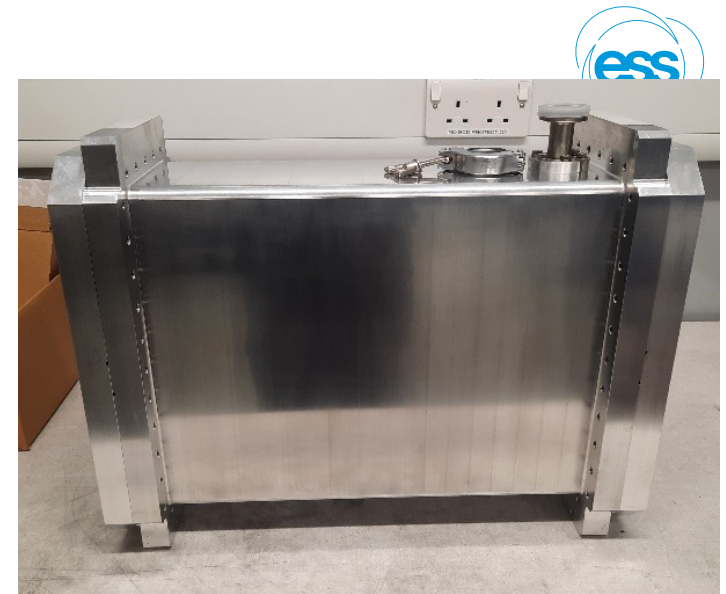
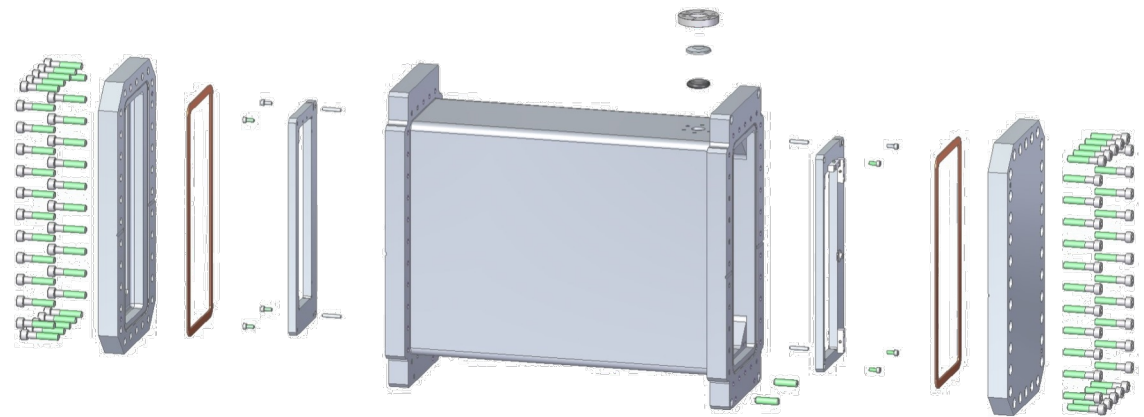
Light Shutter Optics Vessel

The light shutter vacuum housing has been cleaned and successfully vacuum tested. The highest leak rate recorded on vessel was 5.0×10^{-10} mbar l/s.

The housing has been shipped to ESS and is ready for guide integration and installation in the Autumn.

Guide delivery due in October. ESS will integrate with the light shutter mechanism.

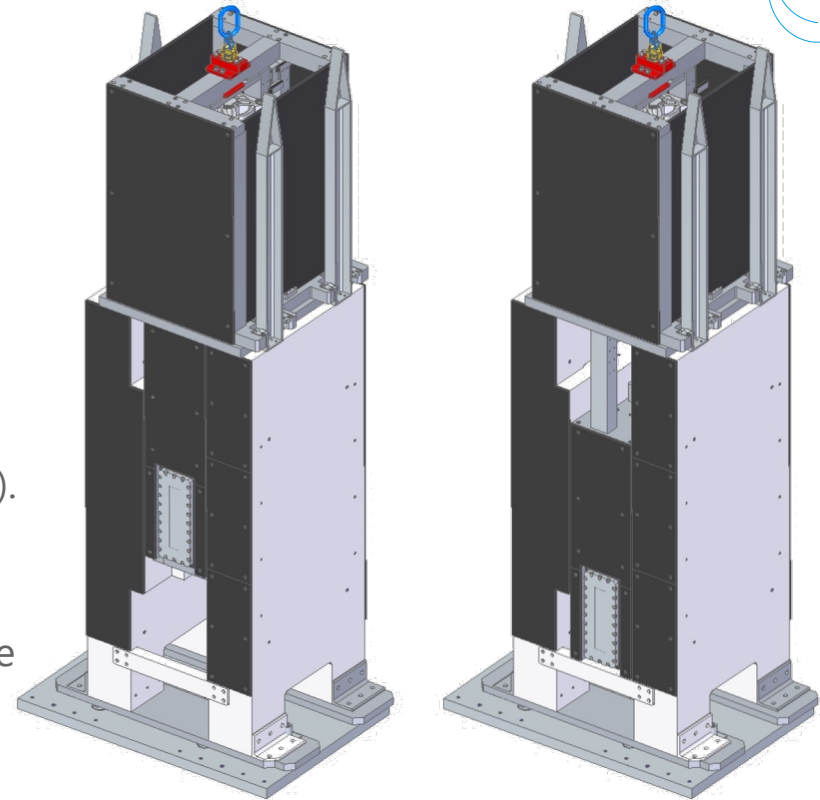
An issue with use of flammable Polyethylene in the bunker has been identified – this derives from a recent decision to omit a sprinkler system in the bunker.

The manufacture is now on hold until this matter is resolved (originally planned to launch tenders in August).

There is a significant risk that any proposed design changes will necessitate further neutronics calculations which will impact the delivery of the shutter in time to be installed in the bunker before it is closed

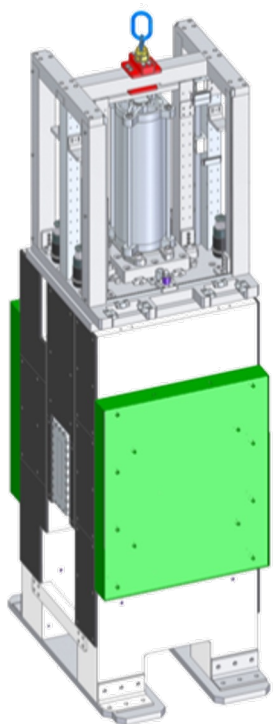
Side blocks of Polyethylene to prevent cross-talk to Loki

The fire requirements also look like they could limit the proposed Poly side panels that prevent significant cross-talk to neighbouring instruments. – likely that these will not be delivered but could be retrofitted later

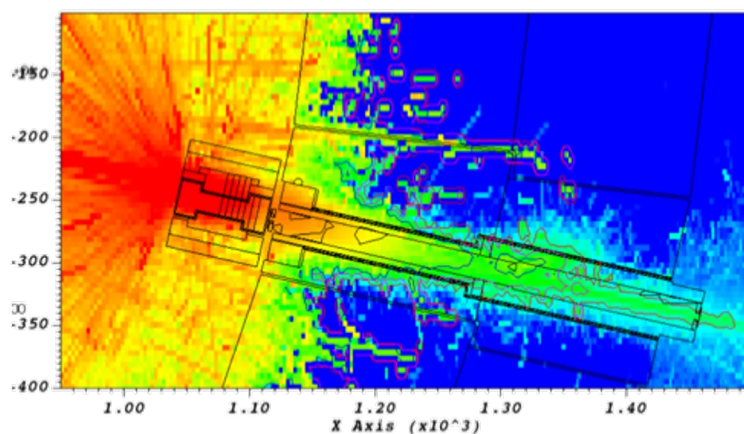
Without

Figure 7 Neutron dose rate map closed shutter horizontal section at bunker wall opening height, high energy neutron source. (scale in $\mu\text{Sv/h}$, with contours at 100, 10 and 1.5 $\mu\text{Sv/h}$)

Note – simulation without Poly is from a previous design iteration so not directly comparable

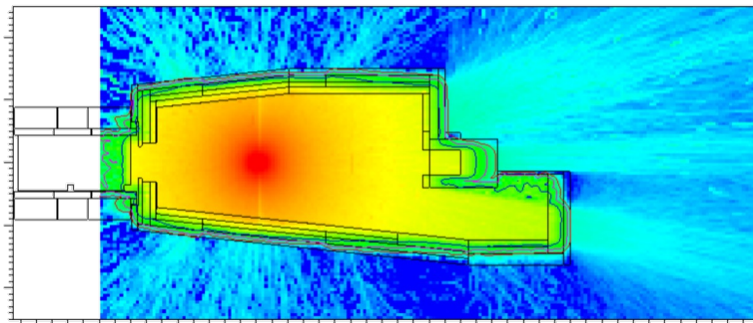
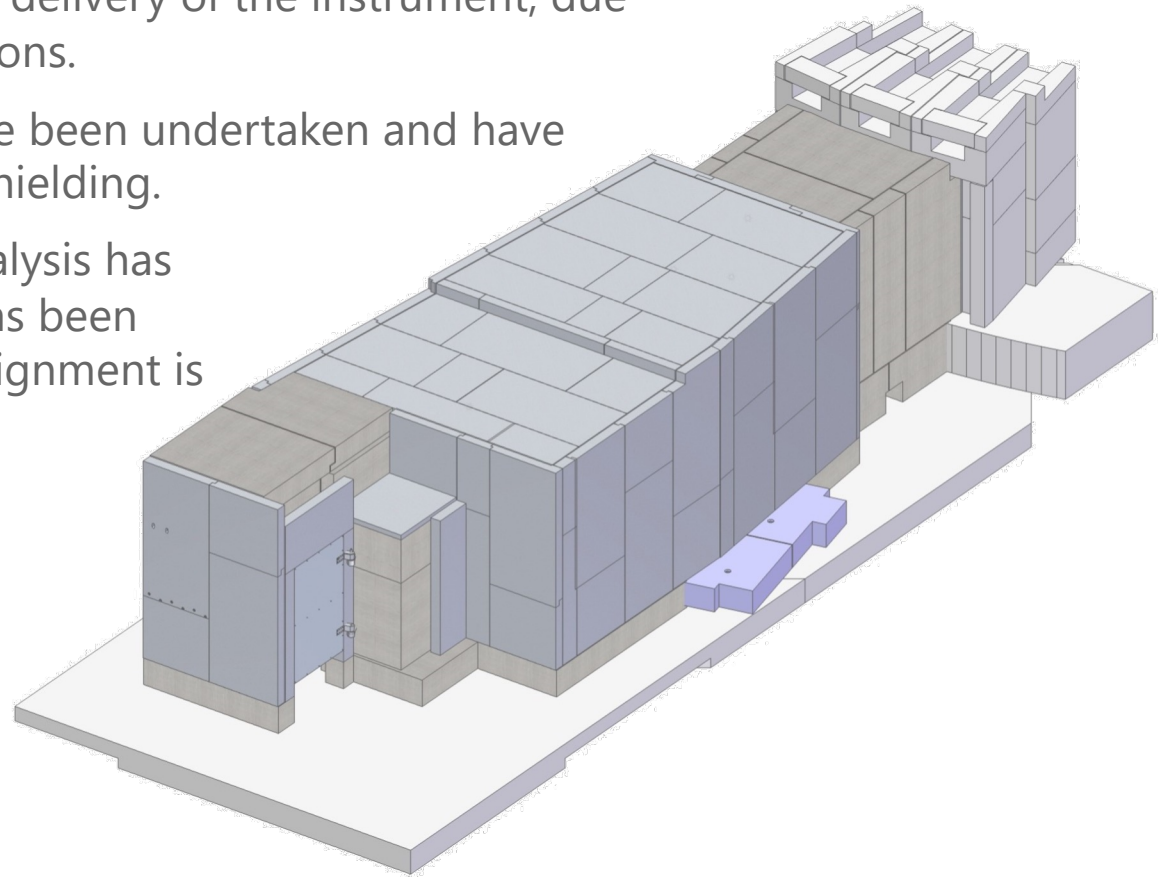
Chopper Pit & Cave Shielding

Shielding is now on the critical path for delivery of the instrument, due to previous neutronics resource limitations.

Preliminary neutronics calculations have been undertaken and have informed the general concept for the shielding.

A contract for additional neutronics analysis has been placed with UKAEA. The model has been successfully imported, and material assignment is underway ahead of the calculations.

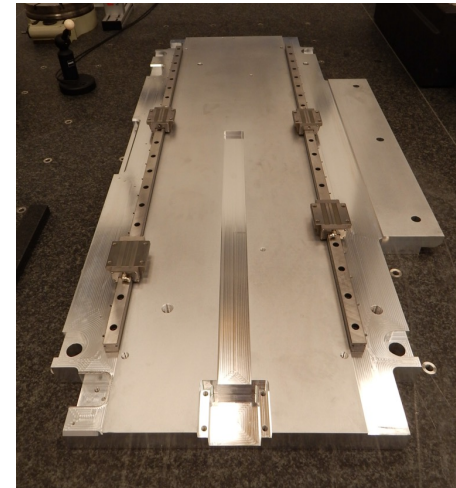
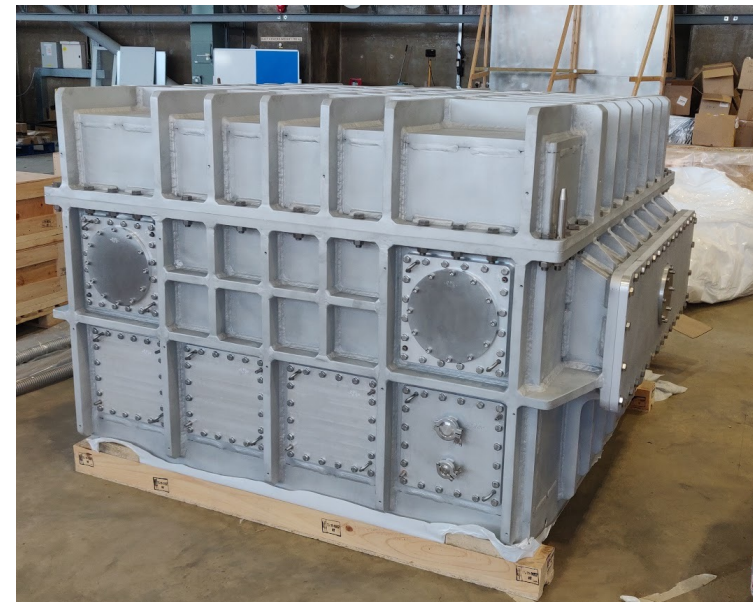
Collimation System

The collimation vacuum vessel has arrived at RAL and has been vacuum tested. The base supports have been delivered to R106 and are ready for pre-build.

The translation stages are currently being assembled – the rails and carriages have been installed. Further assembly of the stages is anticipated in the autumn.

The kinetics slits are out for manufacture. Mechanical components should be ready from late August. The piezo actuators are due in December.

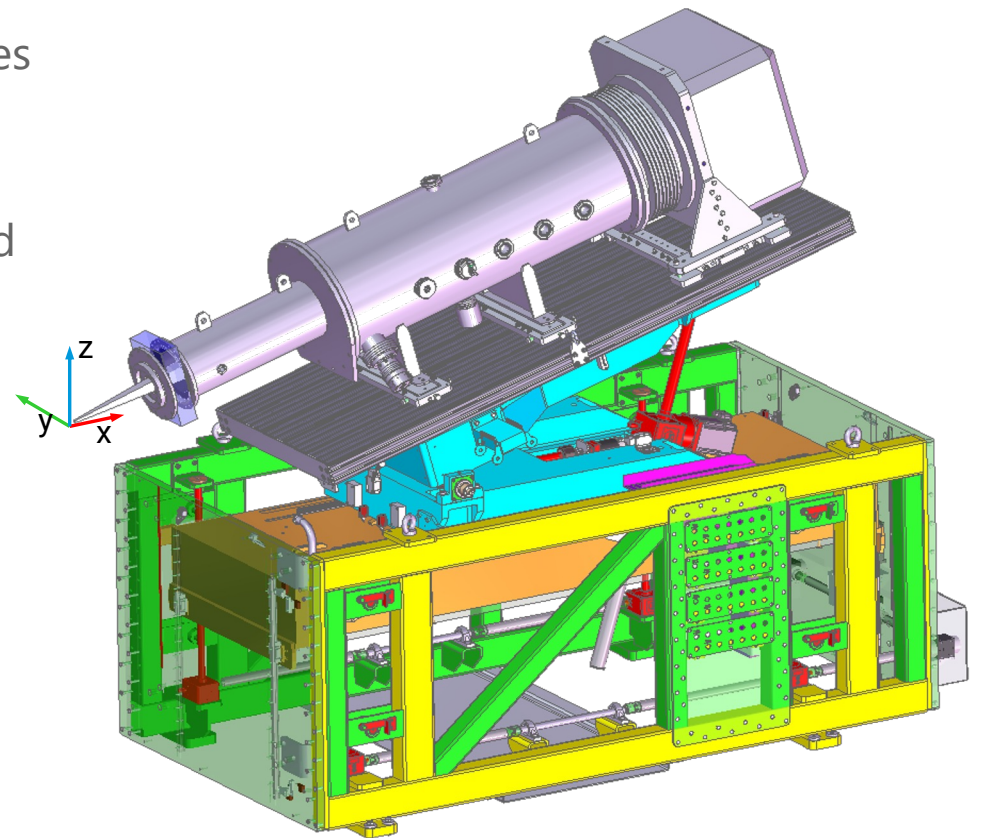
Detector Bench

The first order for manufacturing the welded frames for the detector bench has been placed, with completion due in October.

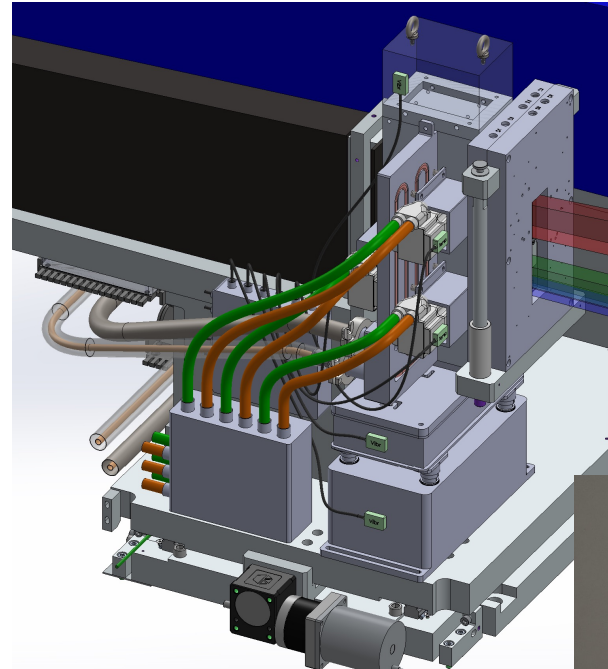
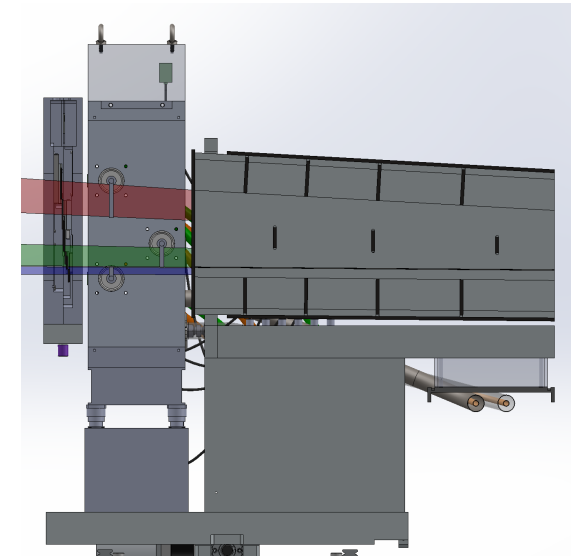
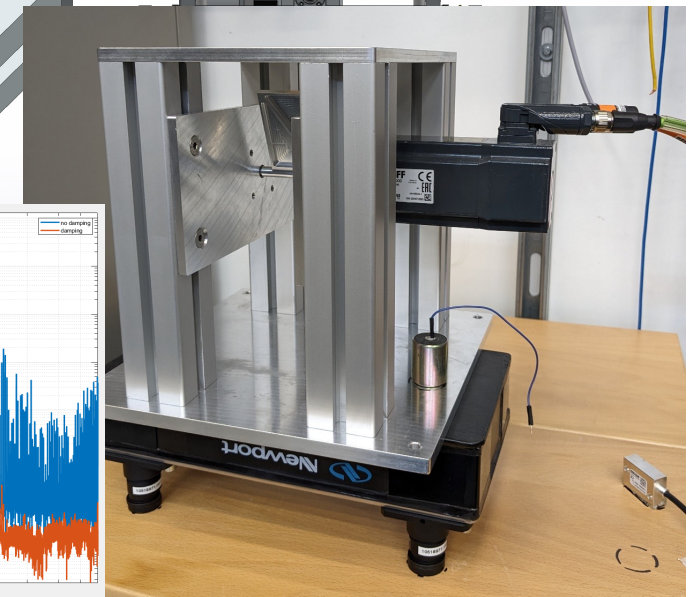
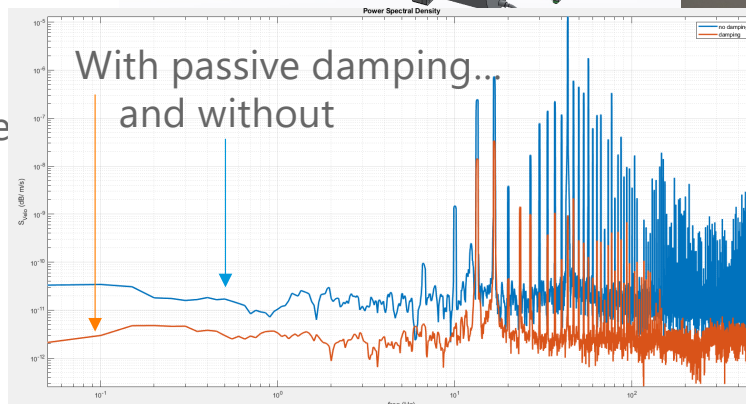
Kinetics Slits Upgrade

A prototype developed by Uppsala University was tested with neutrons at ISIS: The paper has been published:

A final design of the shutter system continues to be developed as part of the Uppsala collaboration, with investigations into vibration isolation and water cooling ongoing.

Conceptual solutions to these issues have been evaluated and are in detailed design.
