Update on ISIS Targets: Analysis and Operating Experience

Dan Wilcox, High Power Targets Group,
Rutherford Appleton Laboratory

ICANS XXV, Malmö, Sweden

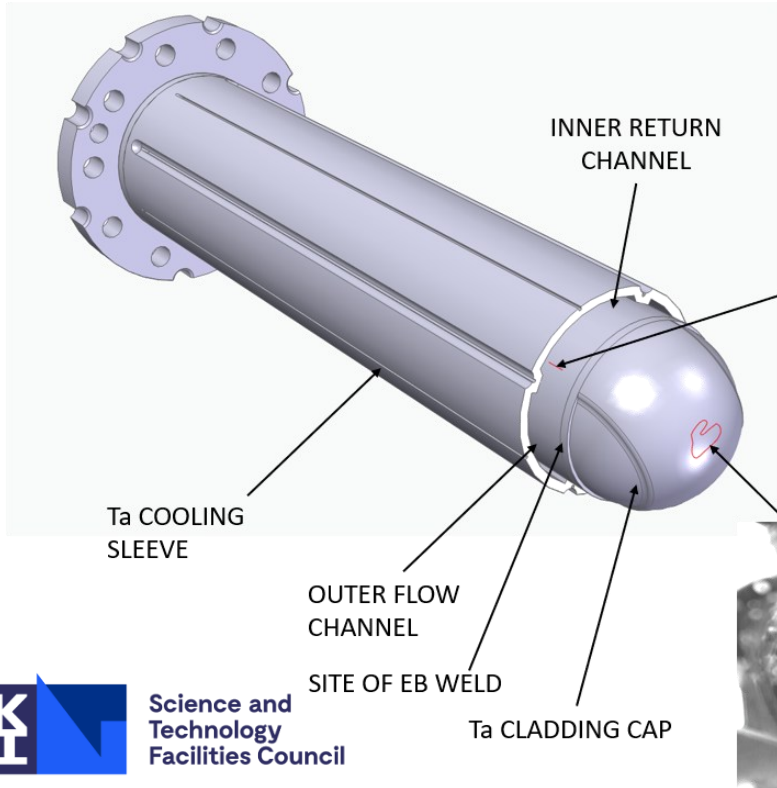
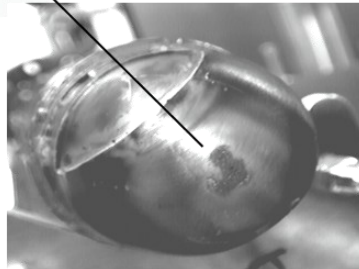
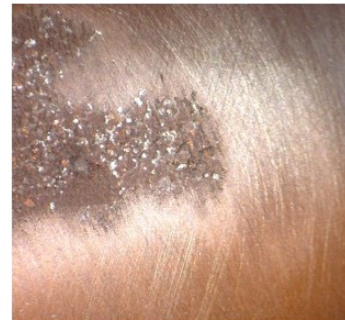
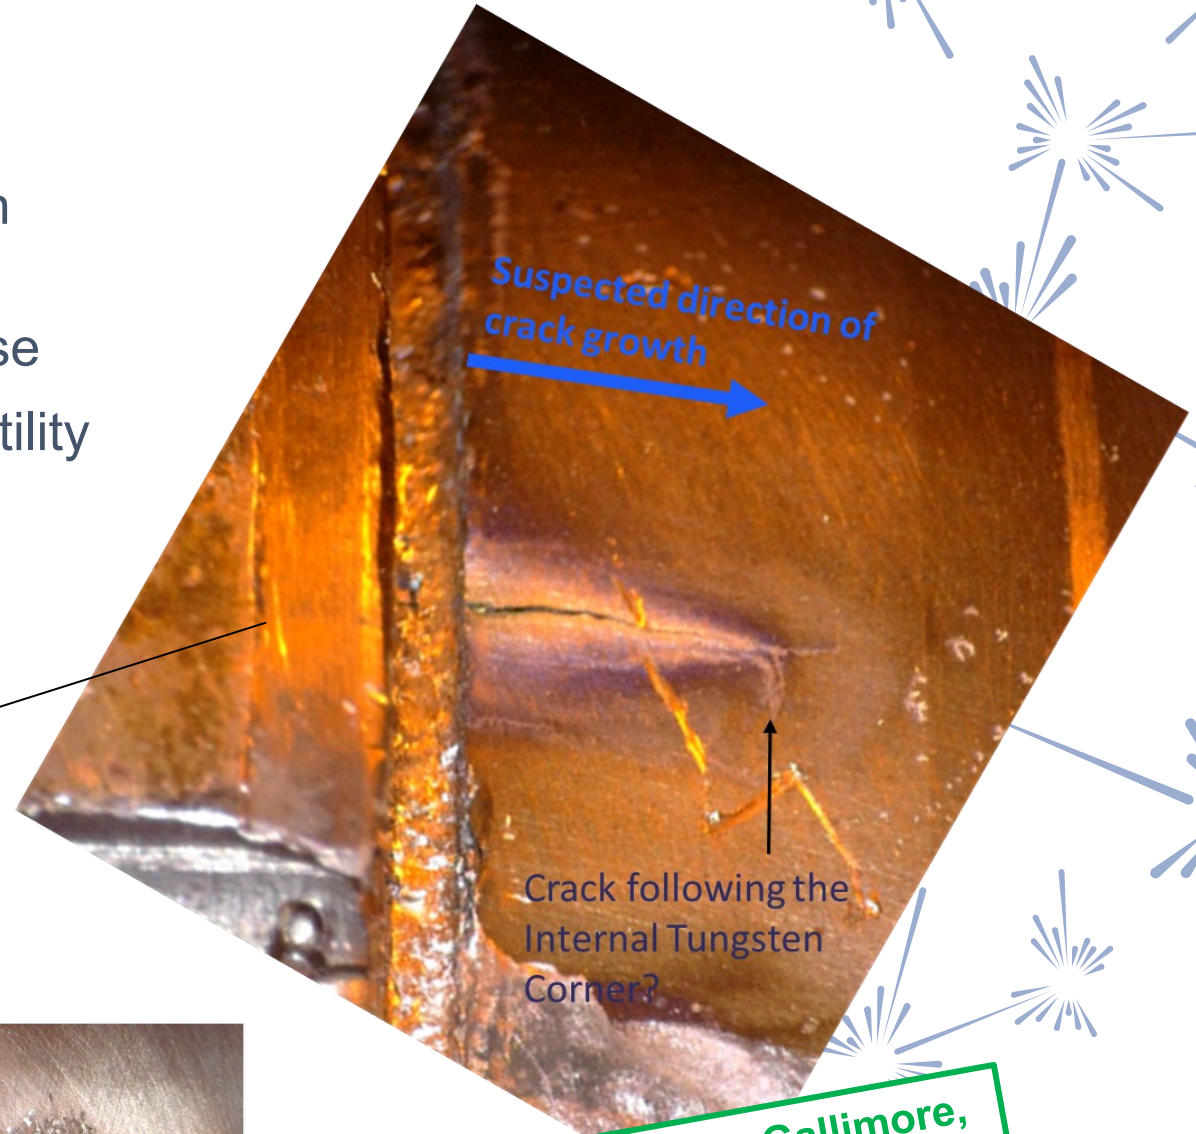
PIE Evidence – TS2 Target #4

- Visible crack in tantalum cladding – consistent with measurements of tungsten in cooling water
- Surface damage but no visible cracks at target nose
- Videos of end cap removal suggest significant ductility is retained in tantalum

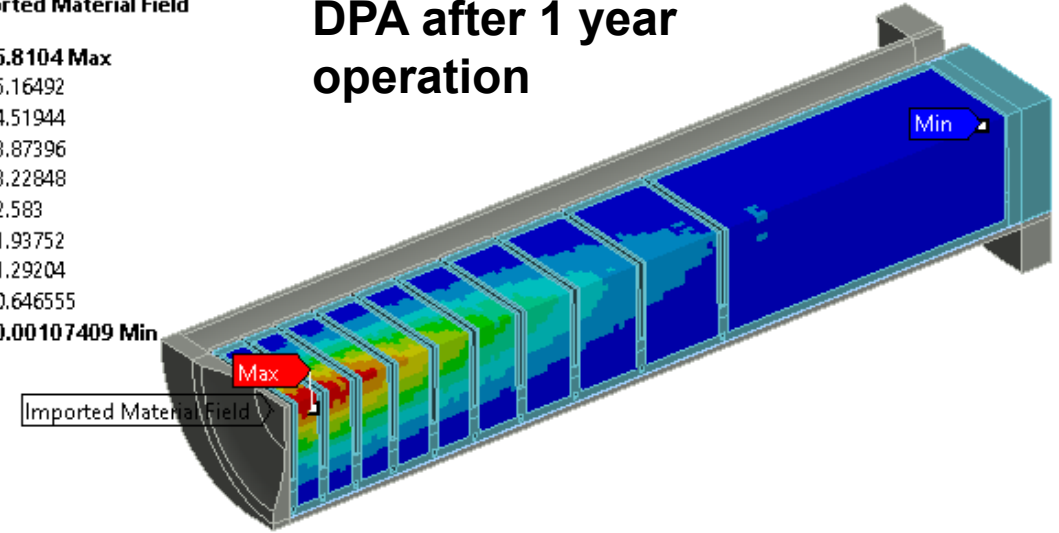
DPA after 1 year operation

DPA map calculated from accumulated beam on target then imported from FLUKA/MCNPX

Each material property can be a function of DPA

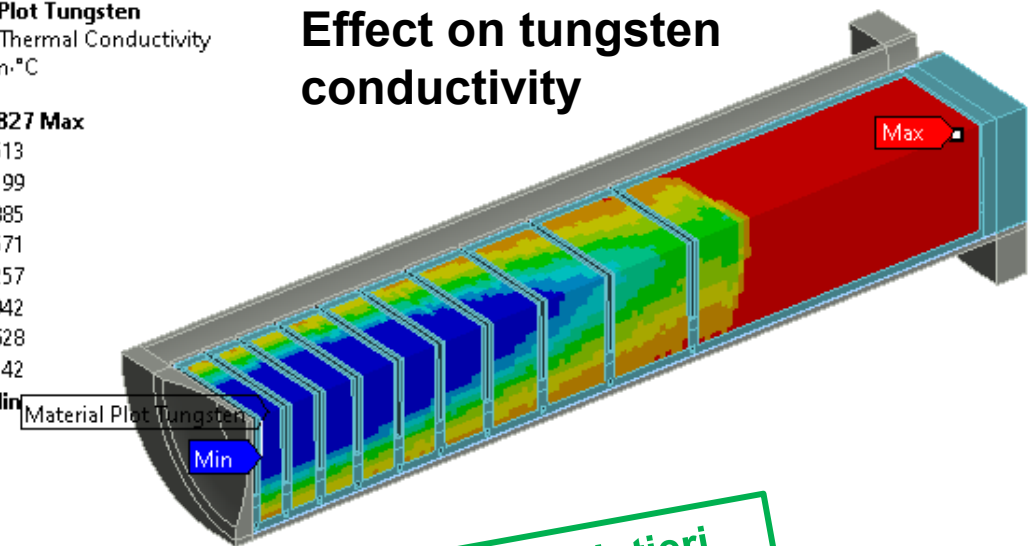
Effect on tungsten conductivity

- **UTS: 560 -> 300 MPa** after 1.3 DPA
 - **k: 175 -> 88 W/(m.K)** after ~2 DPA
- } No further change up to 27 DPA

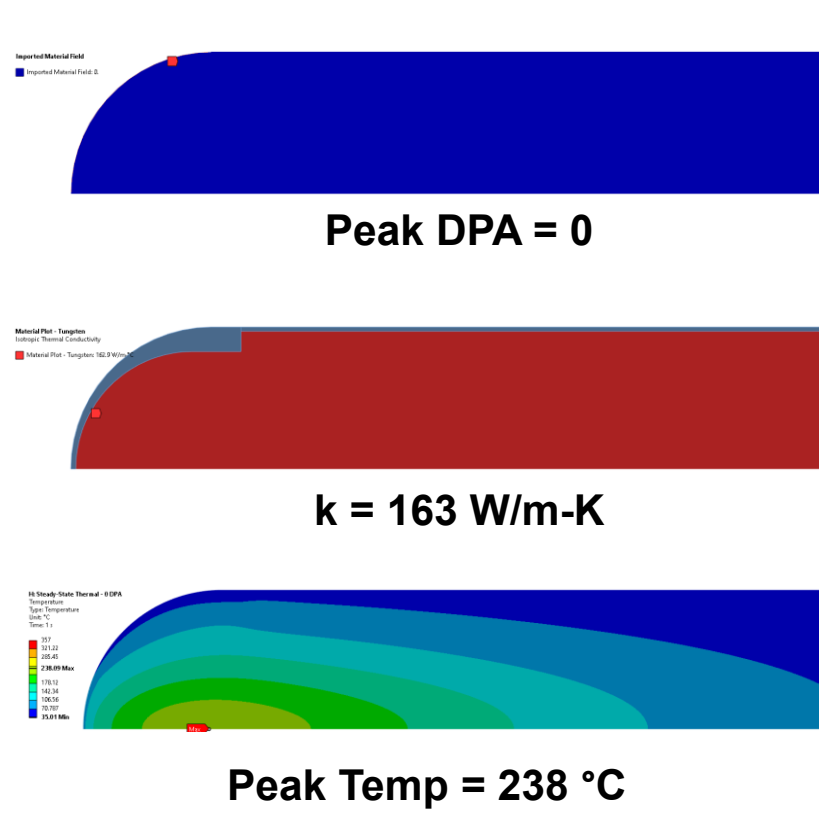
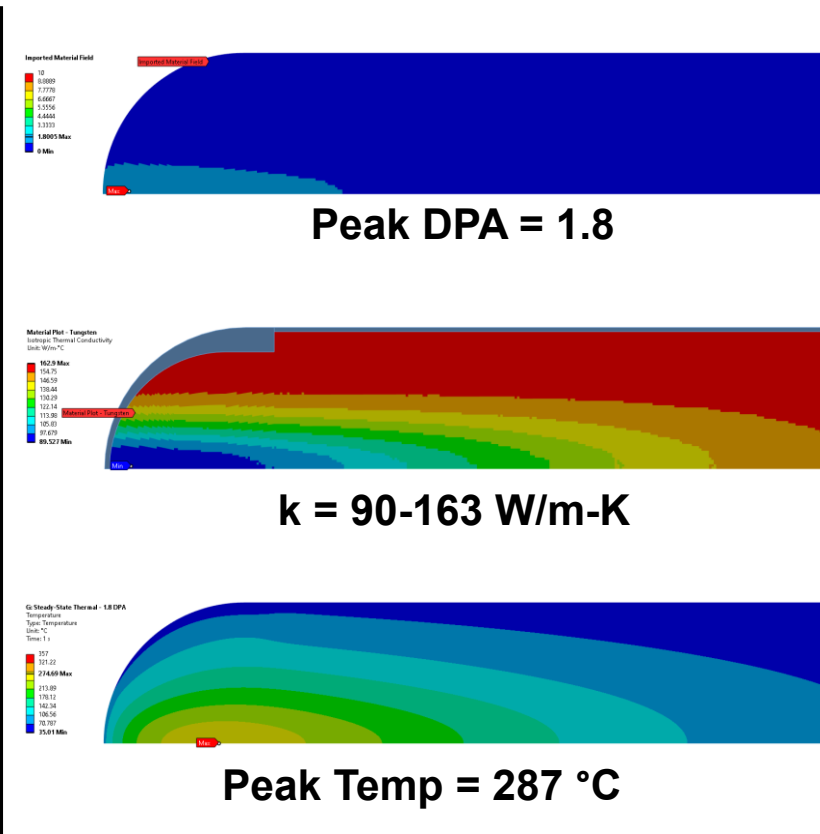
Evolution of Damage in TS2 Target

- Tungsten thermal conductivity degrades as a function of dose, then saturates above 2 DPA

Initial condition

After ~2 months operation

TS2 W#10 target at end-of-life

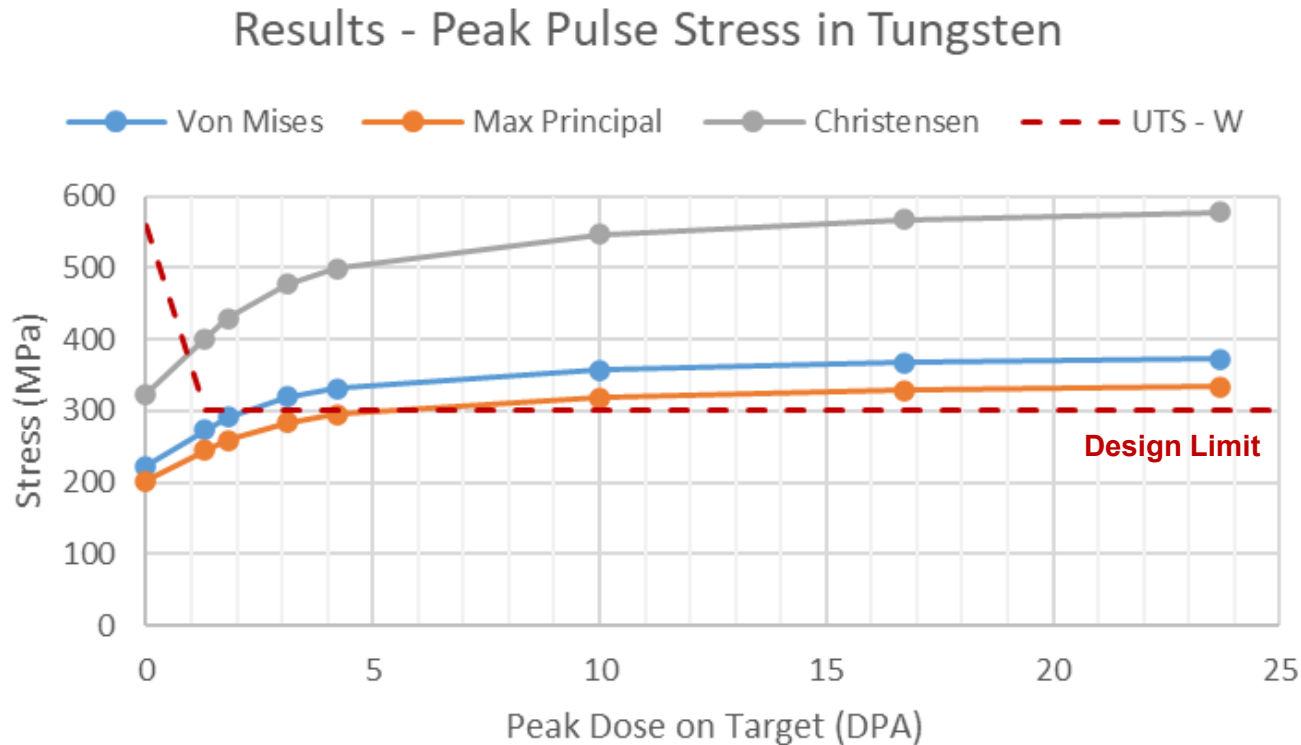
Evolution of Damage in TS2 Target

- Tungsten safety factor is initially large but drops rapidly.
- Tantalum may slightly exceed yield stress but remains below UTS. Limited data at high DPA.
- Measured water activation begins some time after safety factors exceeded

Activity started to rise from around 150mAh (12.3 DPA) on TS2 W#10 target.

Very rapid rise from 250mAh (20.5 DPA).

Ultimately replaced at 290mAh (23.7 DPA)

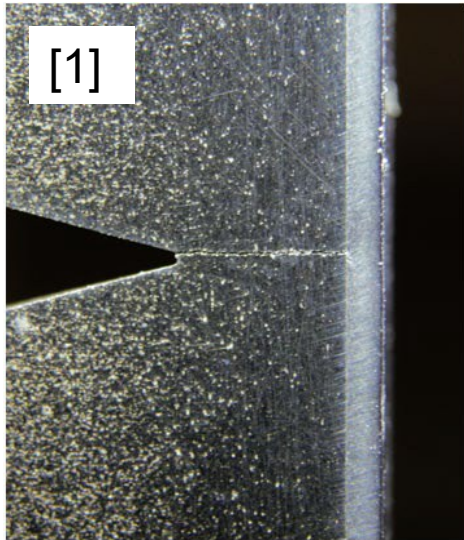
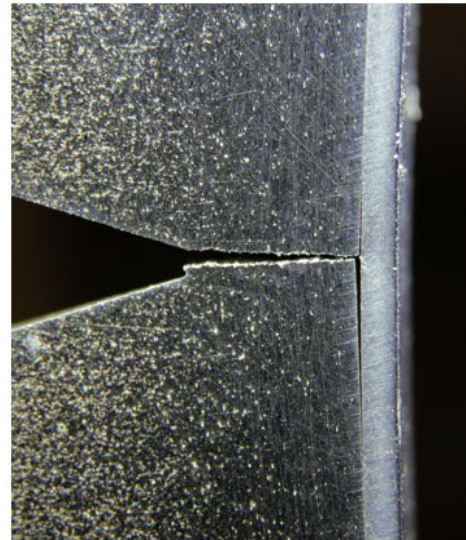
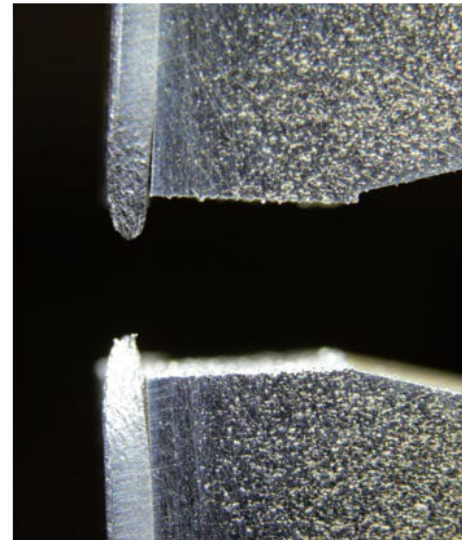
- Testing by SNS Second Target Station team [1] found that: *“Tungsten cracks caused delamination damage then cladding failed in fatigue”*
- Charpy impact tests on ISIS clad samples [2] also showed that the HIPed interface debonds rather than propagates through Ta

Start of stage 3 test

Specimen failed (right side)

Specimen failed (left side)

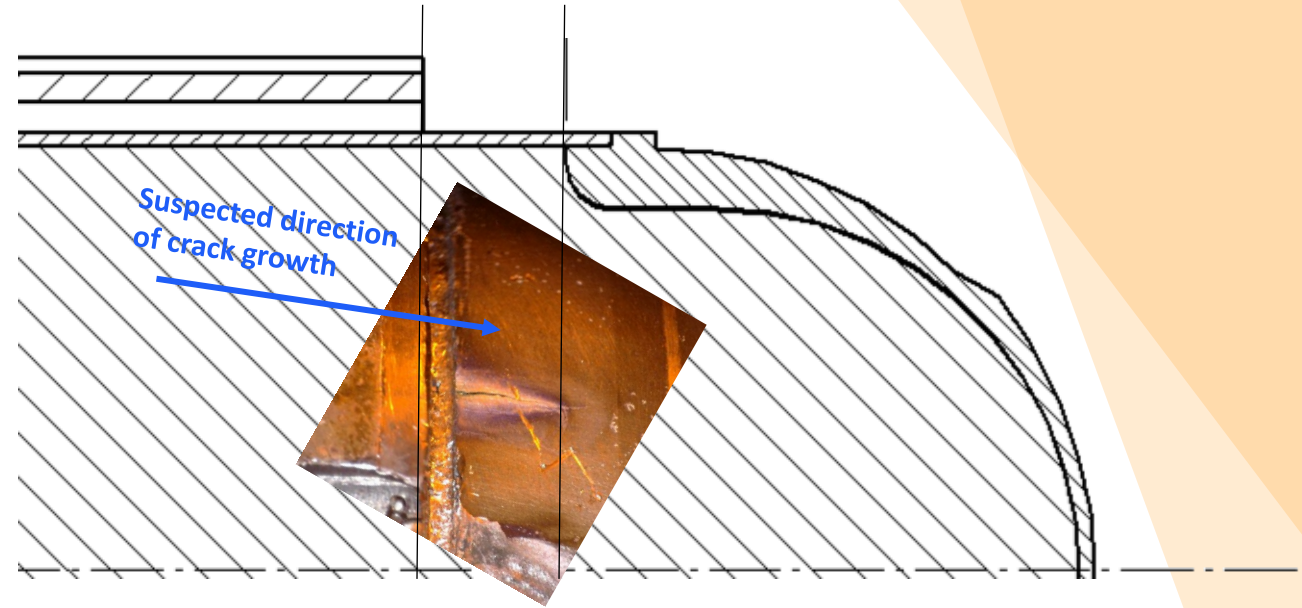
Simulation of TS2 Target #4

Simulated at the actual end-of-life dose on TS2 W#4 target: Peak DPA = 19.2

Crack is not at the first location we would expect from simulations (nose), but is at the second location (shoulder)

Chr, UTS=300MPa, UCS=2120MPa, Tungsten - Max over time
Expression: $(1/300-1/2120)*(S1+S2+S3)+1/(300*2120^2)*((S1-S2)^2+(S2-S3)^2+(S3-S1)^2)$
Maximum Over Time s

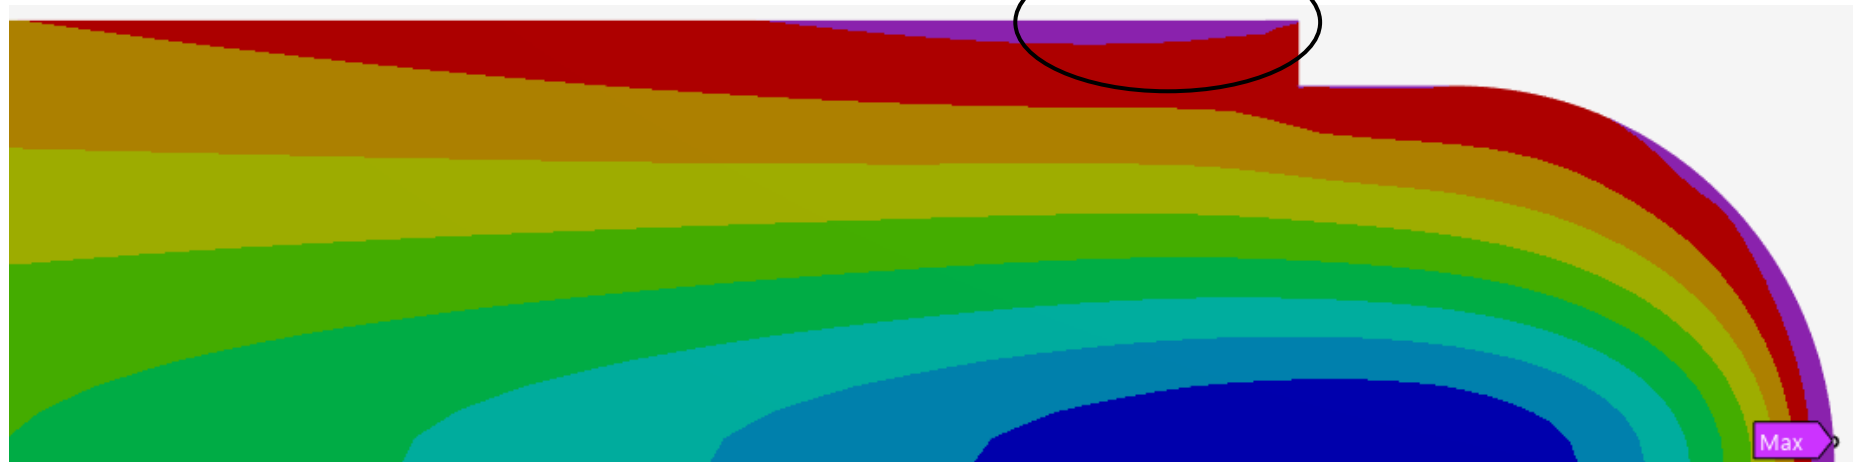
Location of observed crack:

Purple = Christensen failure criterion exceeded

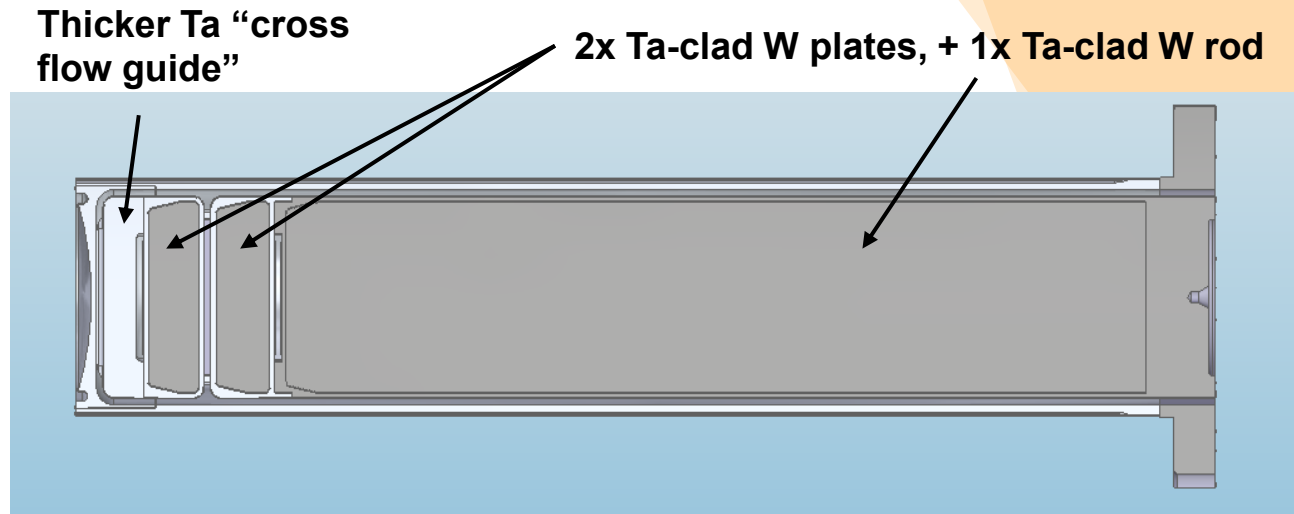
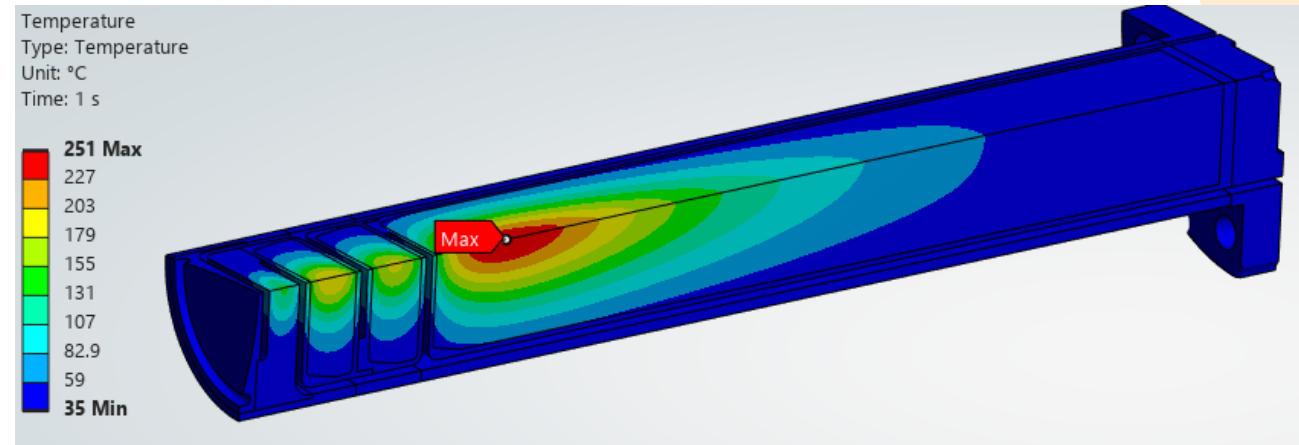
Multiplate TS2 Variant – Mk5 Proposal

- Split monolithic target rod to improve cooling
- Plate thicknesses optimised based on irradiated material properties
- Brings operating conditions more in line with TS1 targets
- Design review expected mid-2026

Results summary with irradiated tungsten properties:

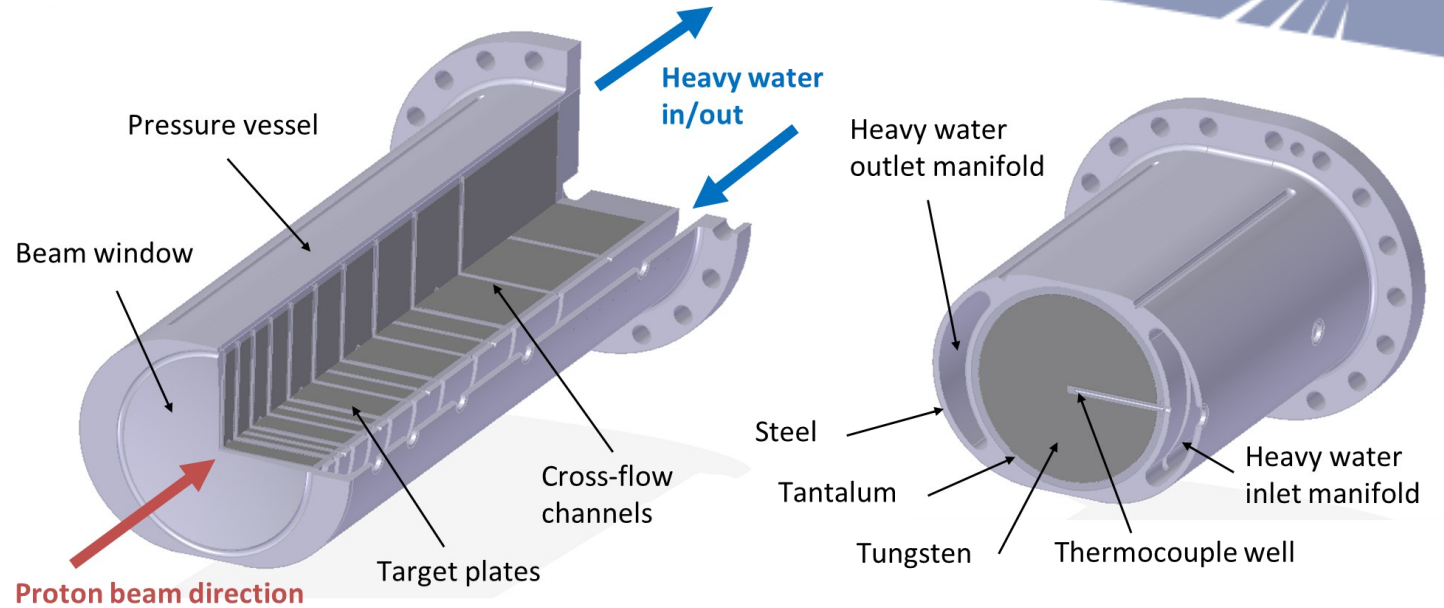
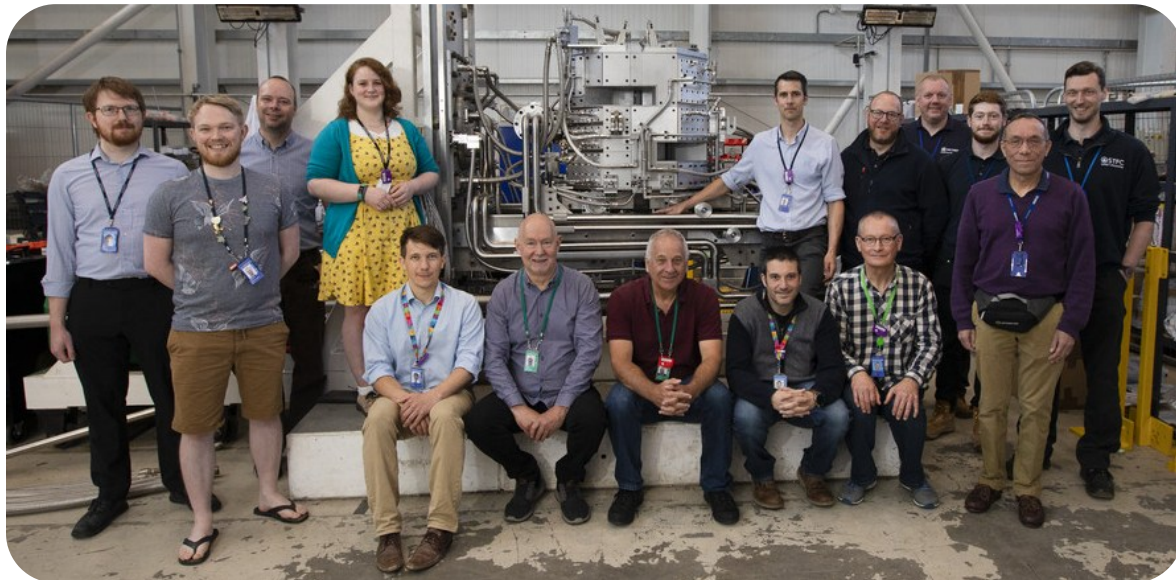
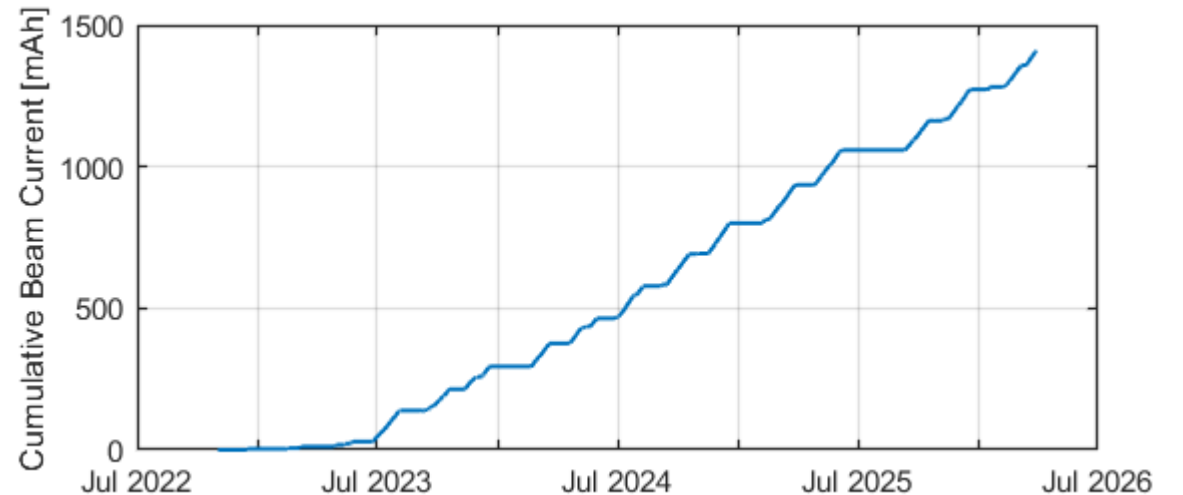
TS1 Project Target Experience

- First beam in November 2022
- Now operating at up to 164 μA
- Accumulated mAh = 1409 so far
- Thermocouples in each plate, and cooling water inlet and outlet

Cumulative beam current on first TS1 Project target
Note: Previous TS1 targets have lasted 2000-4000 mAh

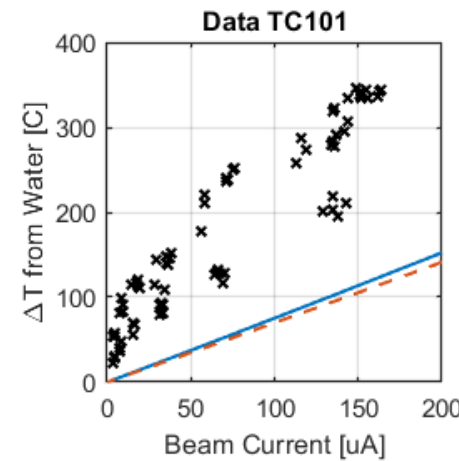
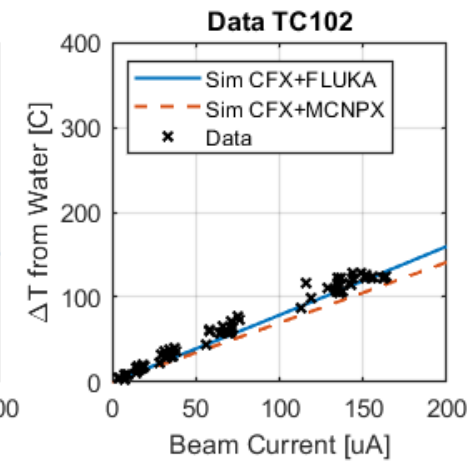
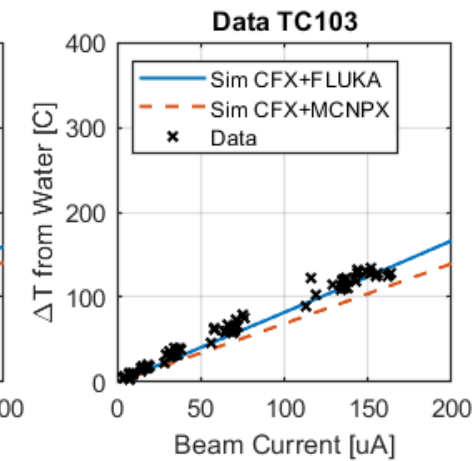
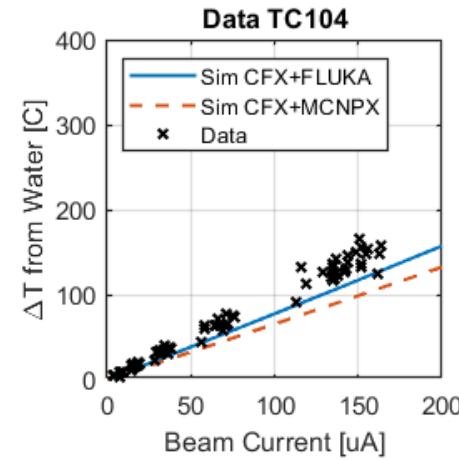
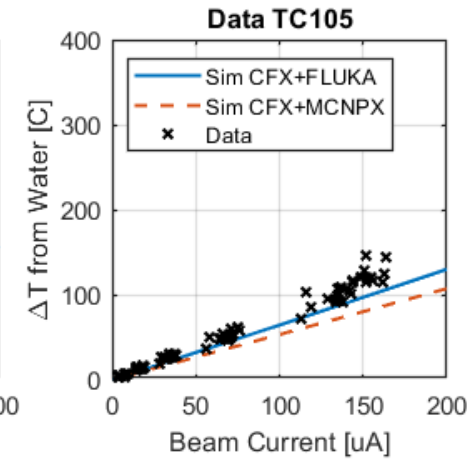
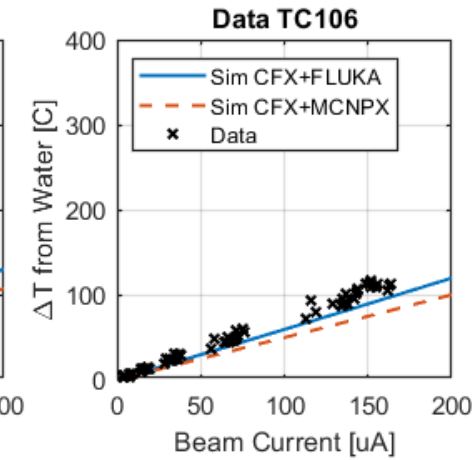
Steady State Temperatures

- Temperature simulations close but consistently slightly high
 - Possible effect of beam focus
- Plate 1 temperature clearly anomalous
 - Thought to be due to poor thermal contact around thermocouple
 - For more details see: *D. Wilcox et al., "Simulated and measured performance of the ISIS TS-1 Project target", Journal of Neutron Research, vol. 26, pp. 47–58, 2024.*

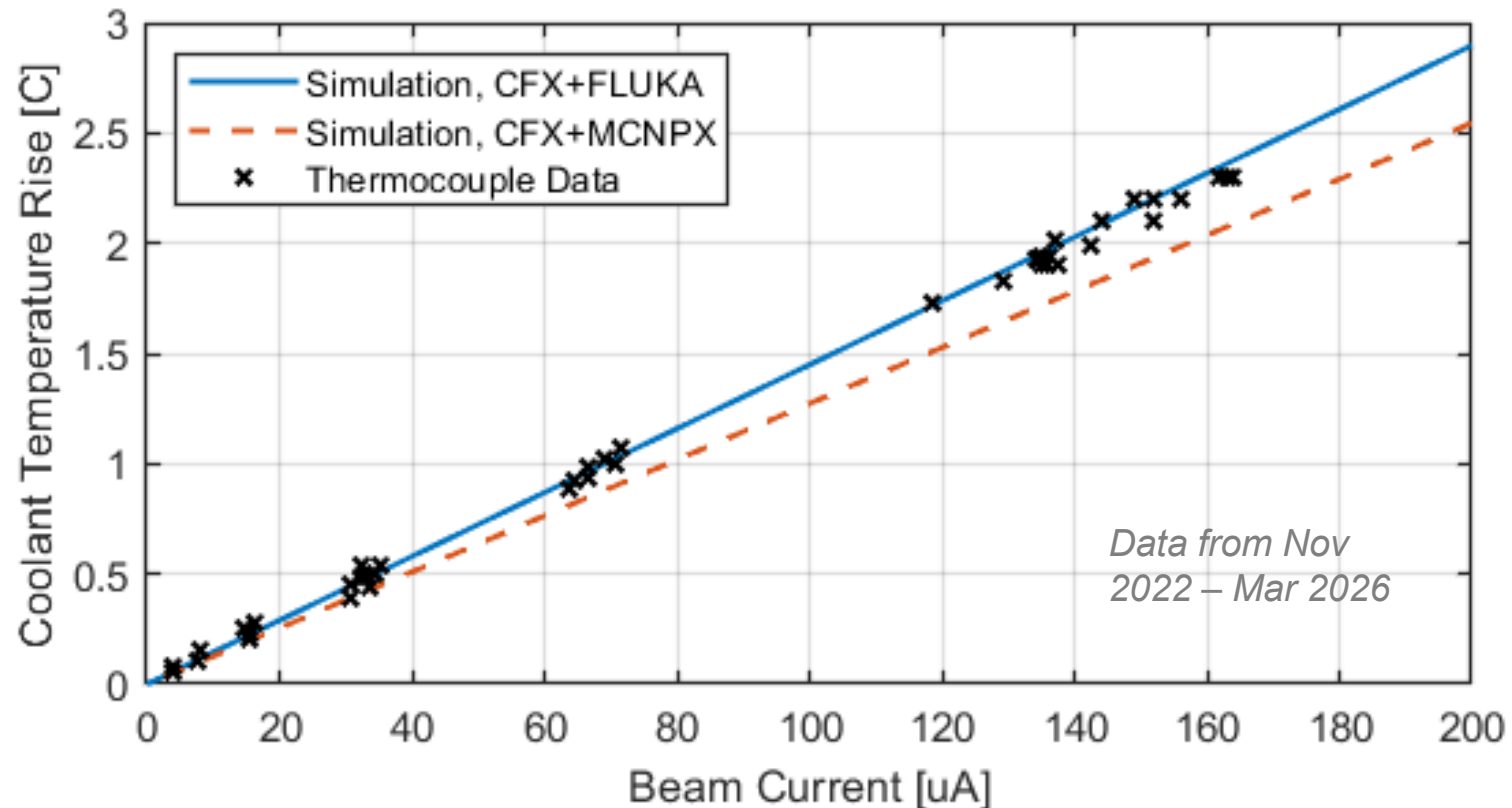
Power Deposition in Target

Calculated from temperature rise in cooling water: $Q = \dot{M} C_p \Delta T$

Water circuit ΔT is small, but appears to be as expected – validating Monte Carlo estimate of heat deposition

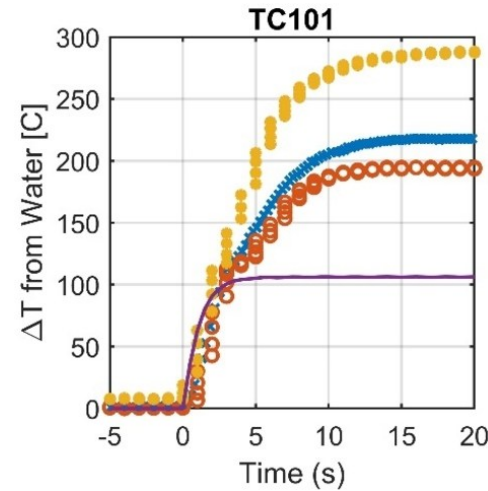
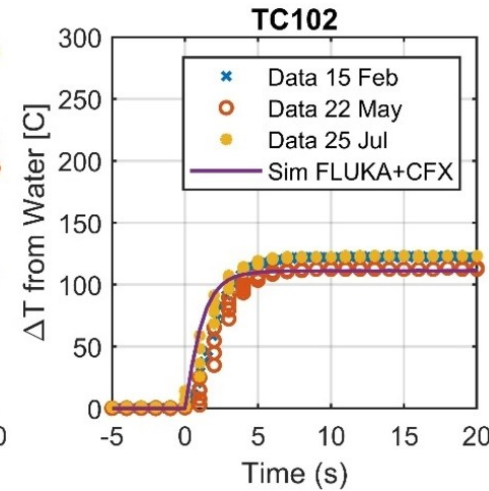
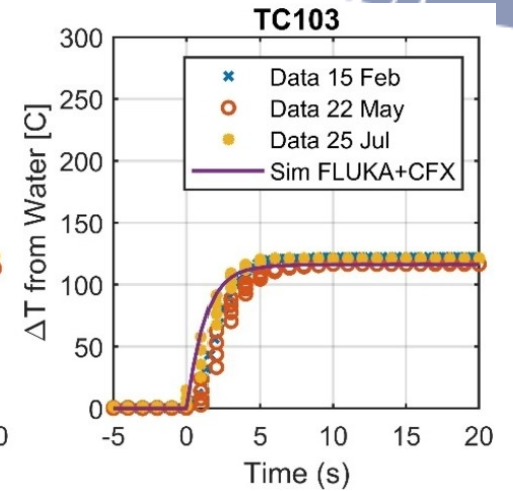
Heating Rates:

- Very low cooling rate on plate 1 at low temperatures
- Broadly good agreement apart from plate 1 (anomalous sensor)
- Initial heating rate gives an independent validation of heat deposition
- Rapid cooling rate indicates water system is functioning as expected

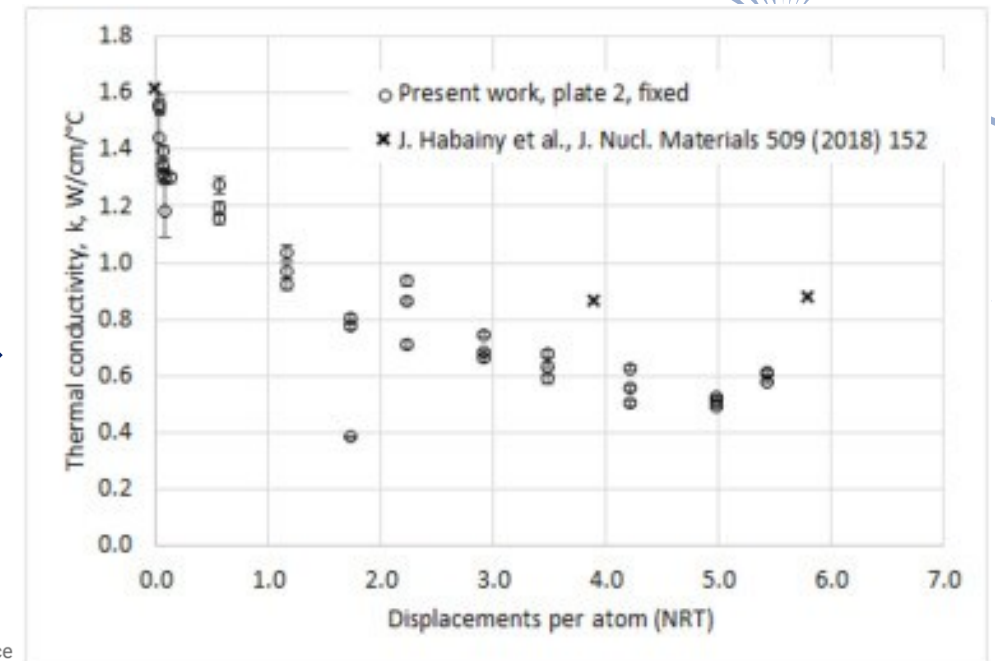
In-Situ Measurement of Conductivity Loss

- Expected effects of thermal conductivity loss in tungsten:
 1. Increase in steady-state plate temperatures
 2. Decrease in cooling rate after beam off
- TS1 plates are thin, effect of conductivity is relatively small ($\sim 40^\circ\text{C}$)
- Beam profile and focus effects are potentially larger, particularly for 1). Beam profile monitor currently not working.
- See recent publication by David Findlay et al. for an investigation of 2):
 - <https://doi.org/10.1016/j.nima.2026.171555>

Potential factors affecting thermocouple temperature:

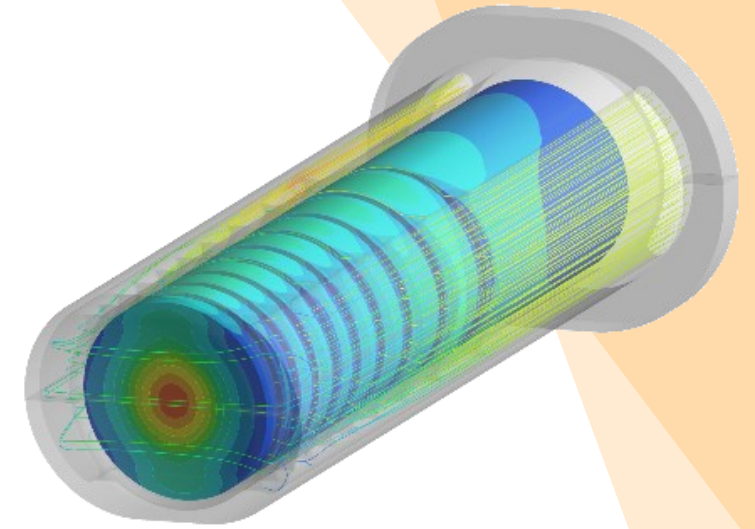
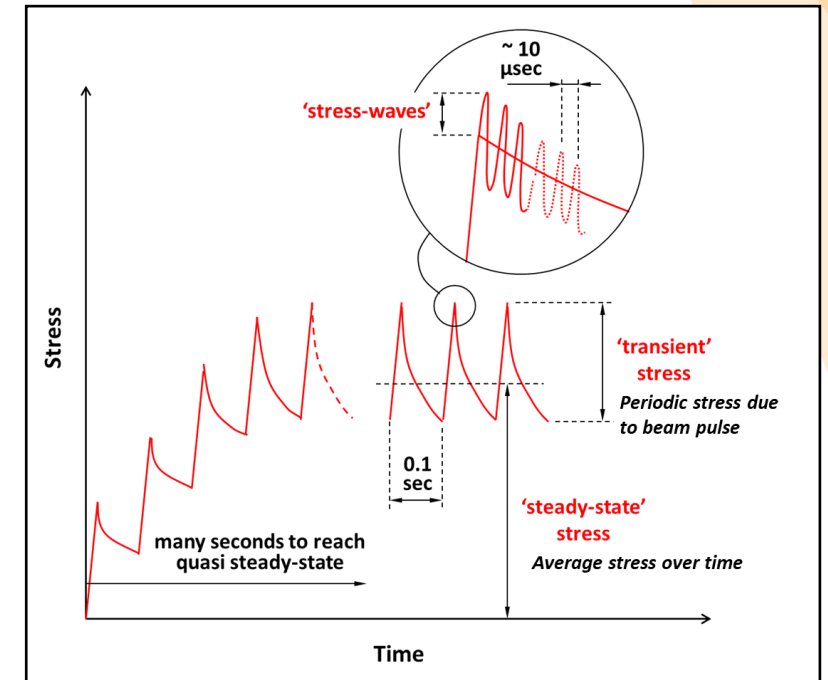
Target Simulation Approach

Ta cladding attached to W core via Hot Isostatic Press (HIP). Residual stress simulated with 500°C “lock-in” temperature [1] [2]:

- Tensile in Ta, induces yielding but not failure. Detrimental to fatigue life.
- Compressive in W – initially beneficial for fatigue life
 - Does radiation damage act to relieve this residual stress? Currently unproven.

Proton beam heating adds thermal stress, which is higher in TS2

Short pulse facility (~400ns), so stress waves are inevitable

- Much worse in TS2 due to smaller beam spot

Fatigue due to beam pulses (many, small stress) and beam trips (few, large stress)

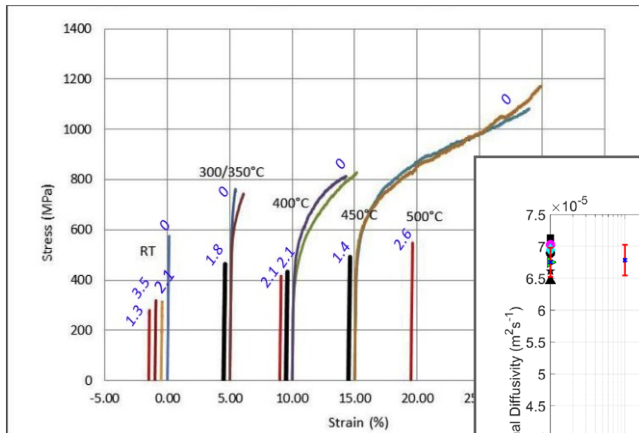
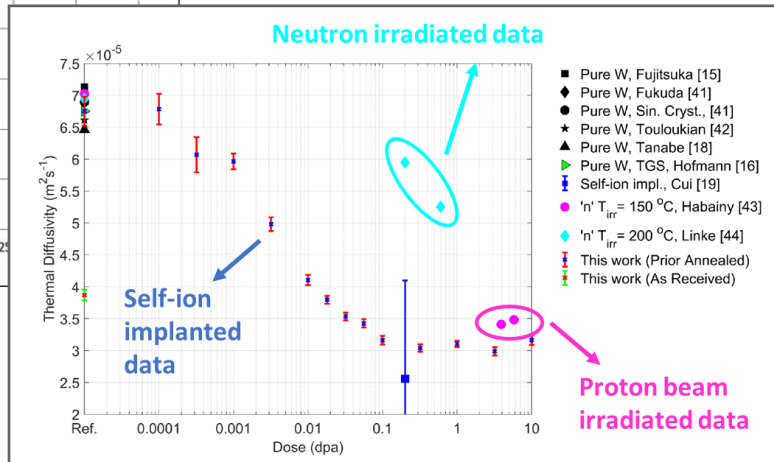
Tungsten

Brittle at room temp. even before irradiation

UTS: 560 → 300 MPa after 1.3 DPA
 k: 175 → 88 W/(m.K) after ~2 DPA } No further change up to 27 DPA

UCS: 1170 → 2120 after 23.3 DPA, no saturation

UCS/UTS: 2.1 → 7.1 (brittle → very brittle)

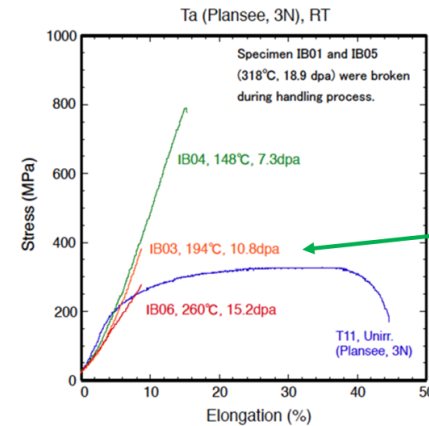
STIP-II specimens were brittle by 7.3 dpa

STIP-II tantalum specimens may have been contaminated by extra hydrogen released by other specimens in the same container

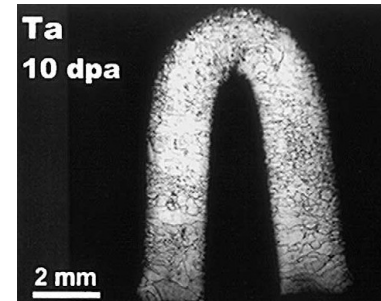
UTS after 10.8 DPA is no worse than unirradiated UTS in either case

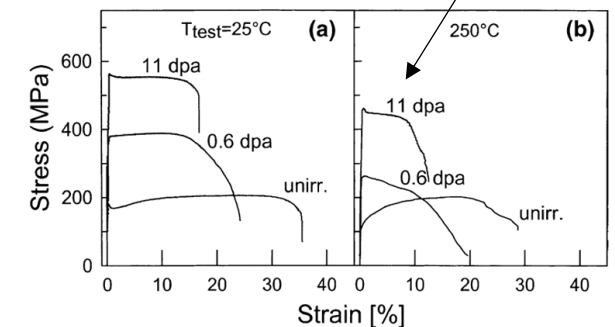
ISIS target cut up at FZ-Juelich remained ductile at 11 dpa

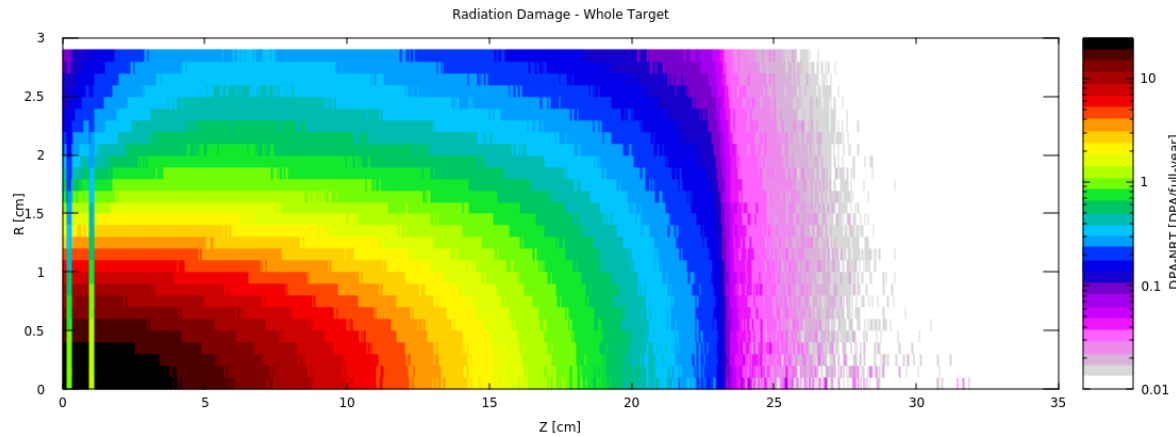
DPA-NRT after 1 full year of 40uA operation:

- What was the condition of TS2 target #4 when PIE was carried out?
- ~16 DPA at centreline (survived), 0.18 DPA at crack location in Ta

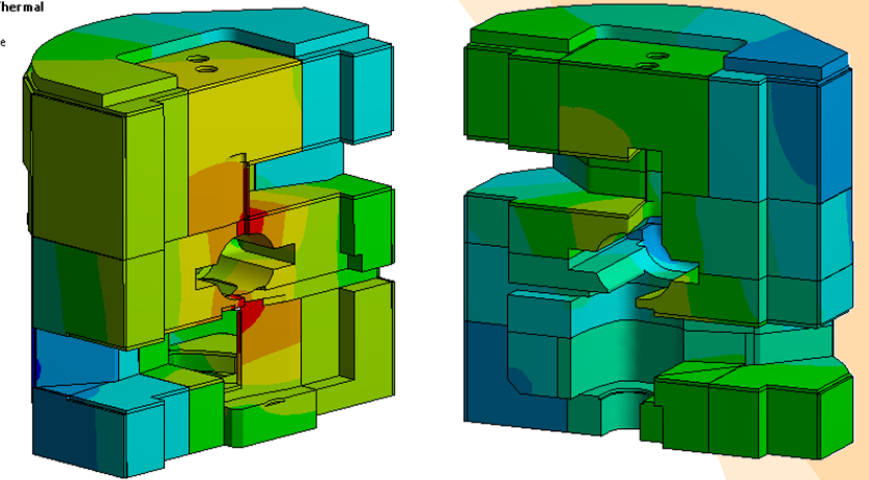
C: Steady-State Thermal
 Temperature
 Type: Temperature
 Unit: °C
 Time: 1

- Total heat deposition estimated from coolant ΔT
- Four thermocouples are directly in contact with Be
- Peak temperature estimated from simulation only
