EUROPEAN
SPALLATION
SOURCE

Fabrication and material studies for SPL cavities at CERN

I. Aviles & N. Valverde
on behalf of SPL team

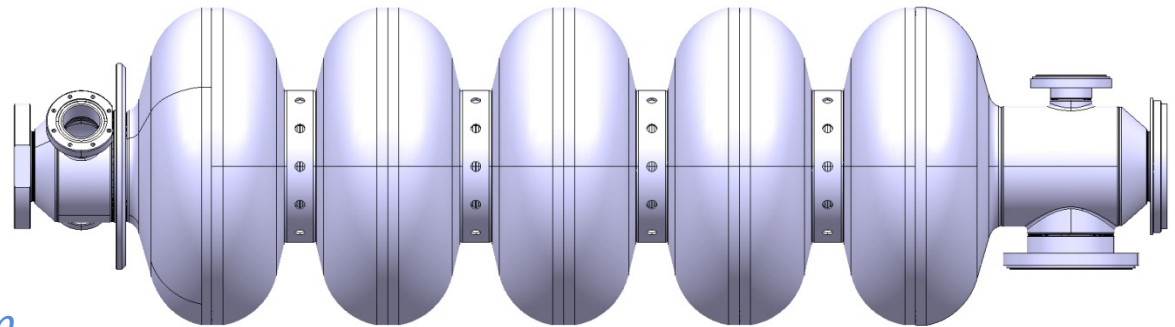
Overview: 5-cell Cavity

PROPERTIES

5-cell cavity $\beta=1$

Material: Bulk Niobium RRR300

Flanges: 316LN

Frequency: 704.4 MHz

Quality factor: 10^{10}

Nominal gradient $E_{acc} = 25 \text{ MV/m}$

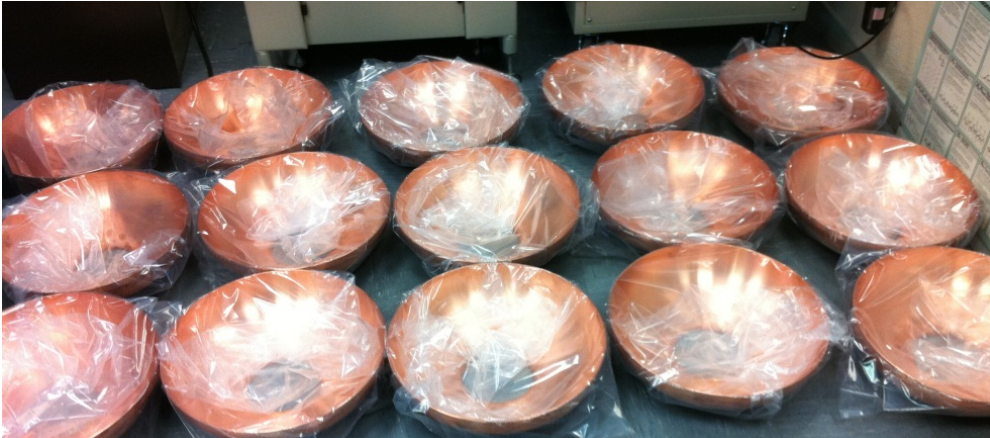
Half-cells shaped by Spinning

Cut-off tube shaped by spinning + extrusion

Brazing the SS flanges to the Cu tubes

Cut-off tube

Cut-off tube + Extremity half-cell

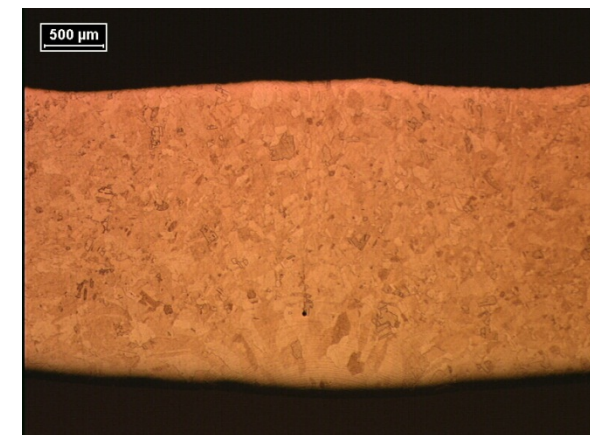
Iris:

Weld from both outside
and inside
Full penetration: 2.4 mm

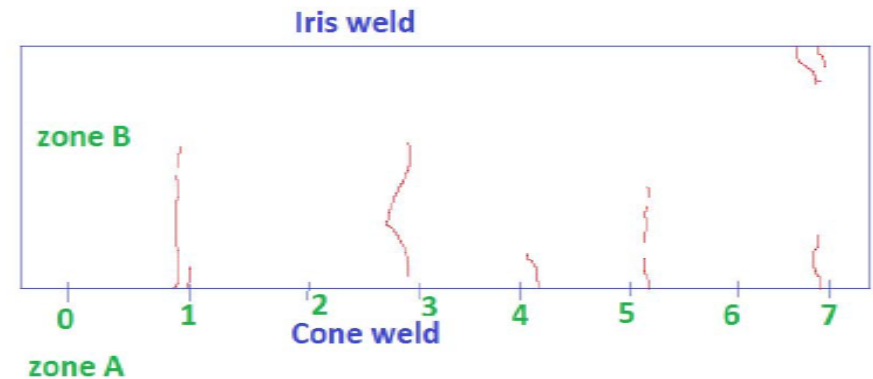
- Radiographic examination

We found cracks only in one beam tube

From 0 to 1 = 6cm
 1 to 2 = 6cm
 From 7 to 0 = 2cm

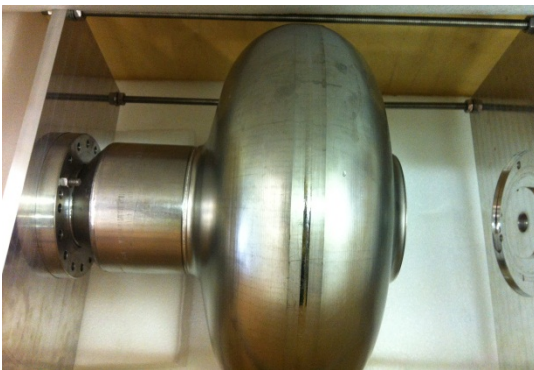
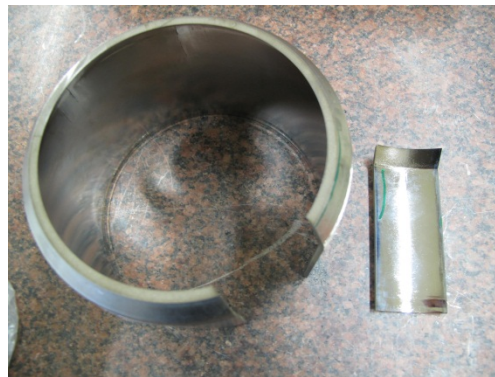
- Destructive examination:

Cutting the monocell to inspect the cracks and study their origin

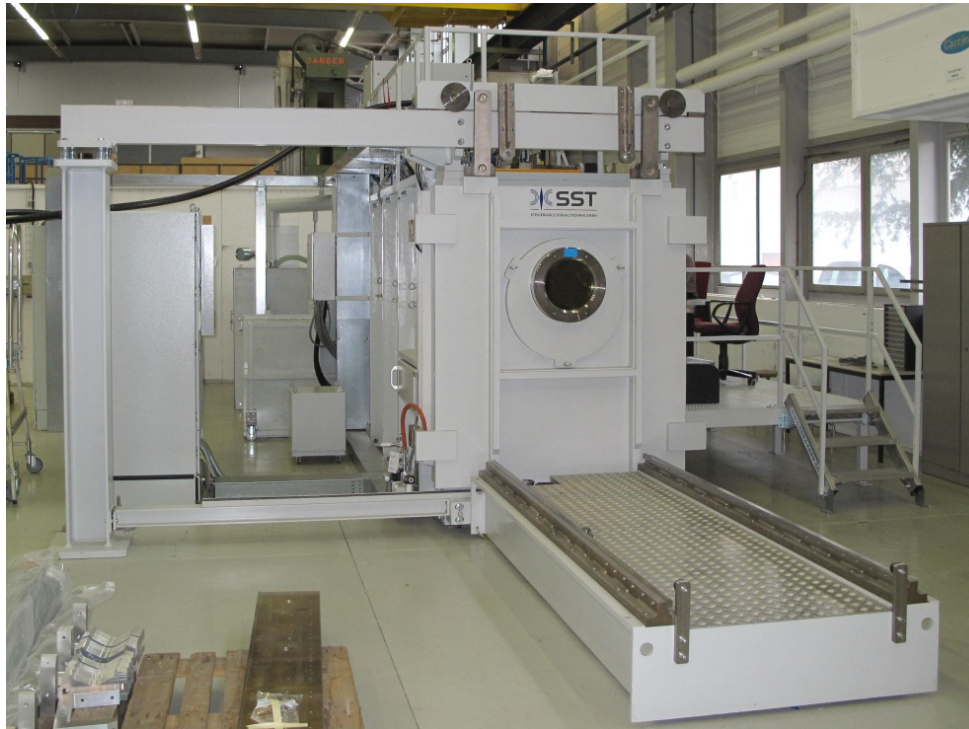
New EB welding machine at CERN (11 m³);

- SS vacuum chamber;
- Vacuum level 1×10^{-5} mbar up to 10^{-7} mbar (cryo. pump) → Adequate for high RRR niobium welds.

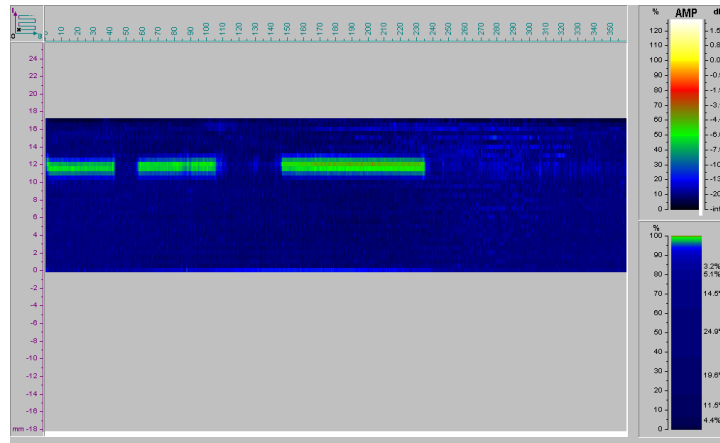
Ultrasonic examination (by immersion) of the brazed area

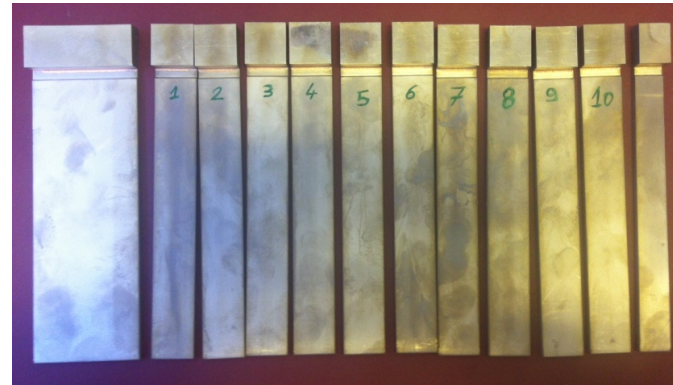
Test II- Effect of the chemical etching on the brazed joint

The bath removed $\sim 300 \mu\text{m}$ of Cu
The bath attacks more the Nb than the SS

It was decided to mask the brazed joint with a polymer

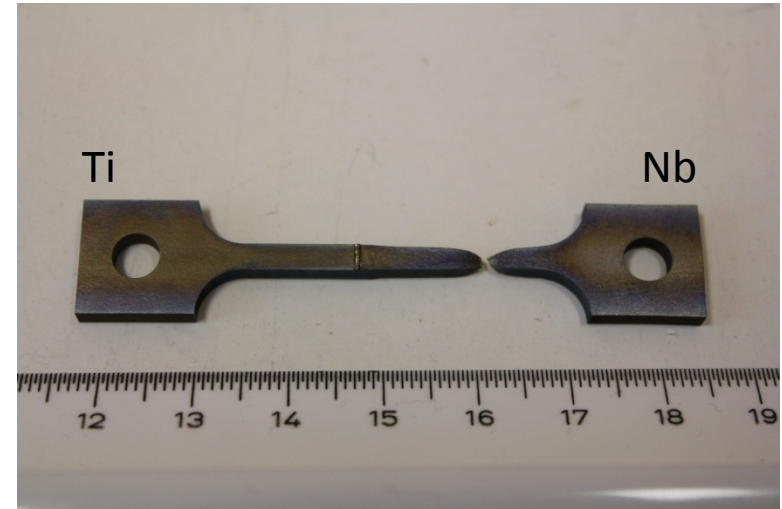
Nb - Ti(V) EBW with improved welding parameters
Heat treatment: 24 hours @ 600 °C

Nb/Ti weld- first tests results point out that could be a suitable solution for niobium/titanium interfaces
