# TG5/SAR Meeting

## ODIN: Status of NCR's and NIT's

## Status of NCR's and NIT's

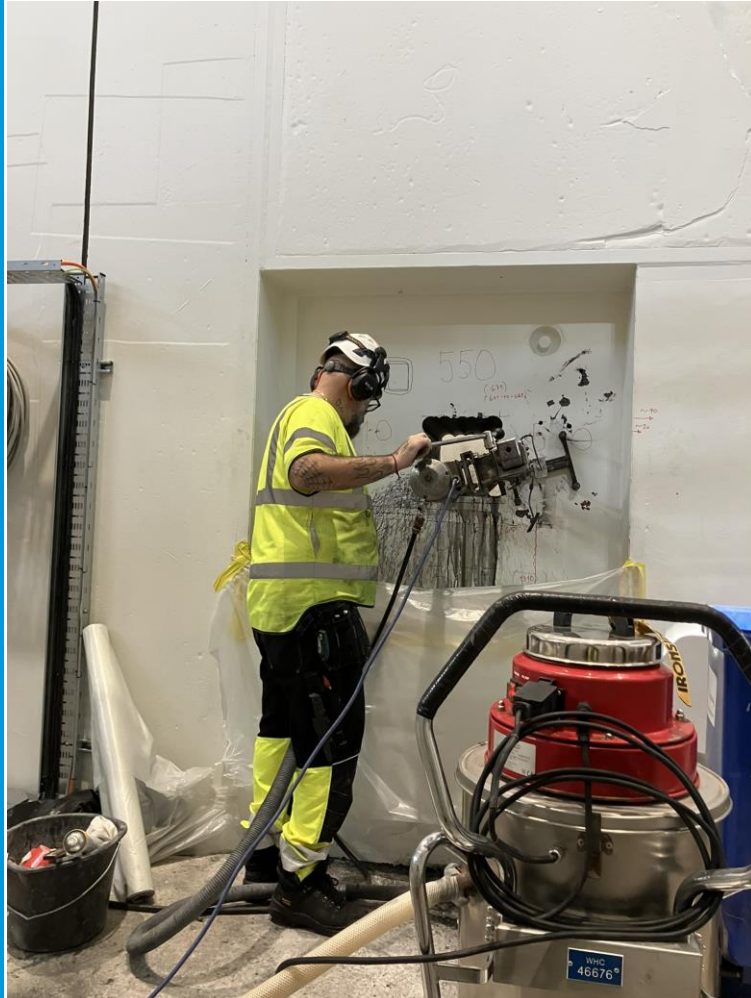
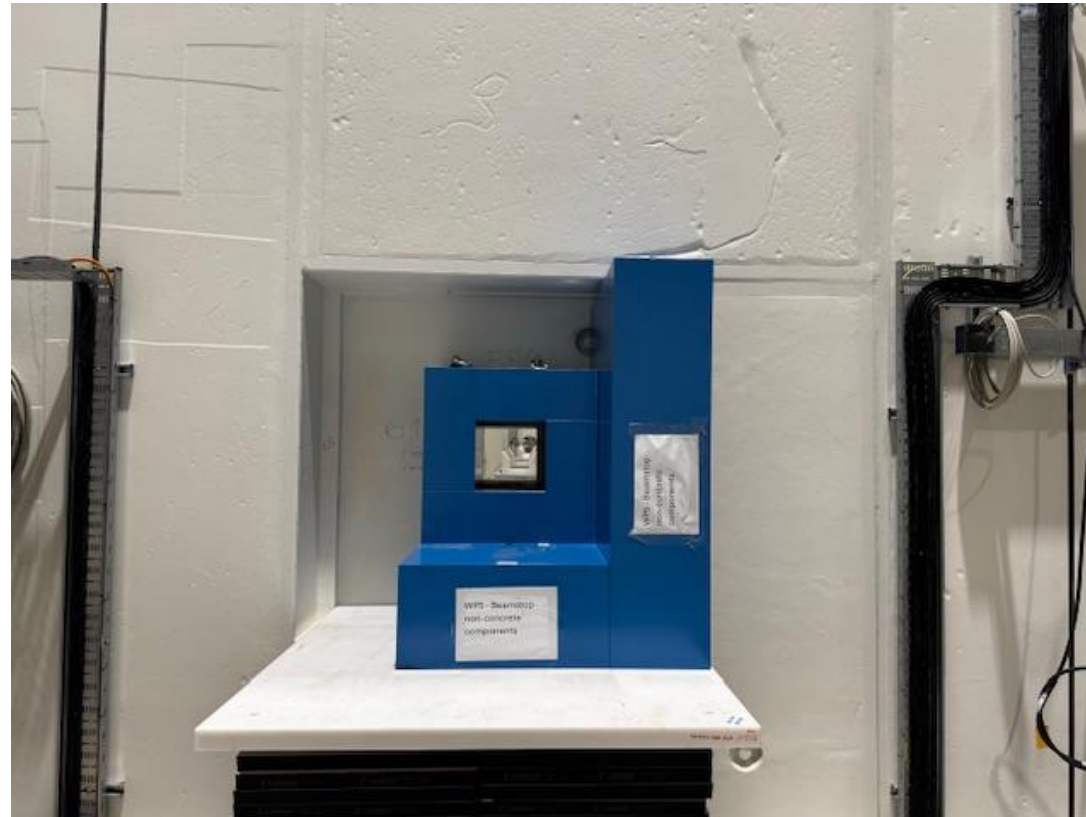
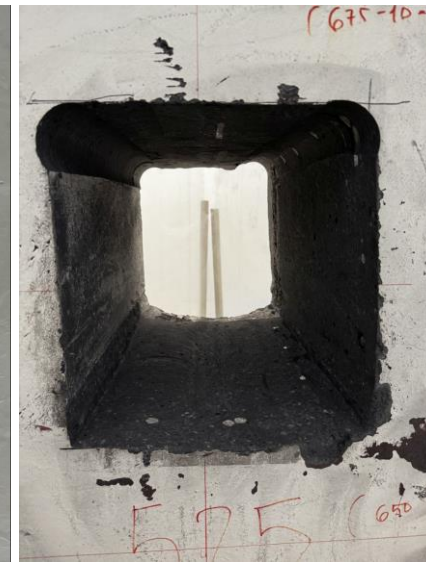
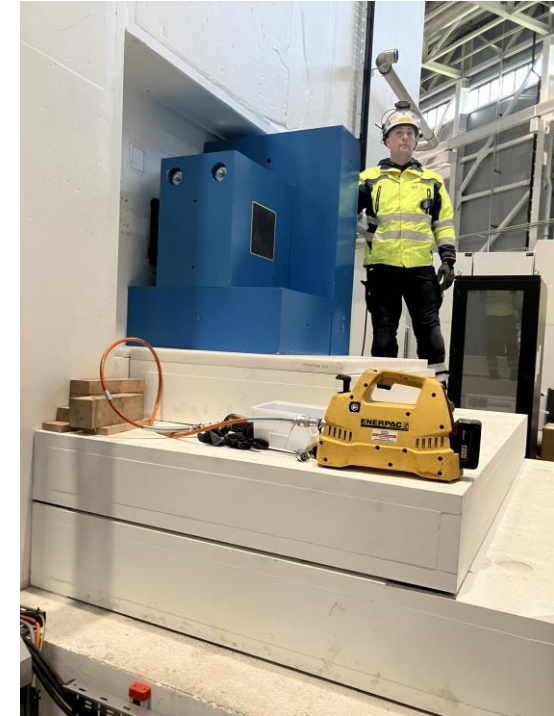
**NCR 10527**

Based on <https://jira.ess.eu/browse/SAM-62>, the opening in the back wall was not exactly aligned with the direct beam (or where we expect the direct beam to be), we had to enlarge the hole slightly. This enlargement ensures that the beam will hit the beam stop and not the wall.

Regarding NC 10527: back when the opening was made, we have visited the ODIN cave together with Radiation Protection (Ana Cintas) and with Günther Muhrer (Group Leader, ESS Spallation Physics). The situation was reviewed on site, focusing on the enlarged opening in the back wall and the alignment with the beam stop.

Since the size, material and position of the beam stop itself have **not** been changed, the adjustment to the wall opening only affects the instrument performance – in a positive way – by ensuring that the full direct beam is intercepted by the beam stop instead of partially hitting the wall. From the shielding and safety perspective, the change does **not** introduce any negative impact; on the contrary, it helps to minimise unnecessary neutron activation inside the cave.

Radiation Protection will in any case survey the cave and beam-stop area during operation as part of their routine follow-up.

Based on this, we consider the non-conformity to be addressed and controlled.

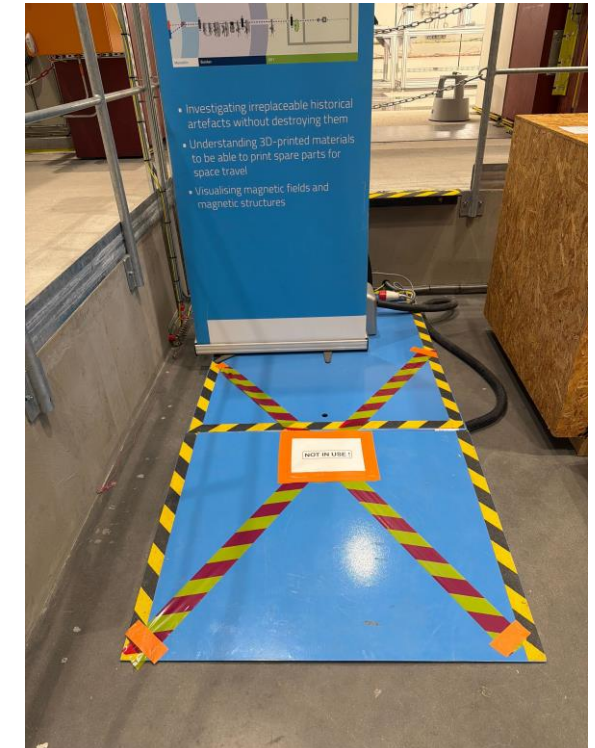
ODIN lifting platform

- Lifting platform was deemed potentially unsafe (despite passing all prior reviews)
- In any case, the instrument prefers to not have it:
  - Was never needed during installation as ramp is available.
  - Access can be better be used by fork lift if something that heavy comes in

The platform has been marked with 'NOT IN USE' by Richard Ammer (until it will be removed later).

**Status:** to be removed
