Exchanging the Plug JMA05 in the Beam Tube SR5 at FRM II

Elbio Calzada

DENIM 2016

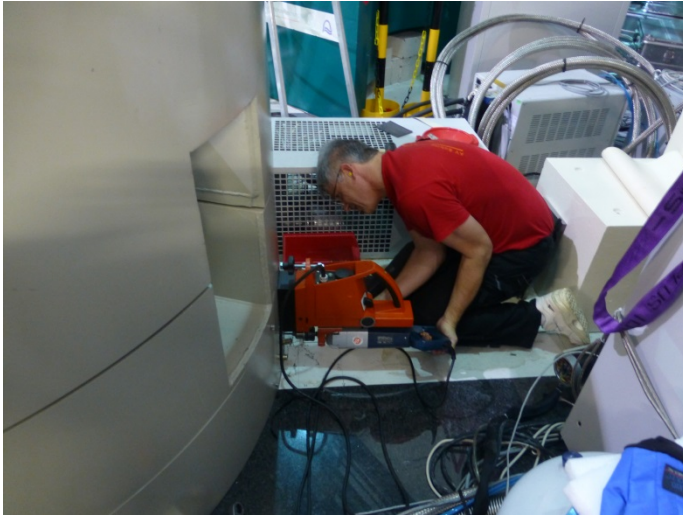
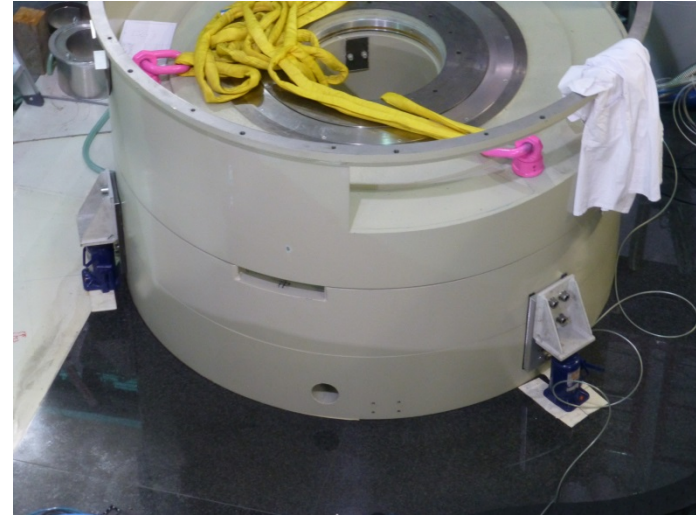
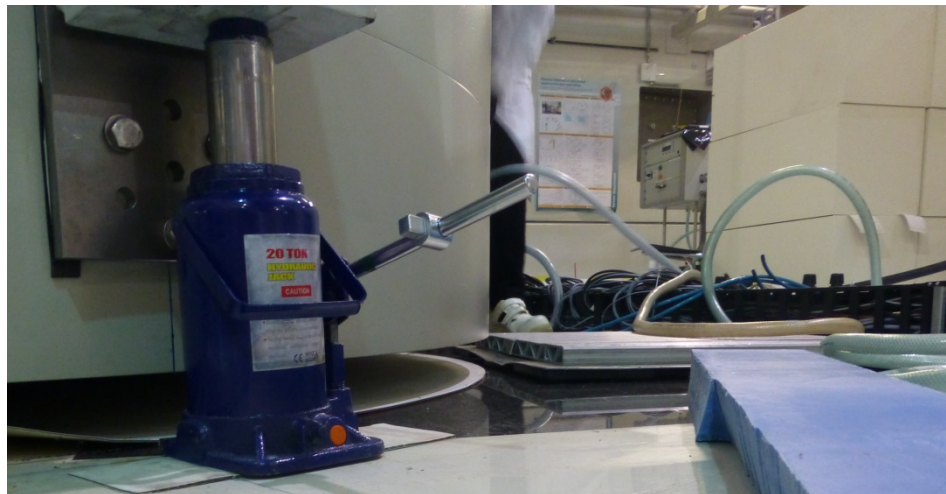
Dismantling of the Instrument TRISP (Unexpected Issue)

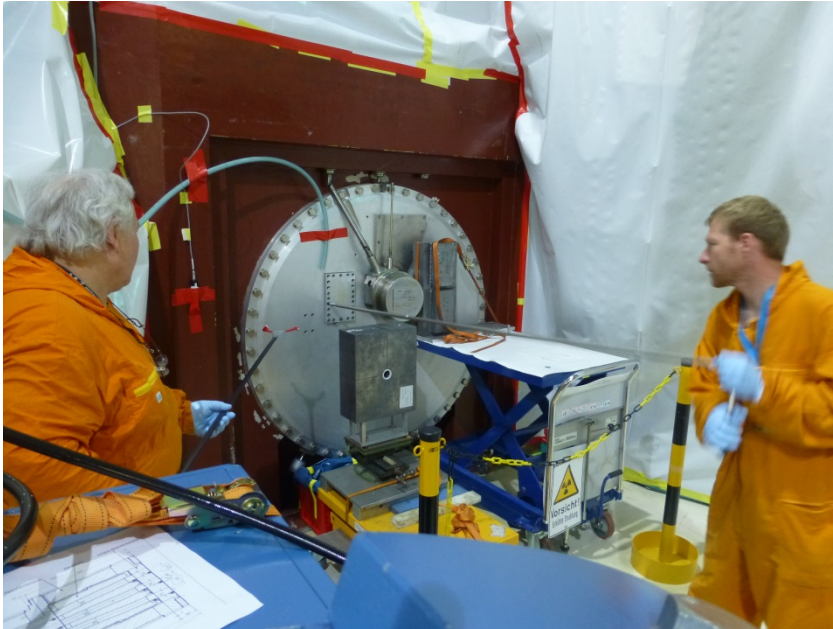
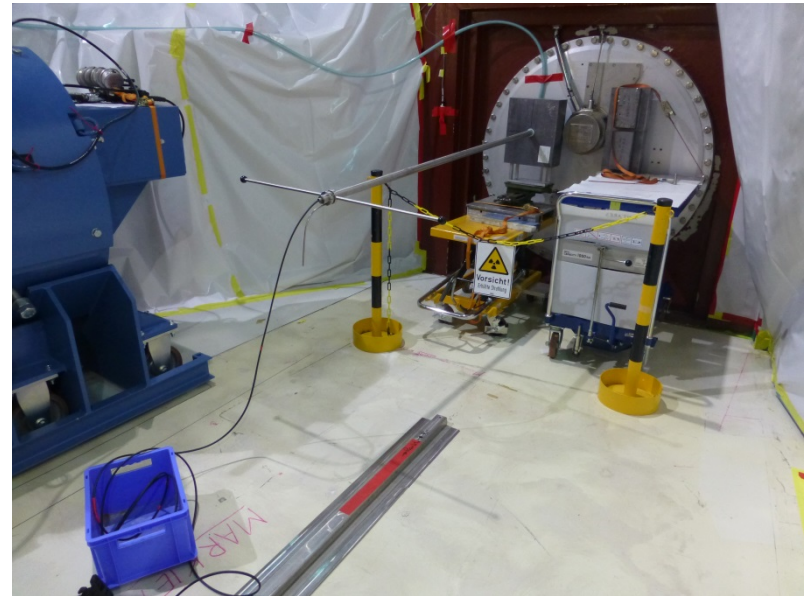
1st Inspection of the Beam Tube SR5

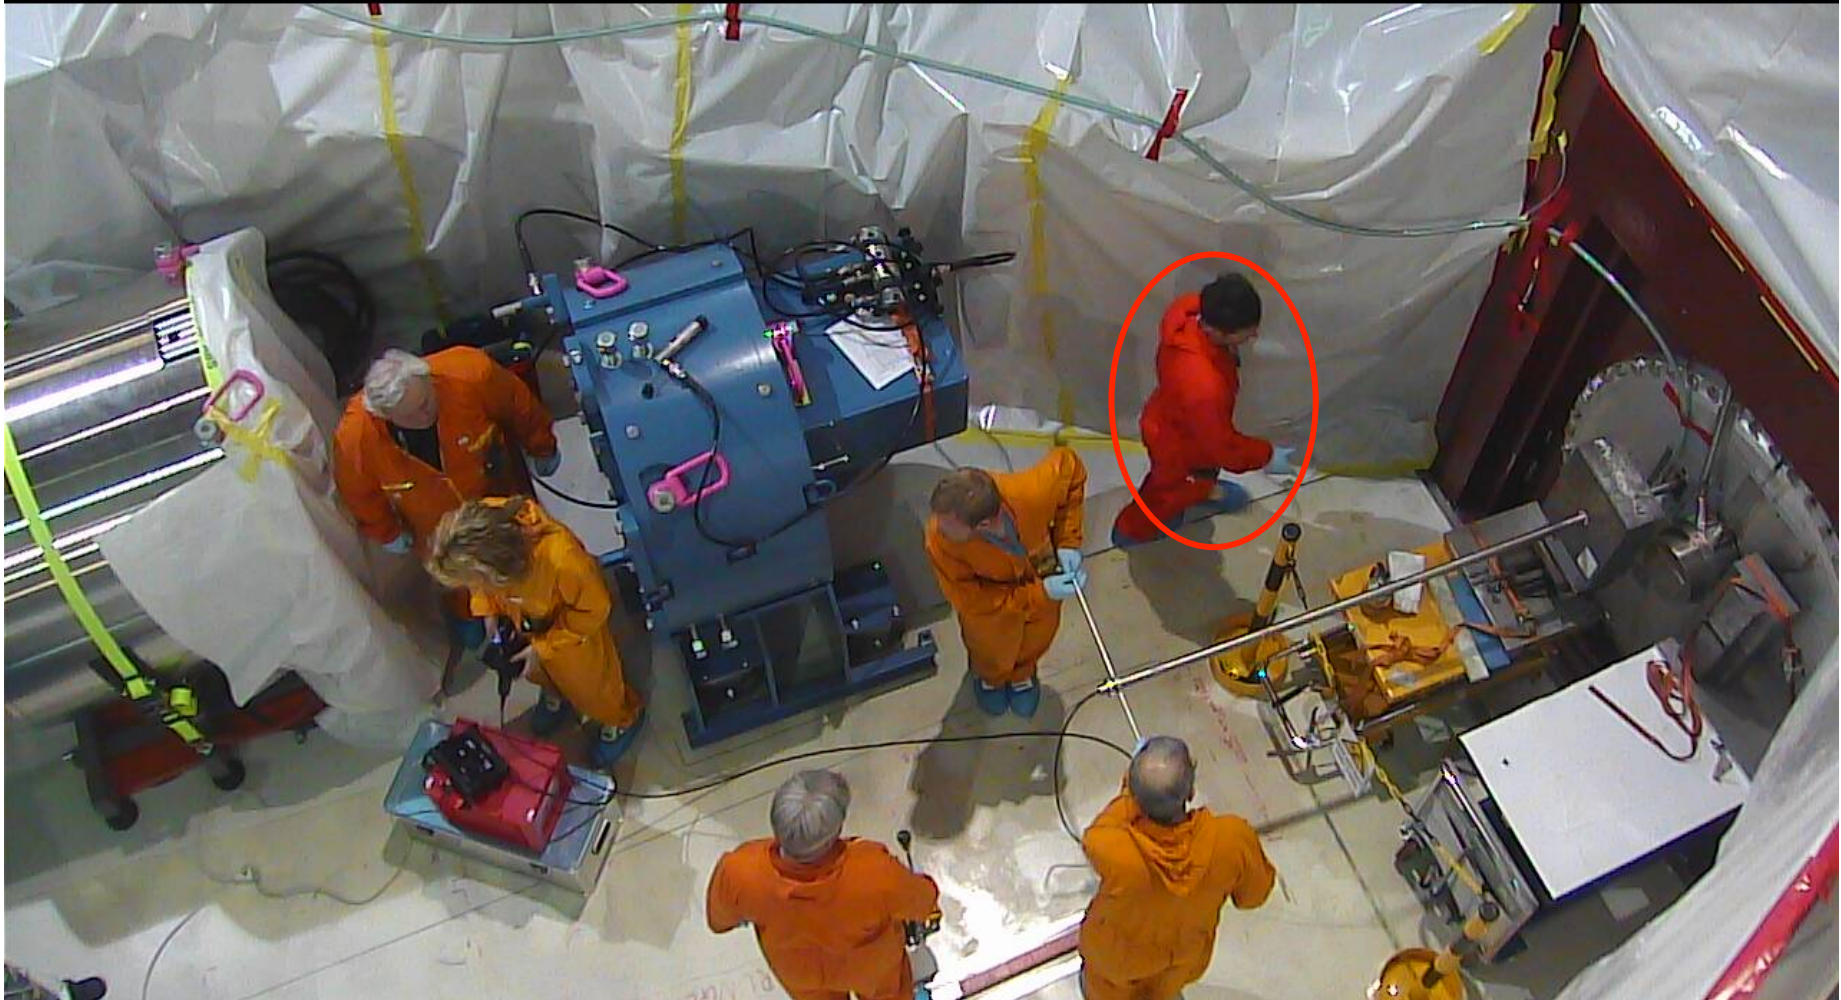
1st Inspection of the Beam Tube SR5

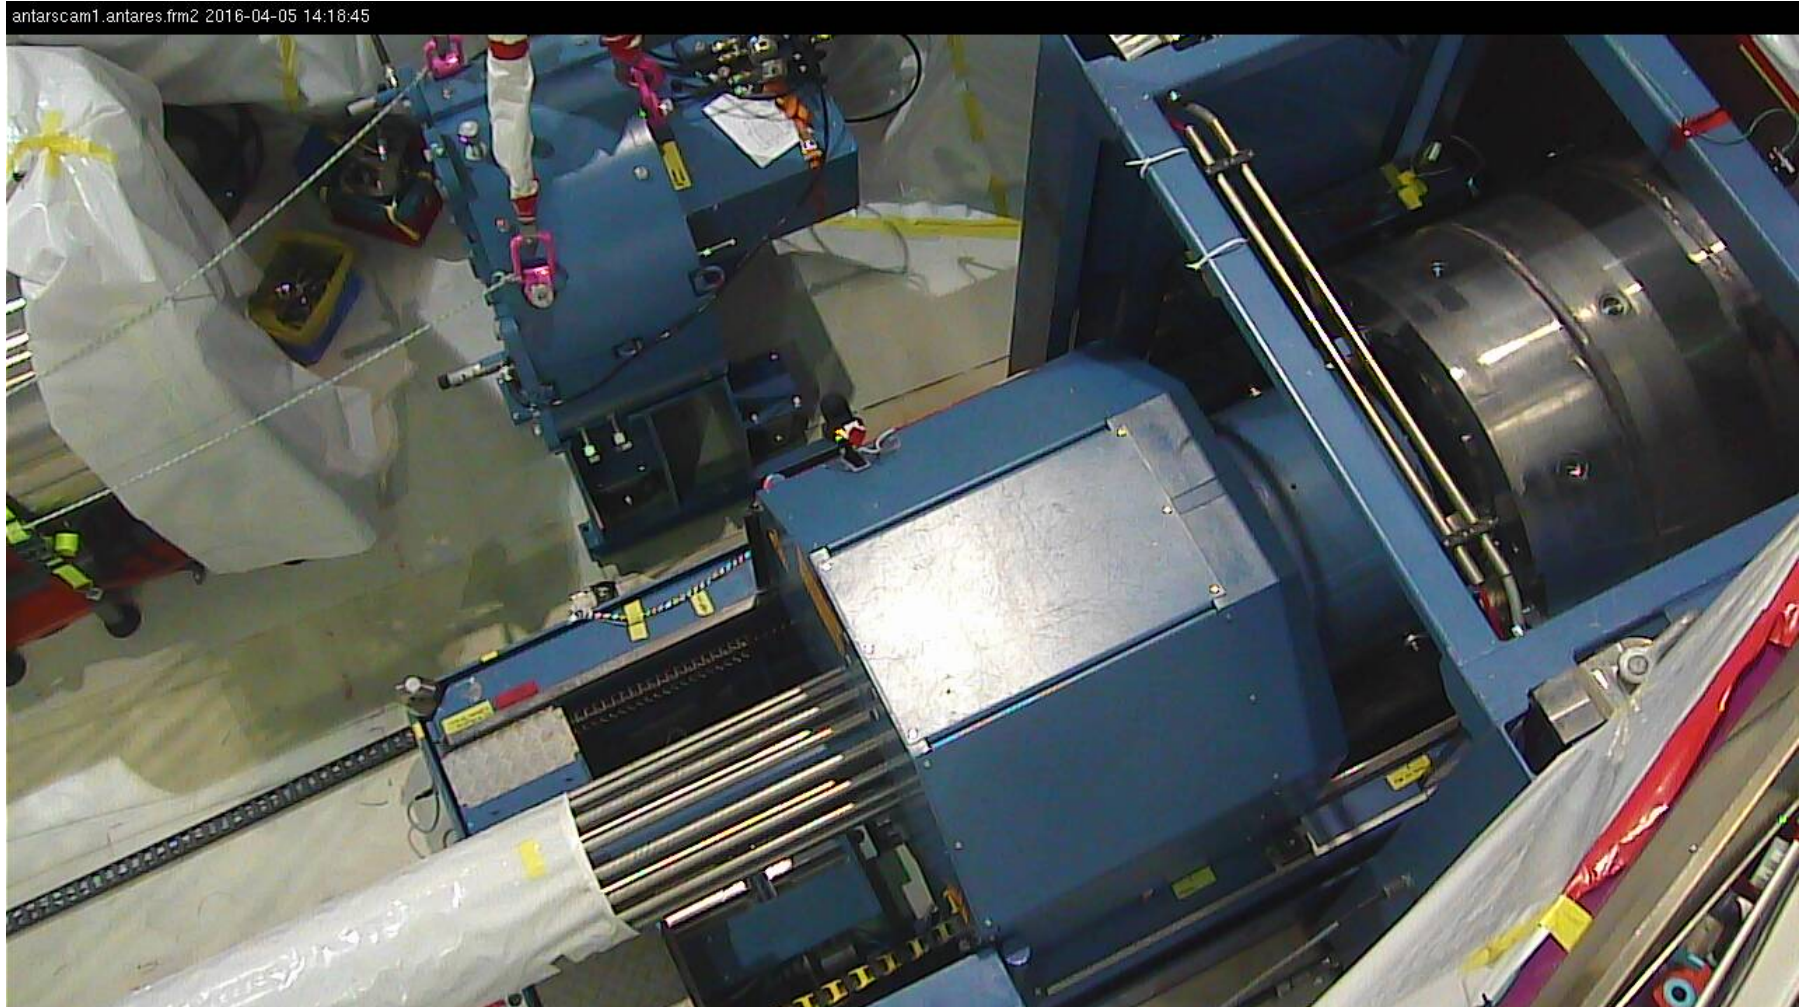
Plug JMA05 is Pulled out

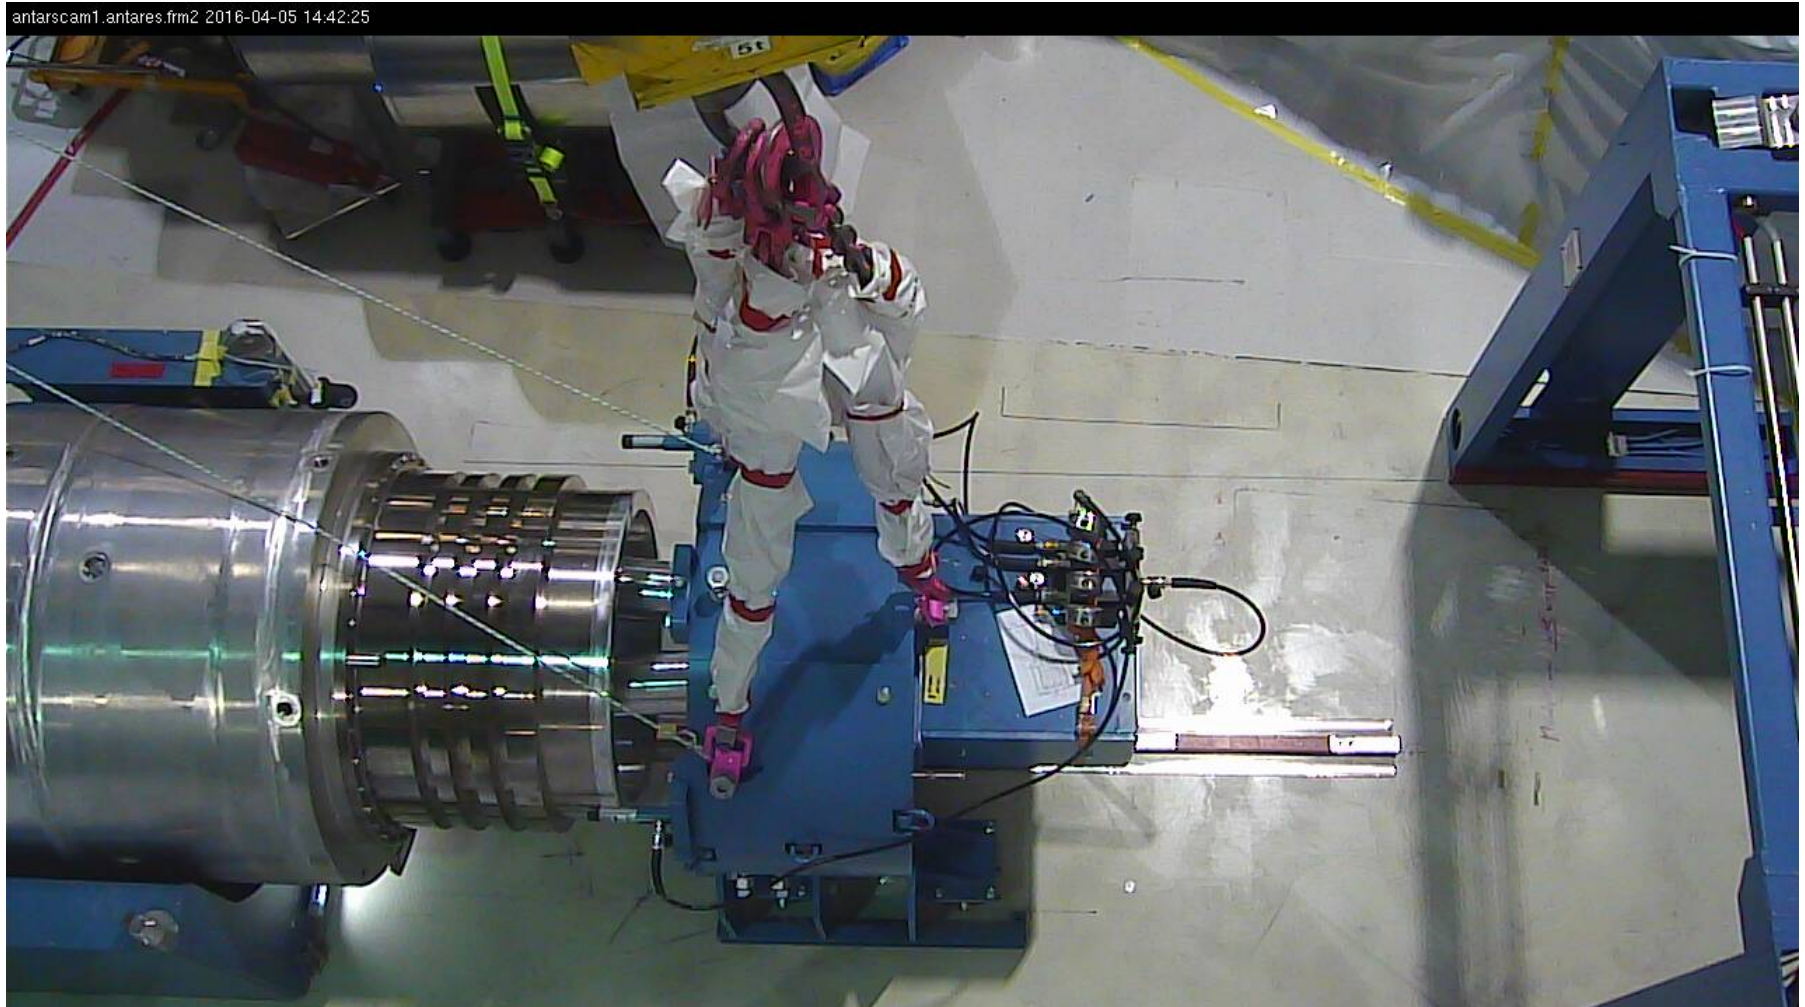
Plug Nose Being Covered with Shielding Bottle

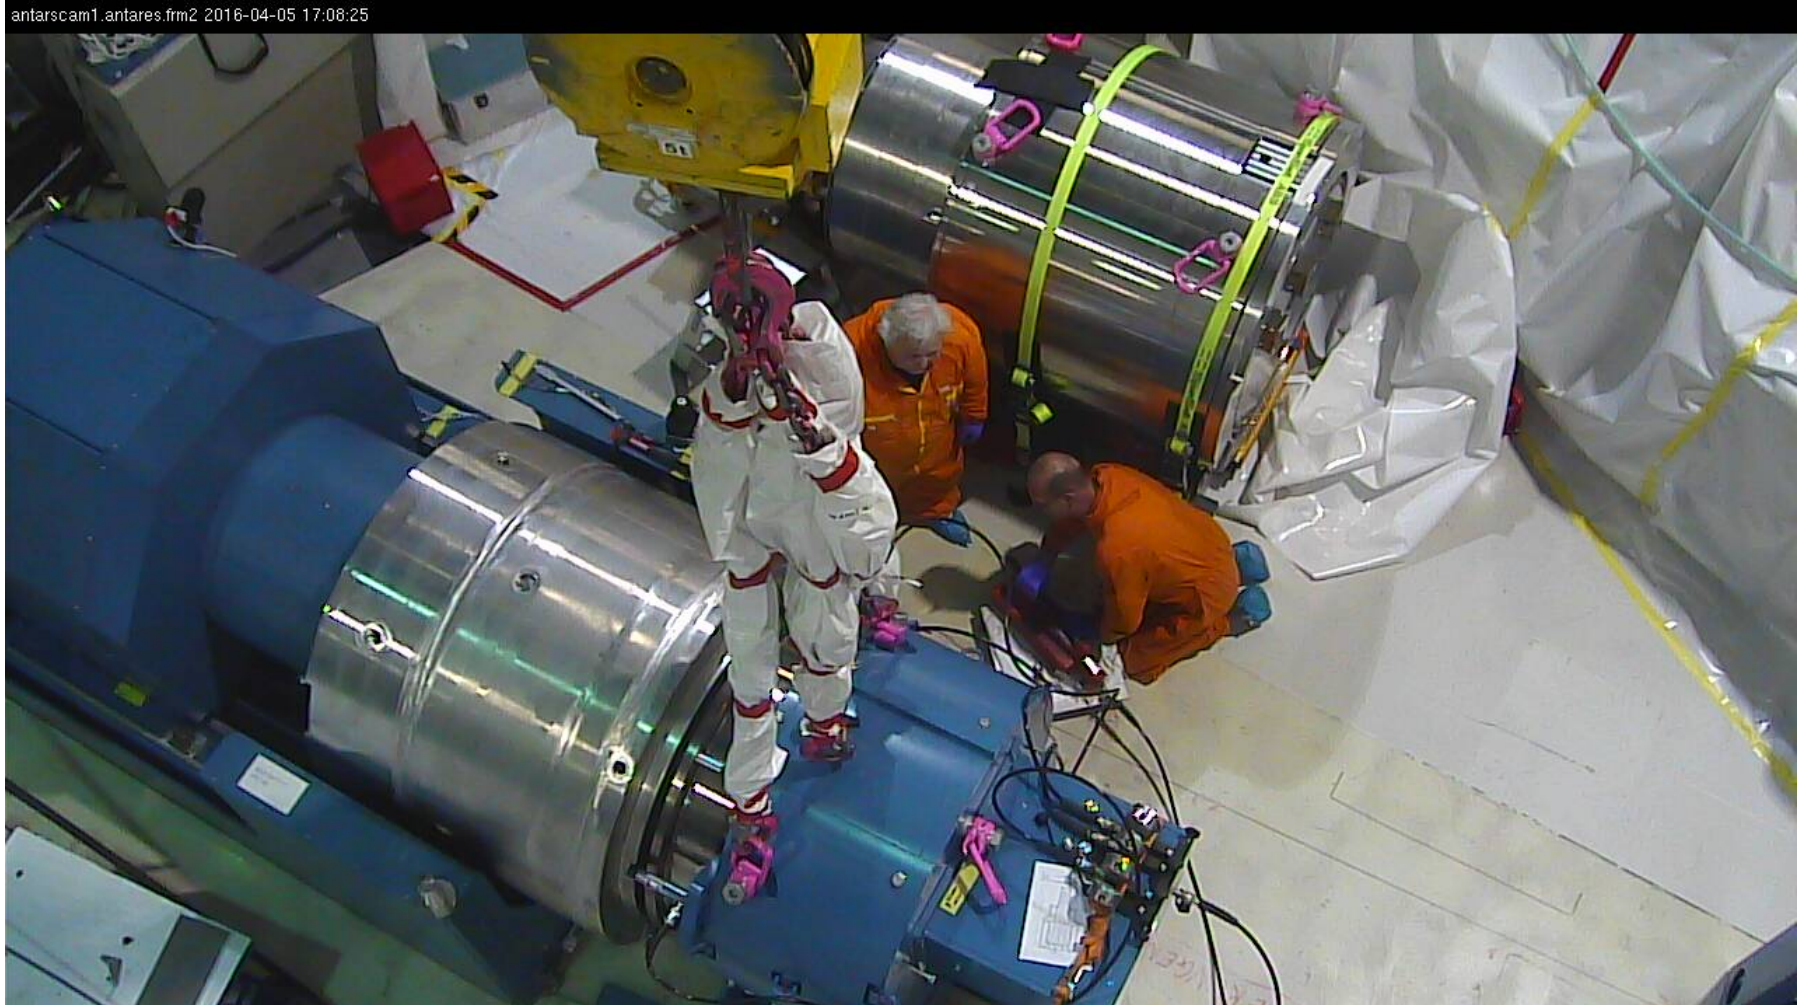
Plug Nose, Fixed with Shielding Bottle, Being Separated from Shielding Body

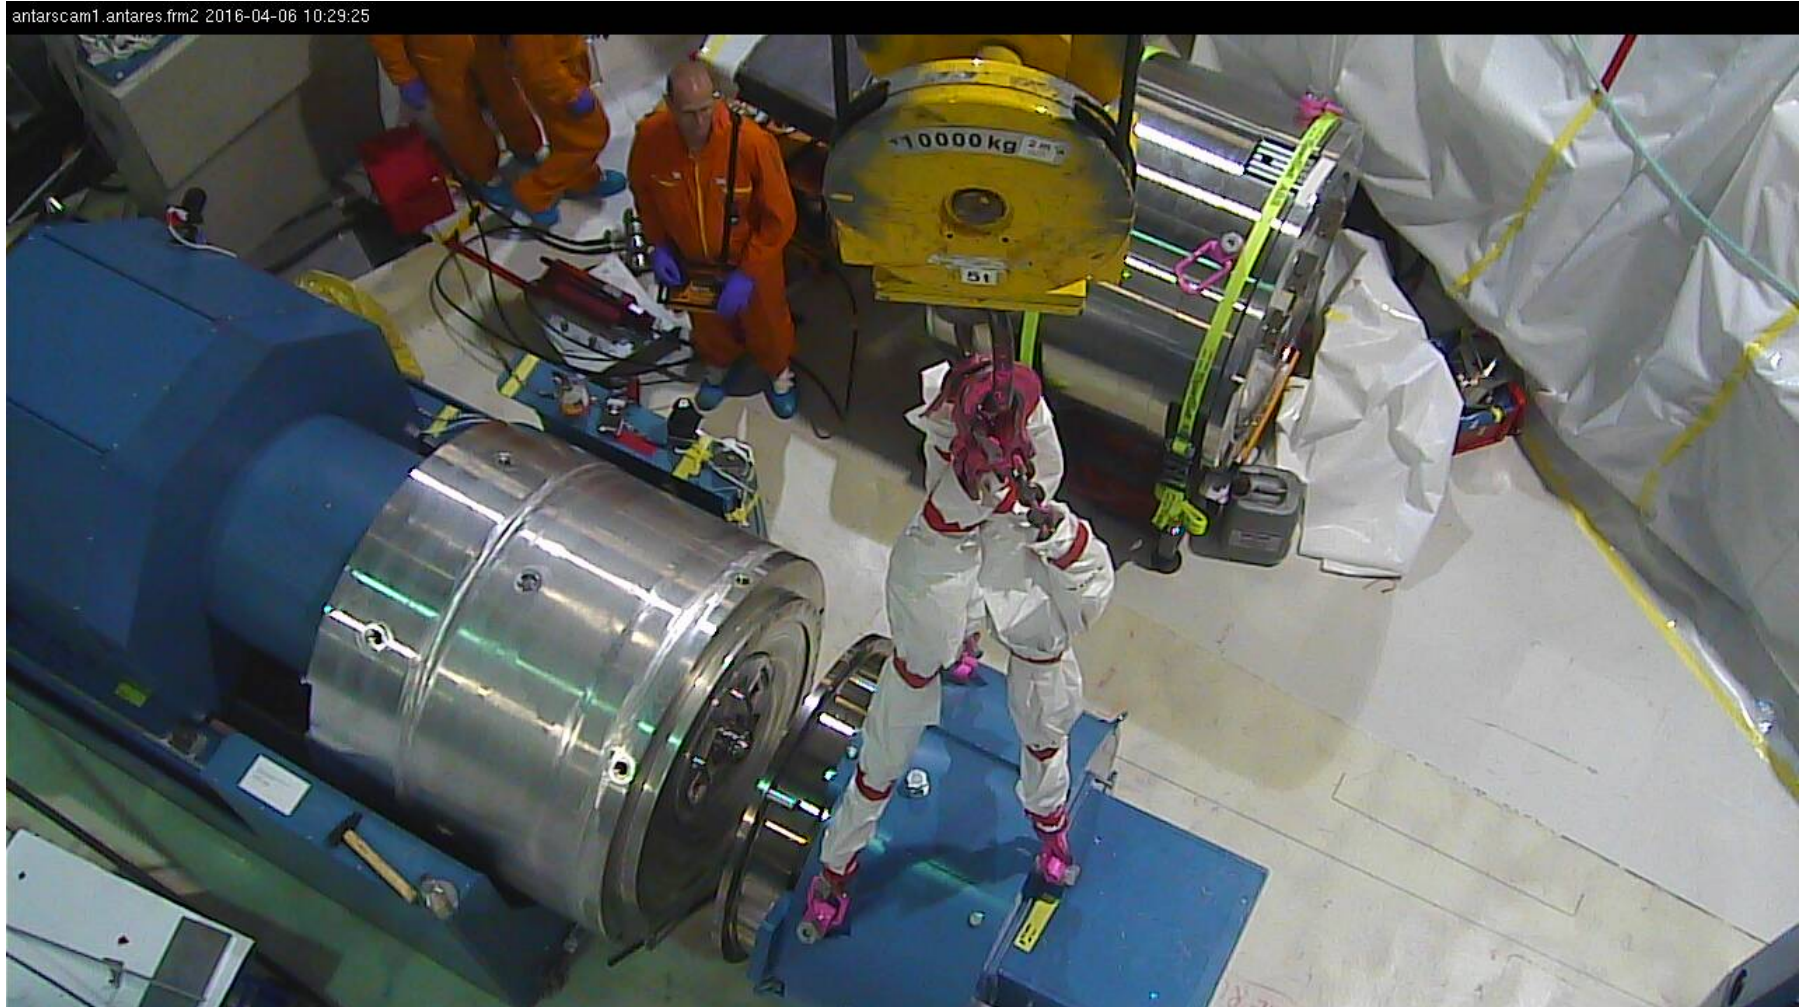
Plug Nose and Shielding Body Separated

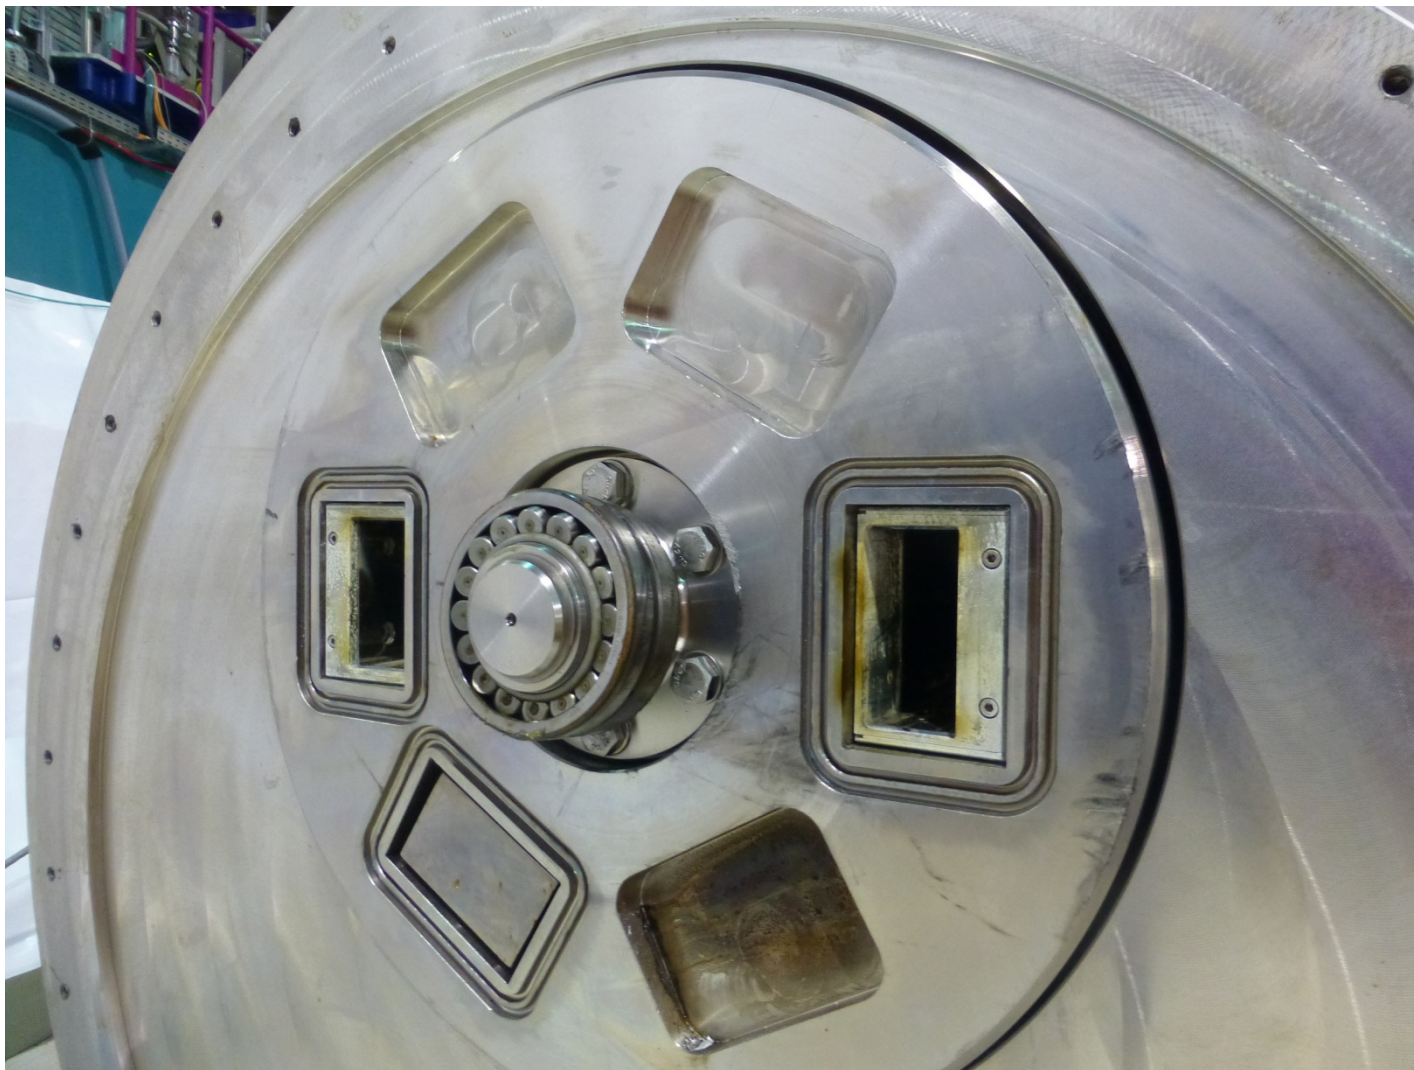
Drum Shutter Detail

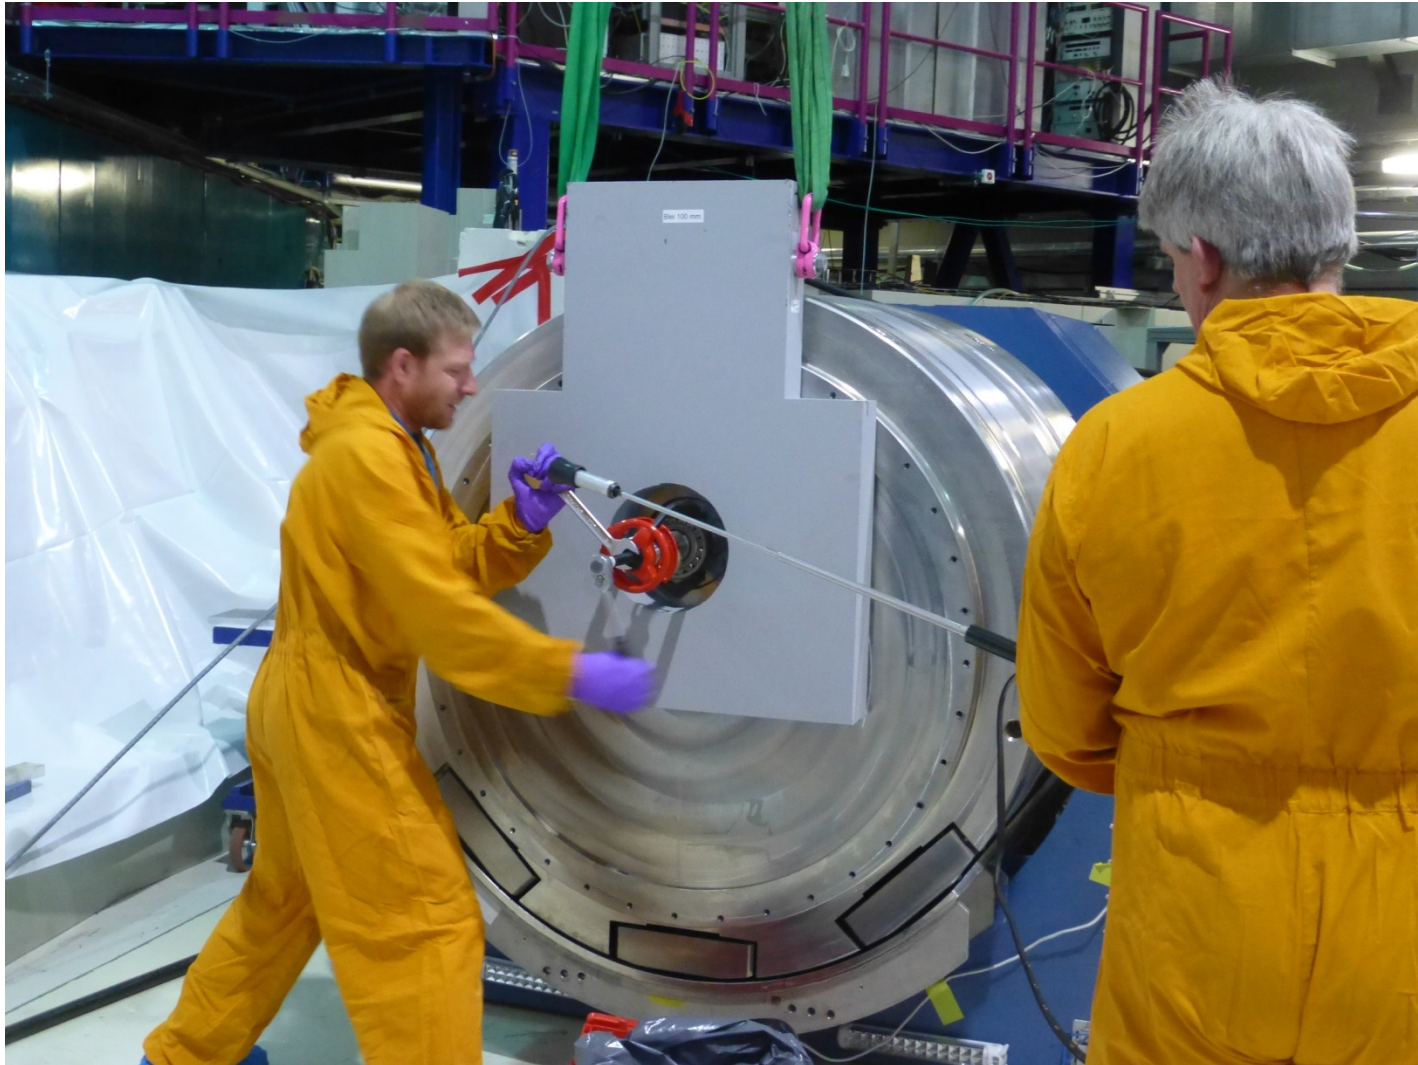
Dismounting Spherical Roller Bearings and Shaft

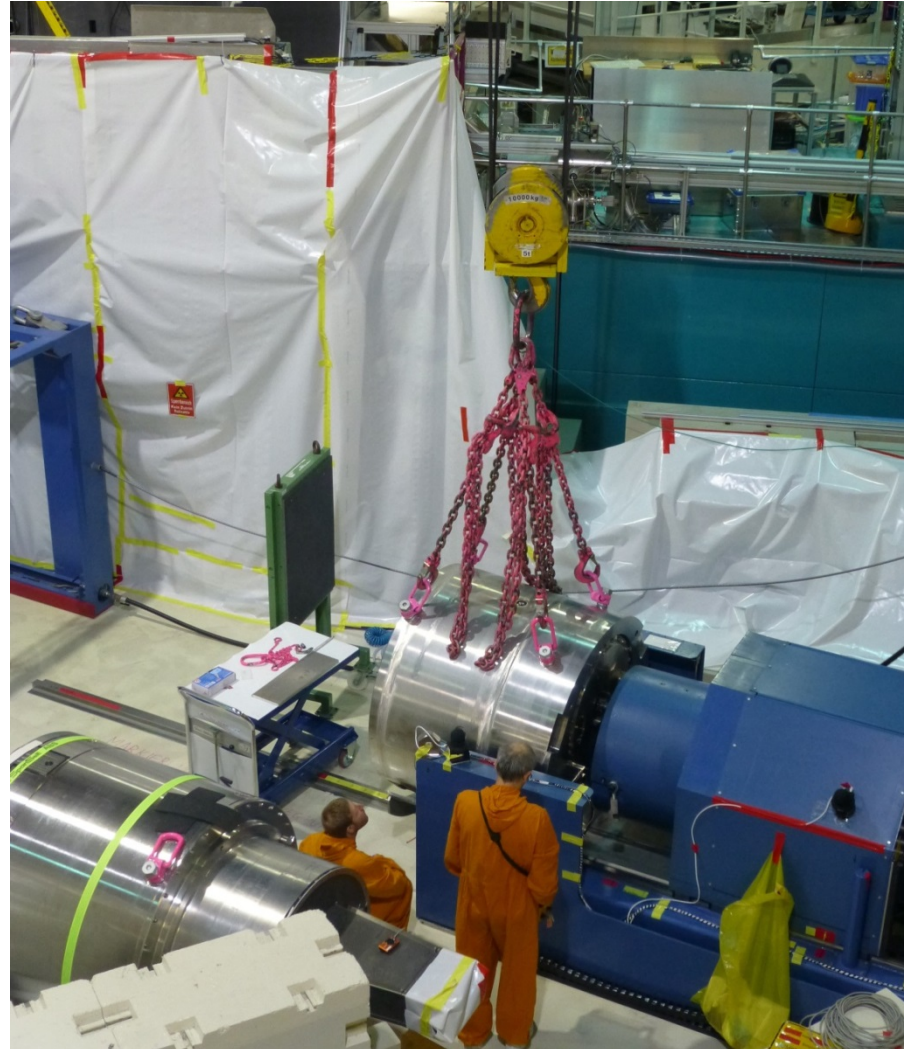
Removal of Shielding Body

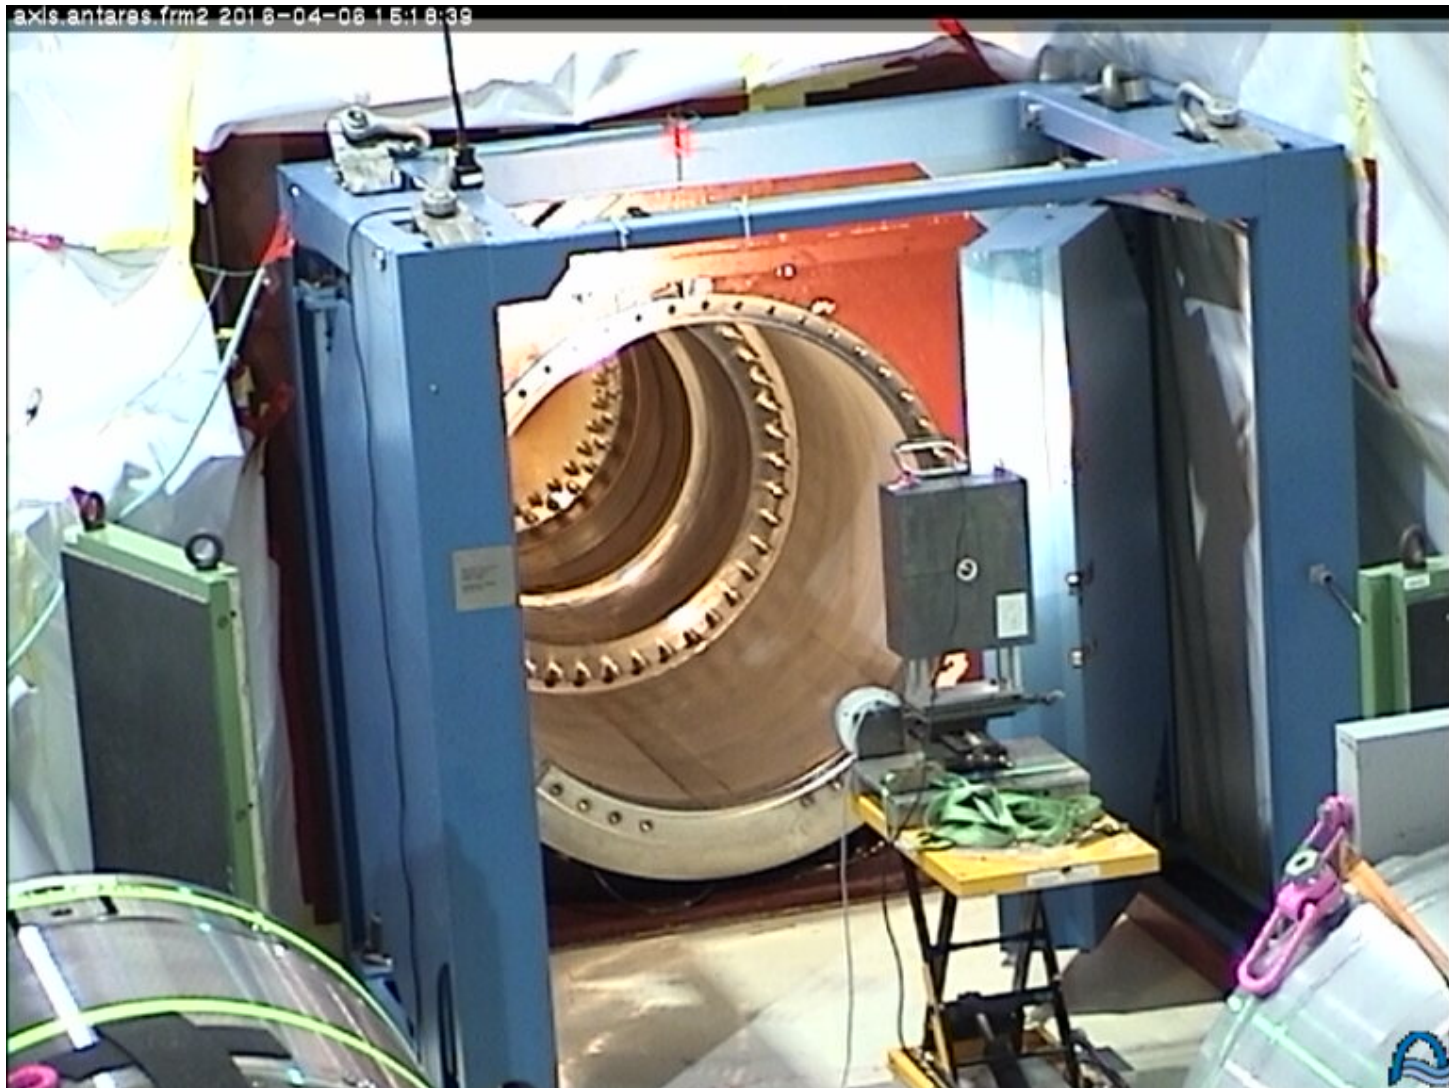
2nd Inspection of Beam Tube SR5

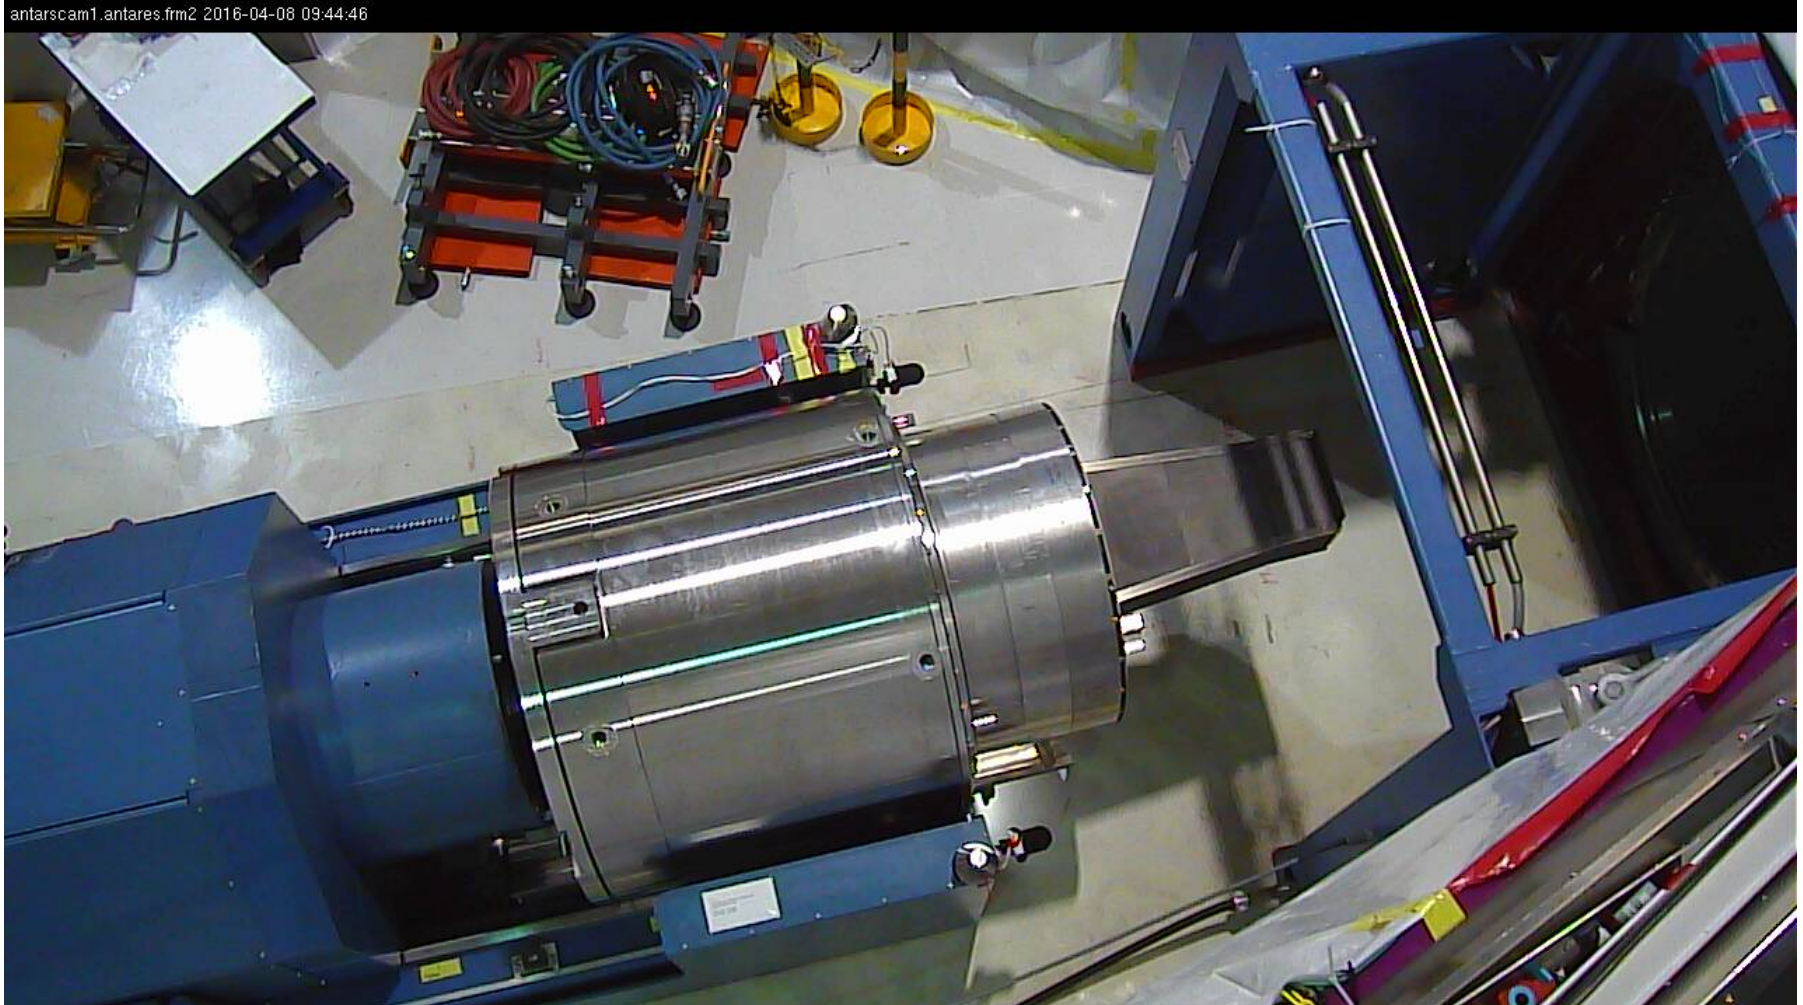
New Plug JMA05 Being Pushed into Beam Tube SR5

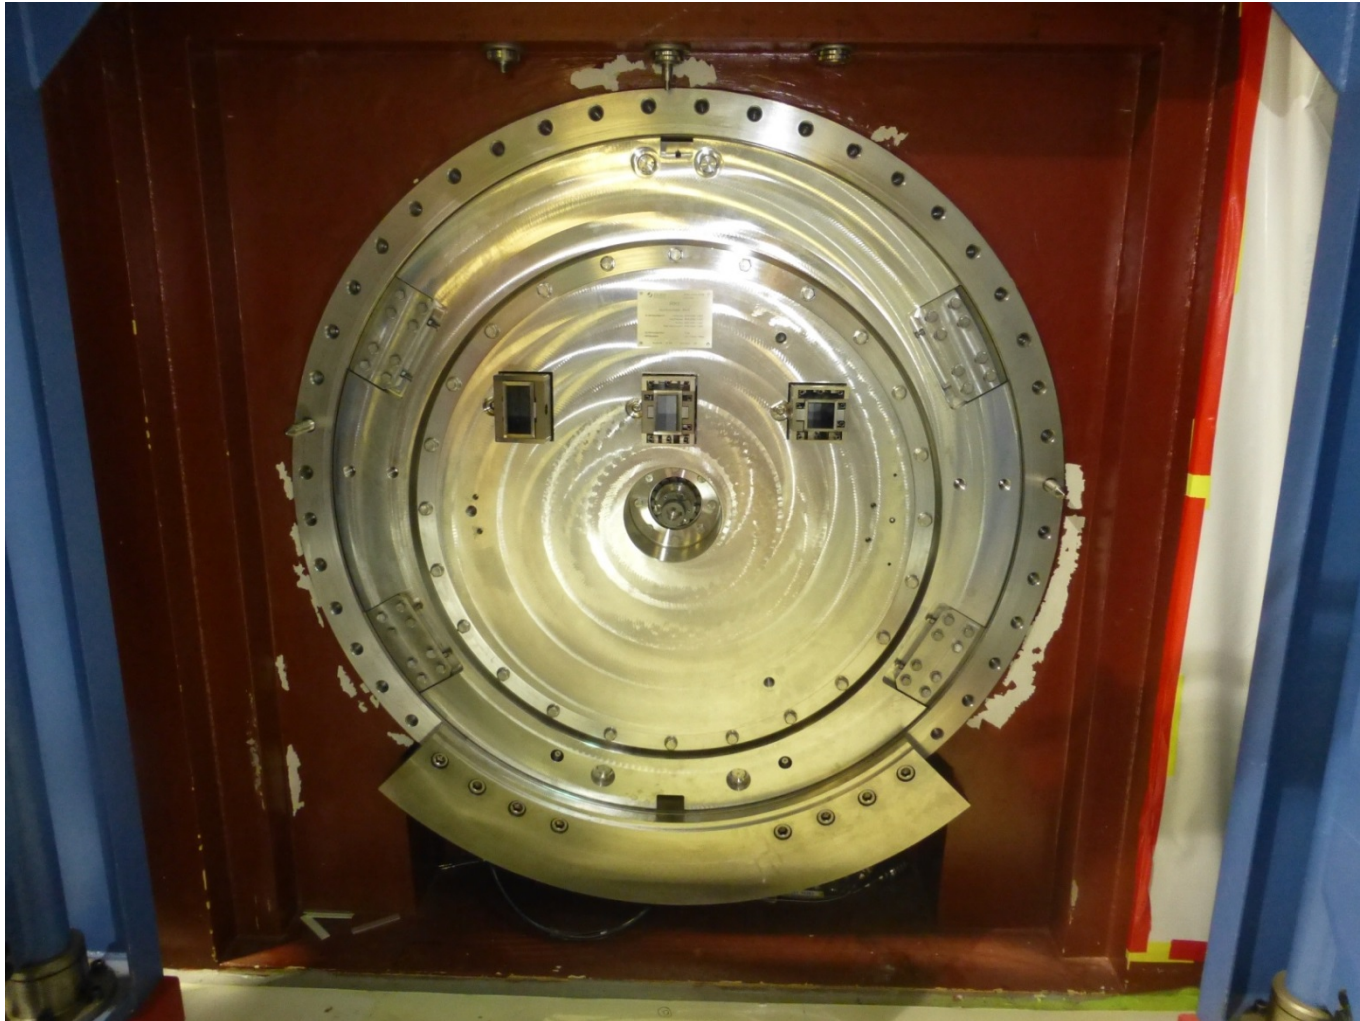
New Plug JMA05 Placed into End Position – a Successful Installation!

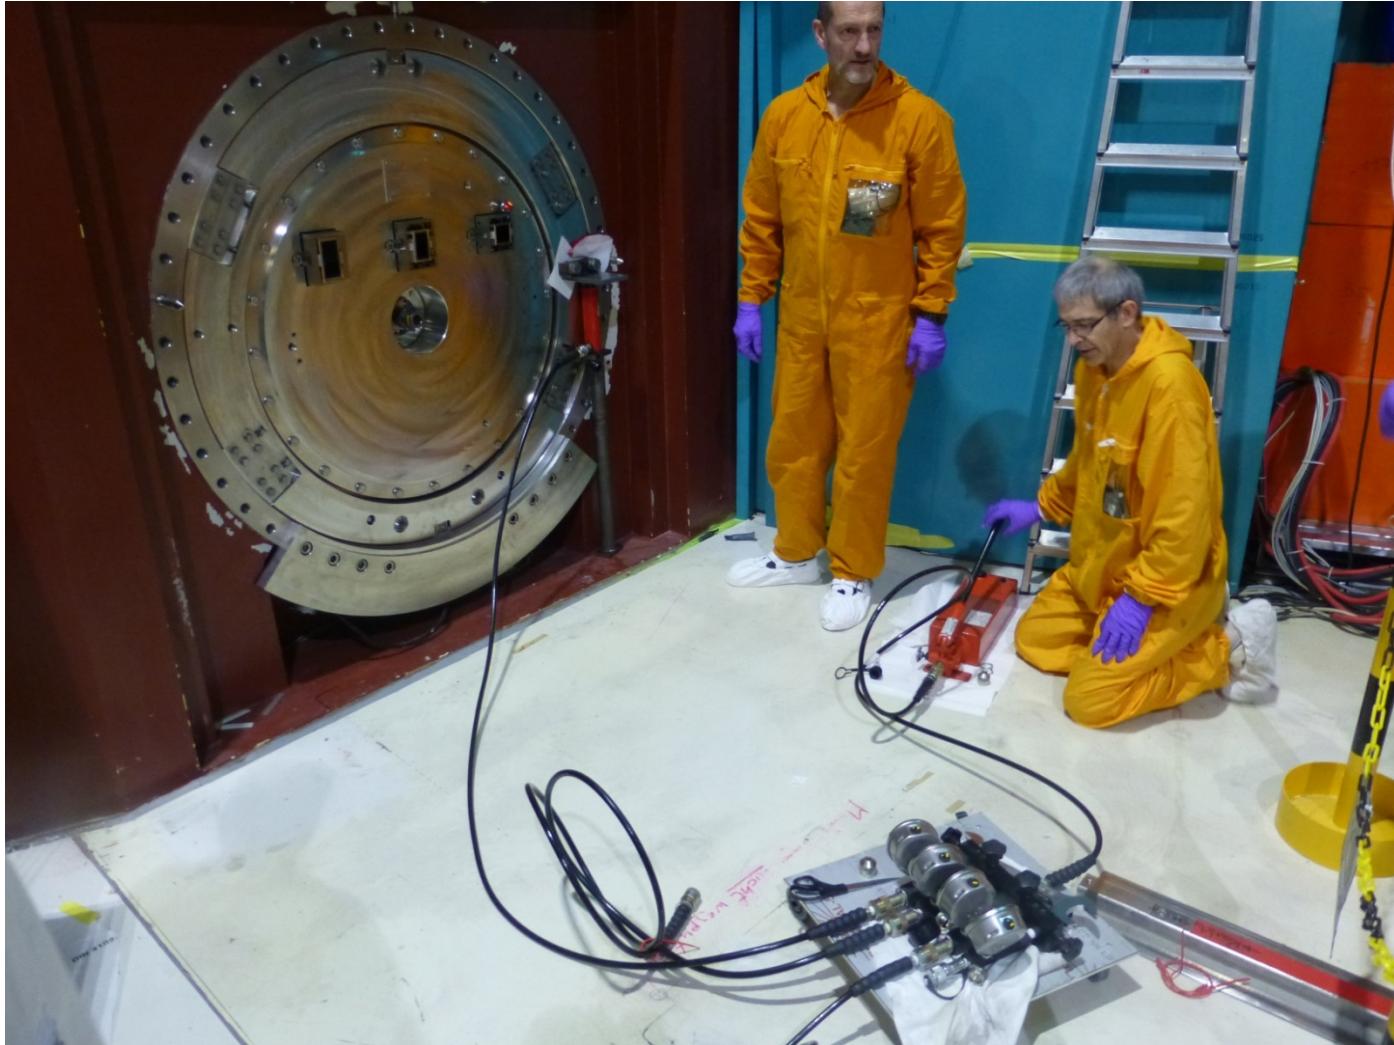
Adjustment of the Three New Beam Axis

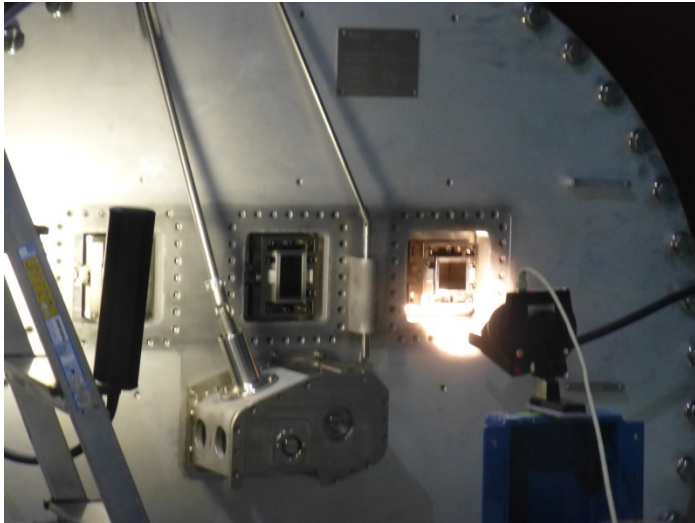
Adjustment of the Position „Shutter Open“

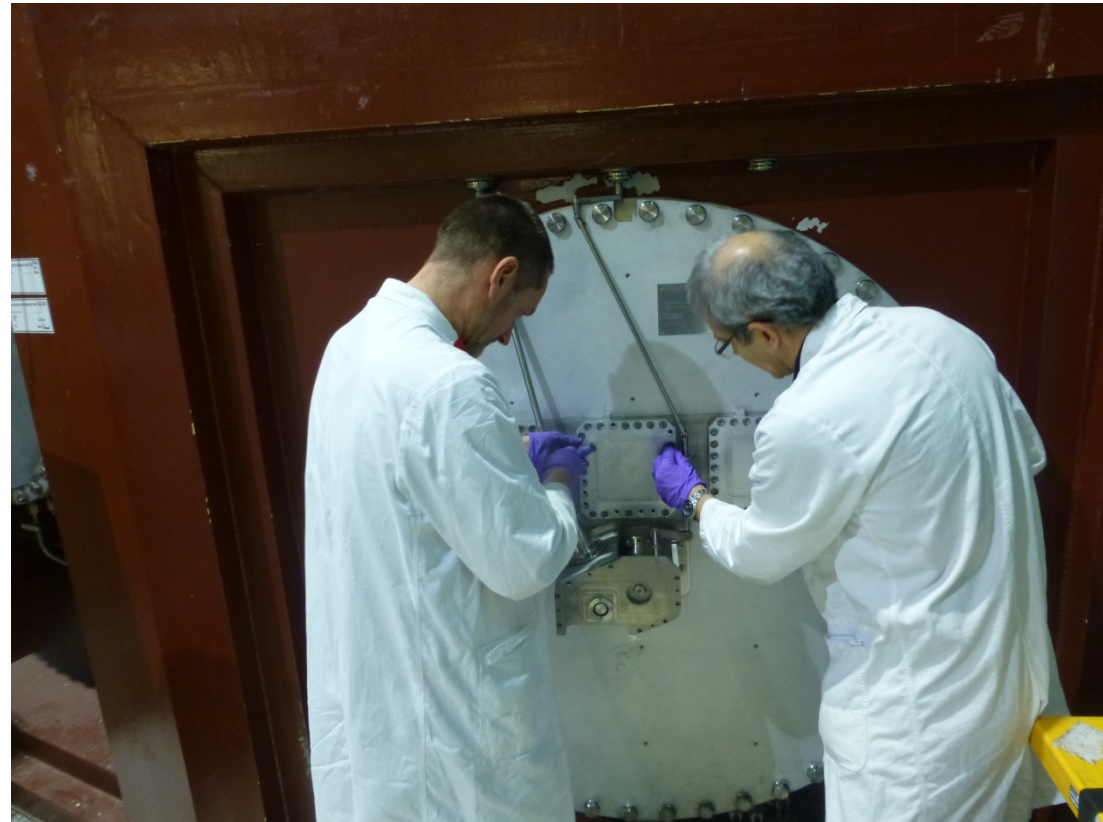
mounting neutron windows
