Selection of tungsten bricks for the target of the European Spallation Source

ESS Target Review Panel, Lund, 27/09/2016

ESS
bilbao

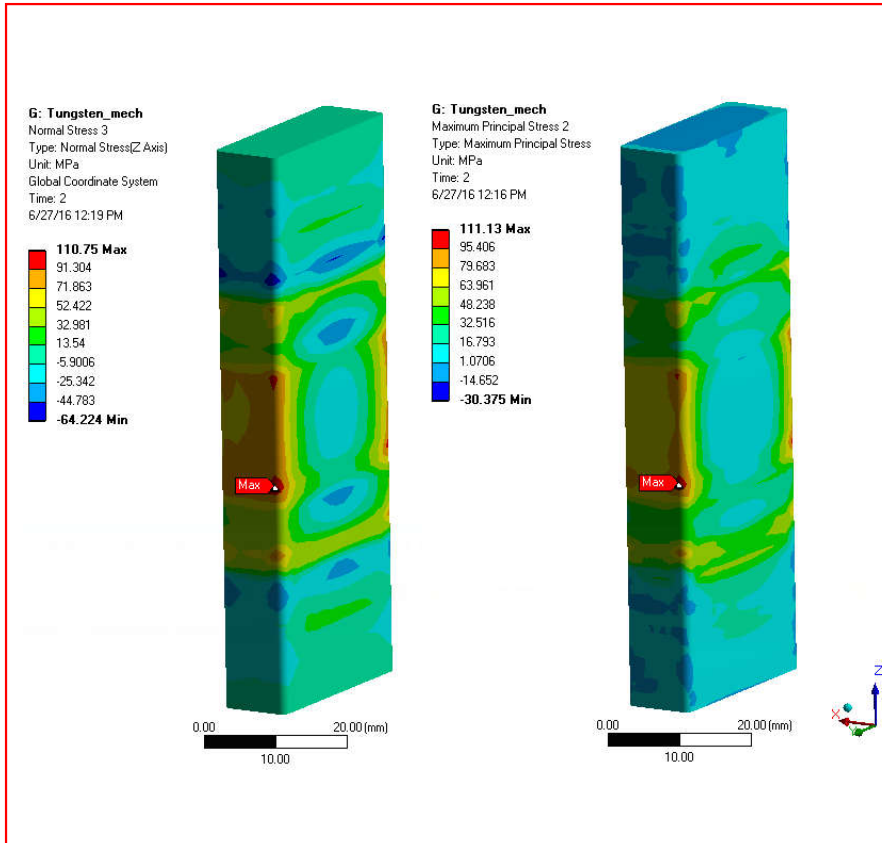
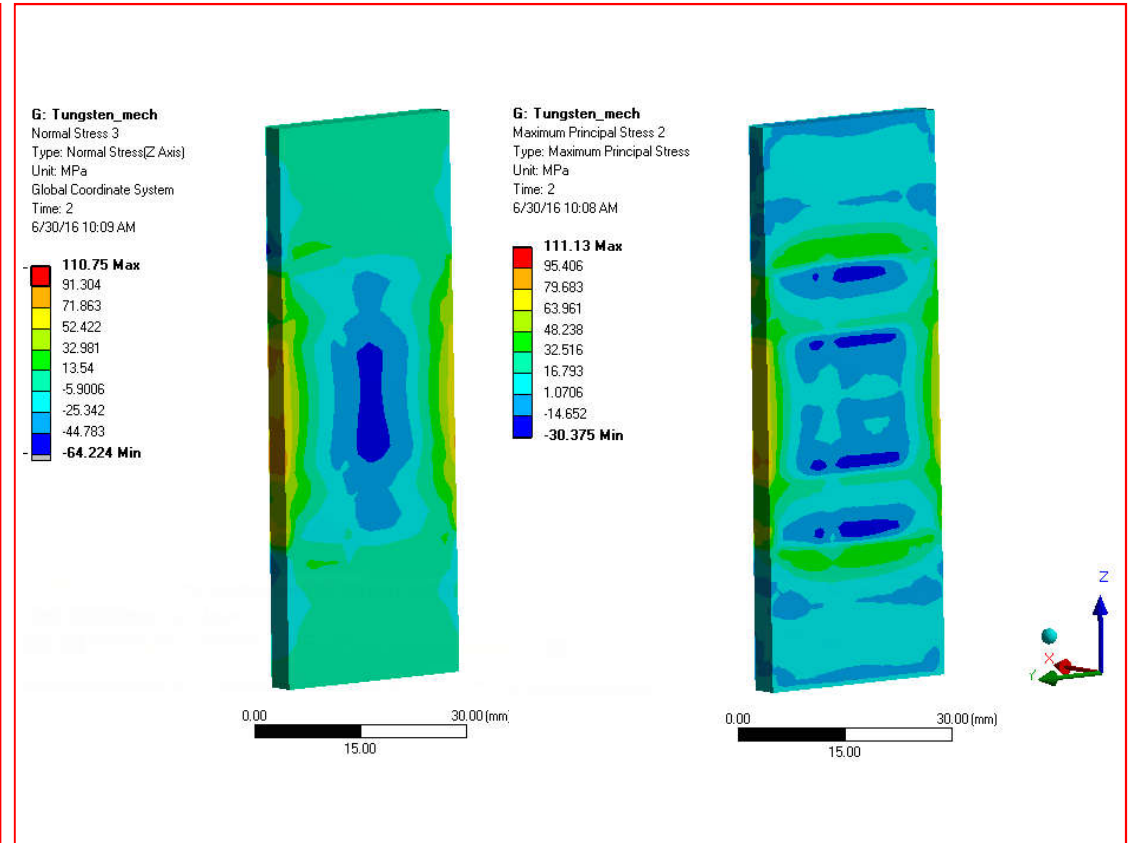
Maximum applied tensile stress: ~ 111 MPa in longitudinal direction at the surface, in the central part of bricks

Surface

Mid-thickness

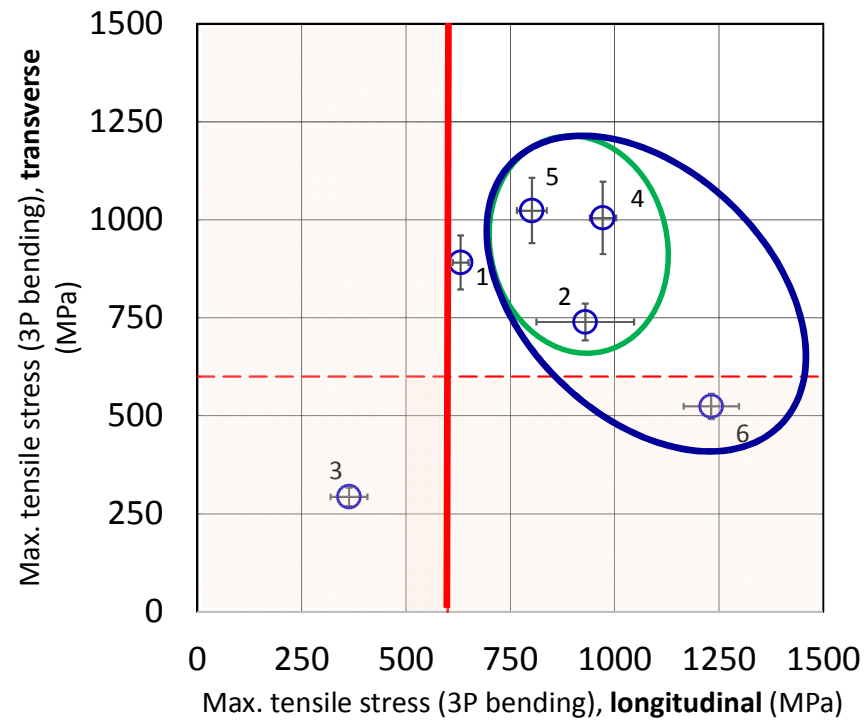
TENSILE FRACTURE STRENGTH AT RT

3, to be rejected

1, borderline

2, 4, 5, 6, OK considering the longitudinal fracture strength

6, high anisotropy of tensile strength (although transverse strength still acceptable according to design)

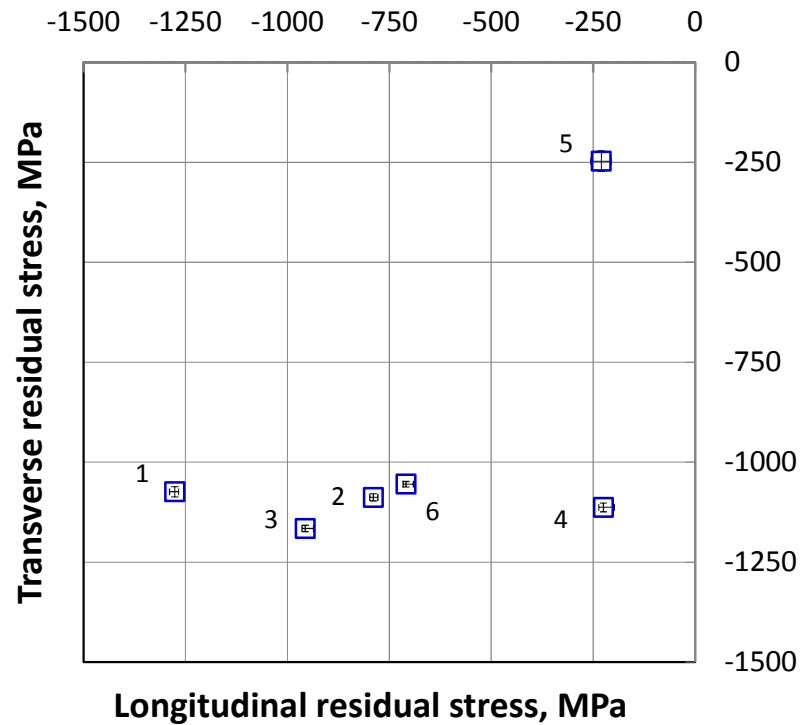
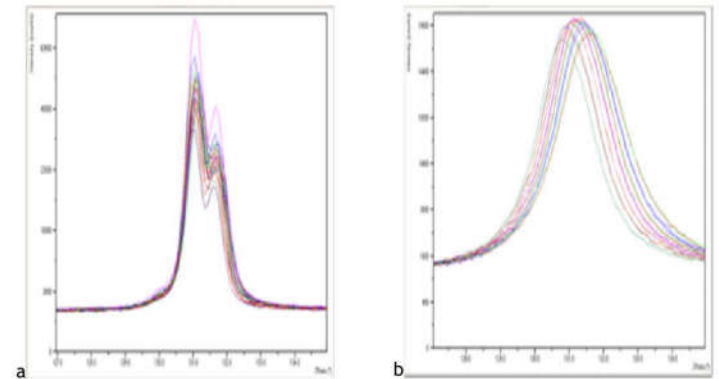
Figure 3. X-rays (321) diffraction peaks, samples 5 (a) and 2 (b).

Biaxial residual stress pattern of **brick 5** very different from that of other bricks

Longitudinal residual stresses of **brick 4** also rather weak

Diffraction peaks of **brick 5** do not show any broadening typical of deformed microstructures, as the others do

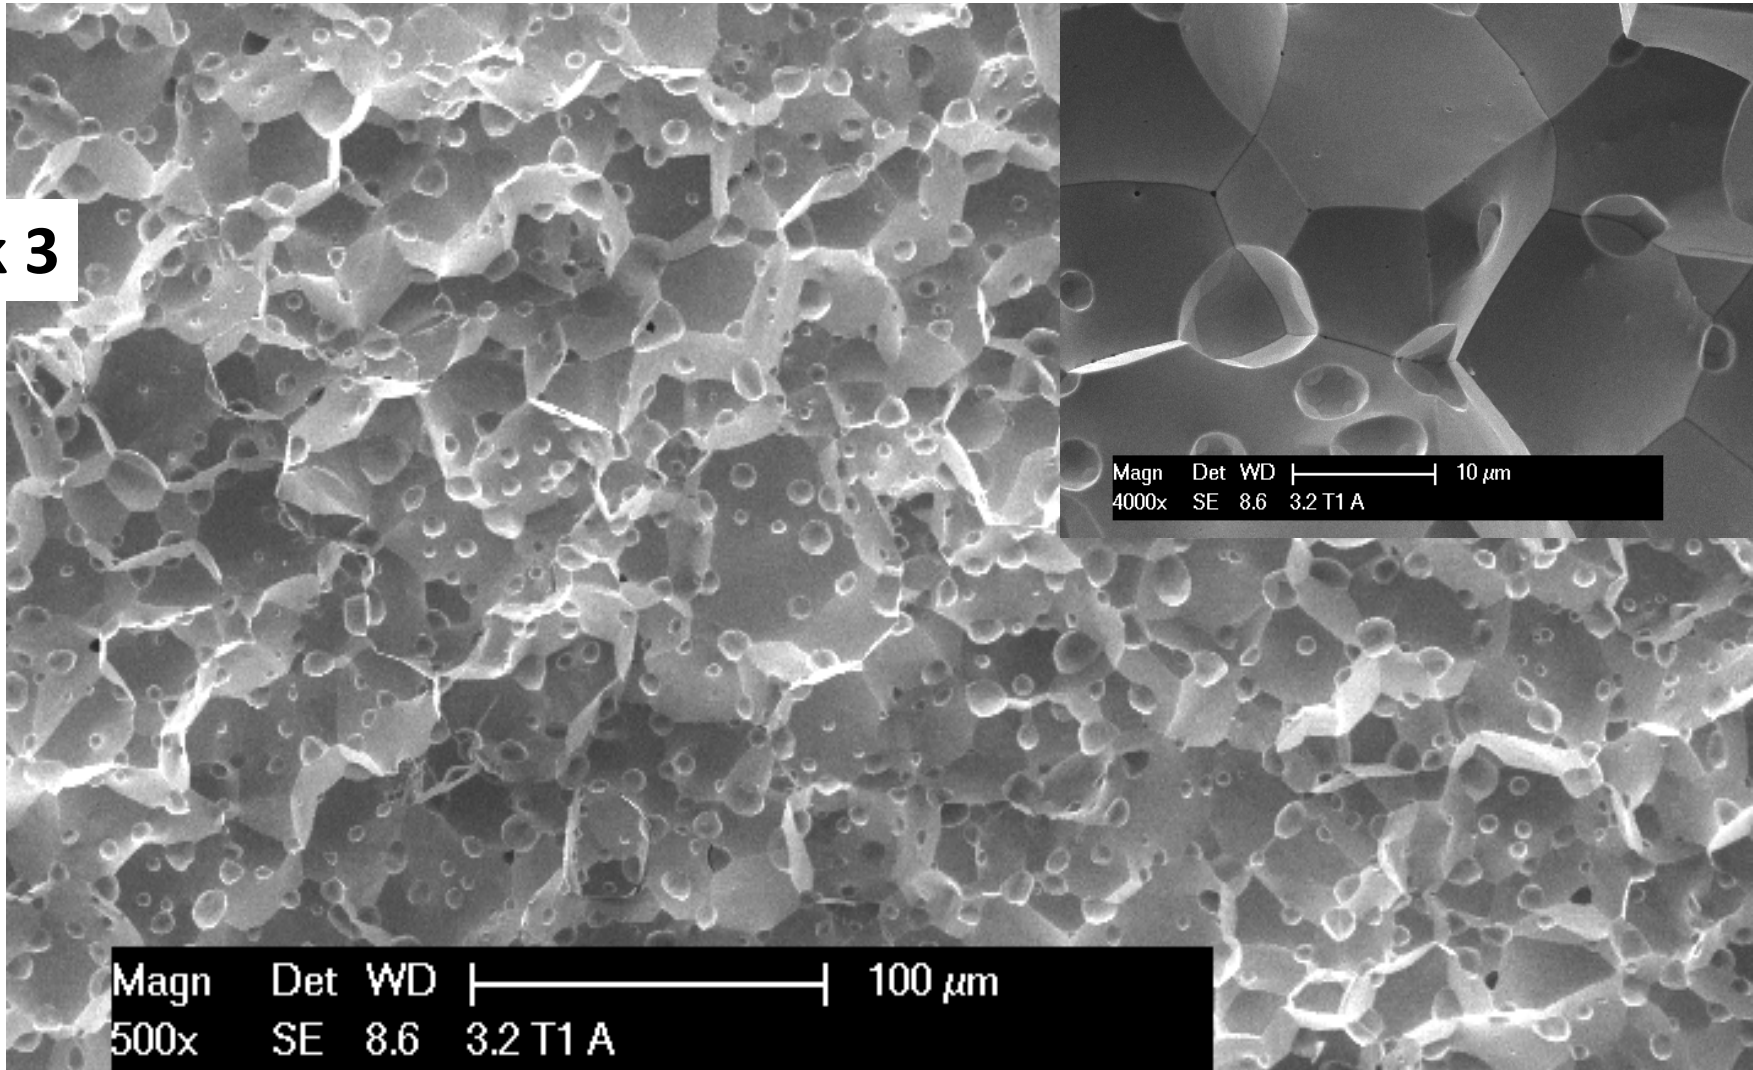
Brick 3

FRACTOGRAPHY (fracture under tension stress in longitudinal direction)

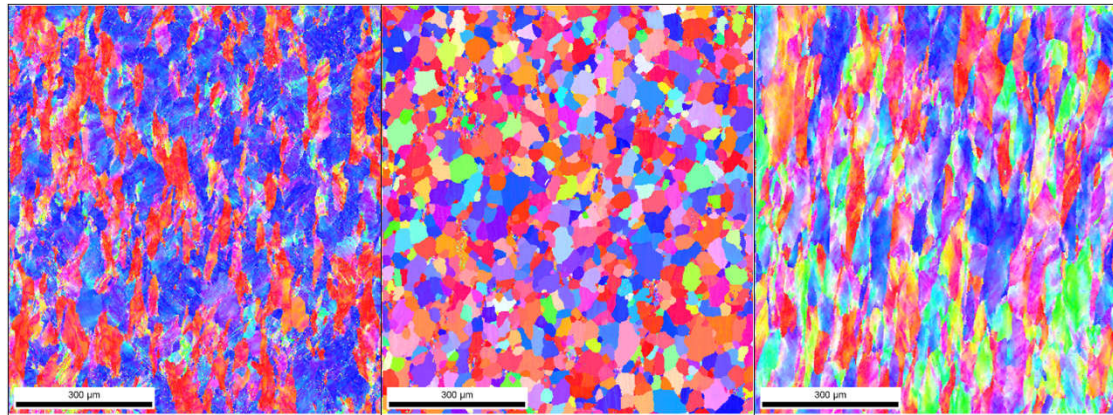
LN section, midplane. From left to right: 2, 5N, 6

Notorius structure/texture differences between both, different materials or between surface and interior of the same bricks

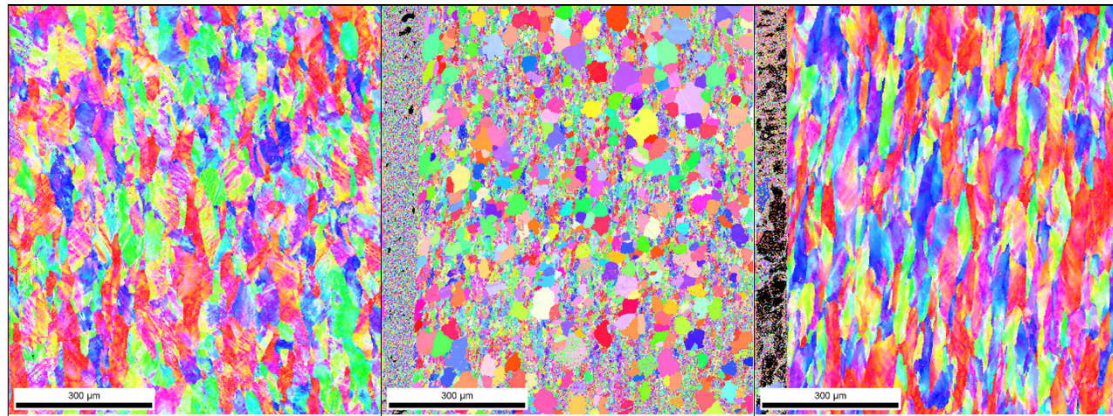
LN section, surface. From left to right: 2, 5N, 6

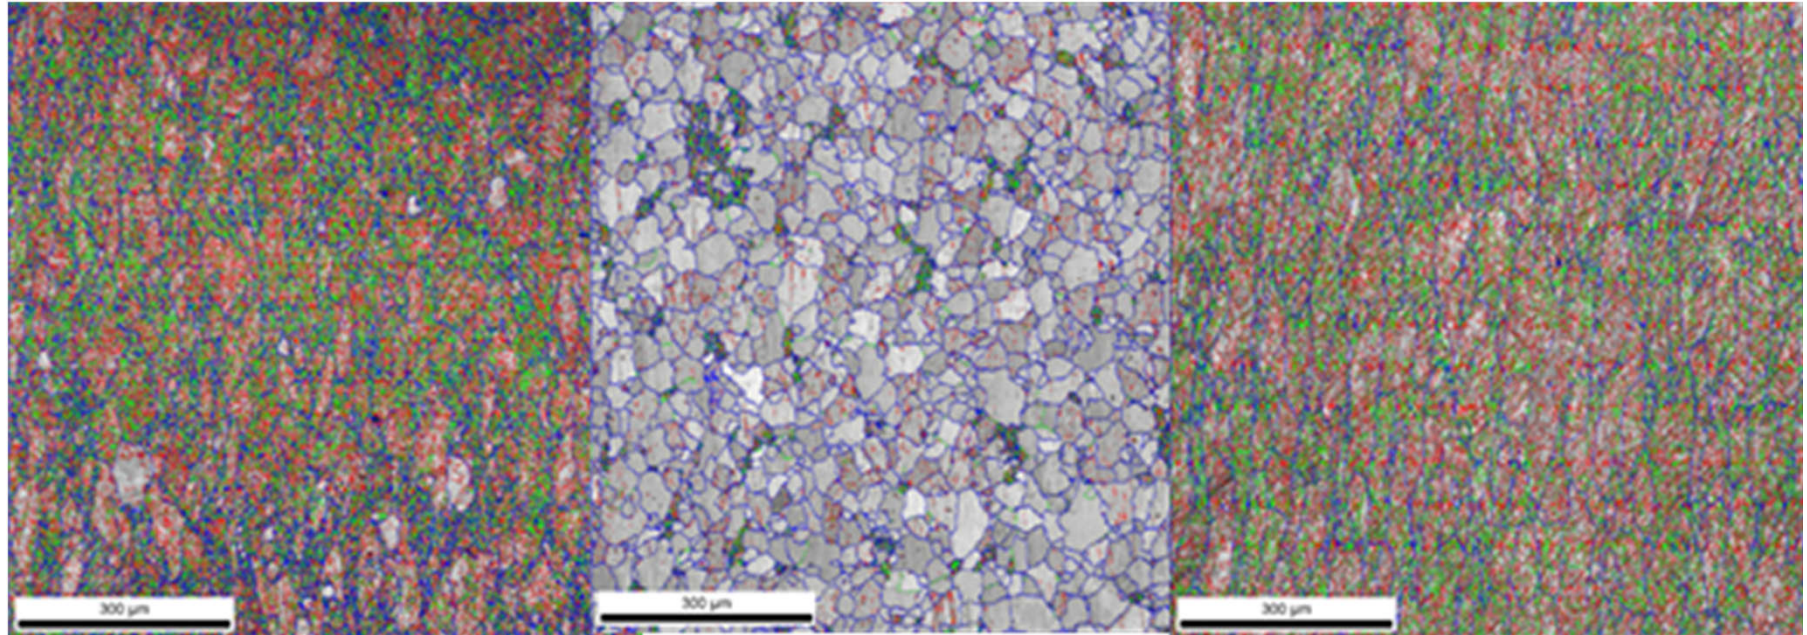
Superposed: HAB (blue), LAB (green or red) and image quality gray scale

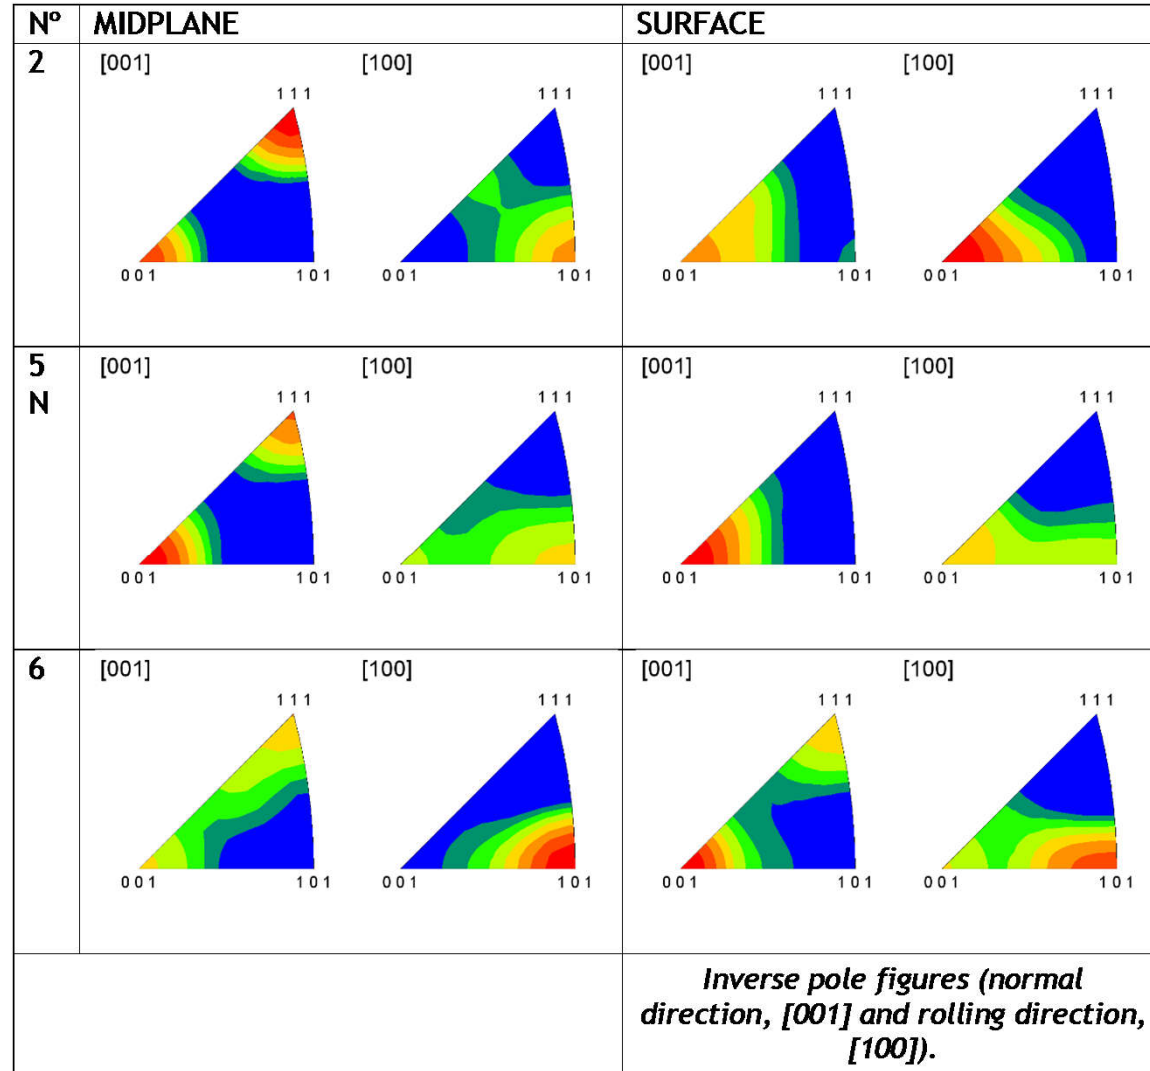
Typical bcc rolling texture components in the midplane:

$\{001\} \langle 110 \rangle$
+
 $\{111\} \langle 110 \rangle$

Texture intensity is weak

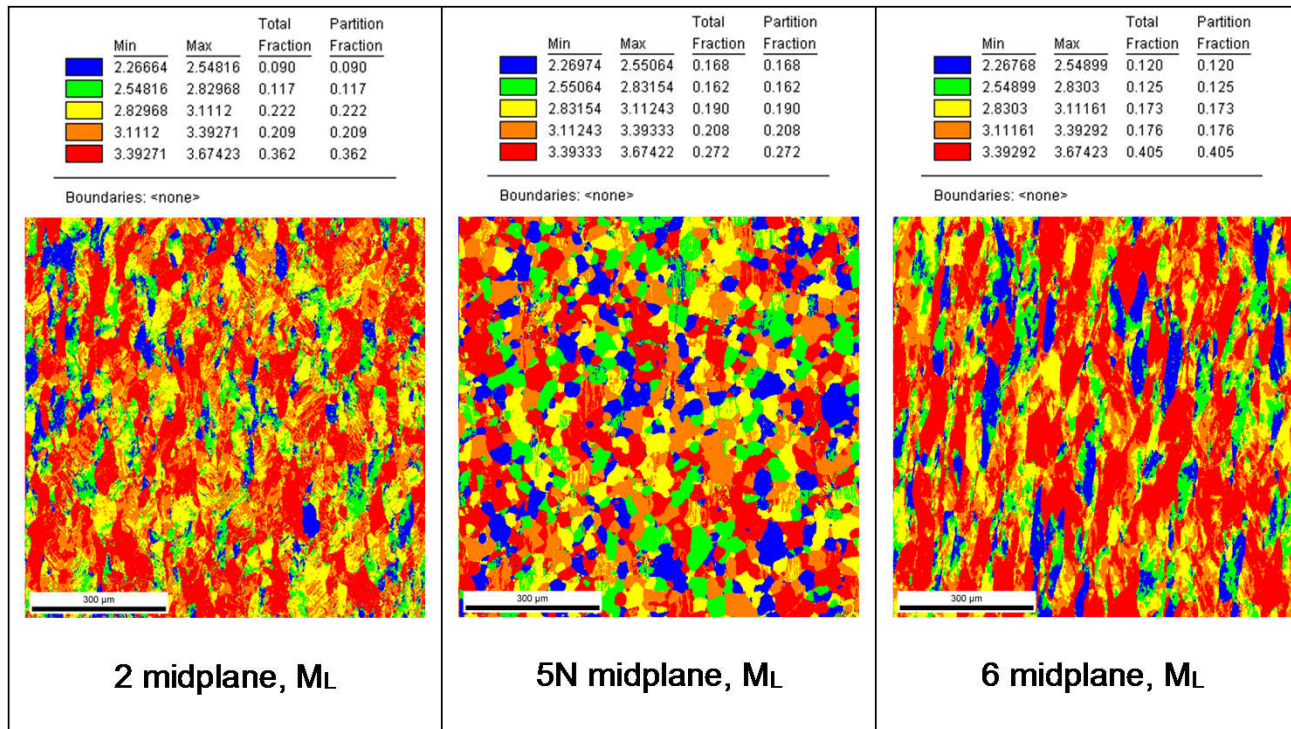
Taylor factors, axisymmetric tension

Plastic anisotropy is not important

Sample	M_L	M_T
2 midplane	3.164 (0.383)	3.185 (0.373)
5N midplane	3.048 (0.413)	3.028 (0.427)
6 midplane	3.161 (0.418)	3.087 (0.436)

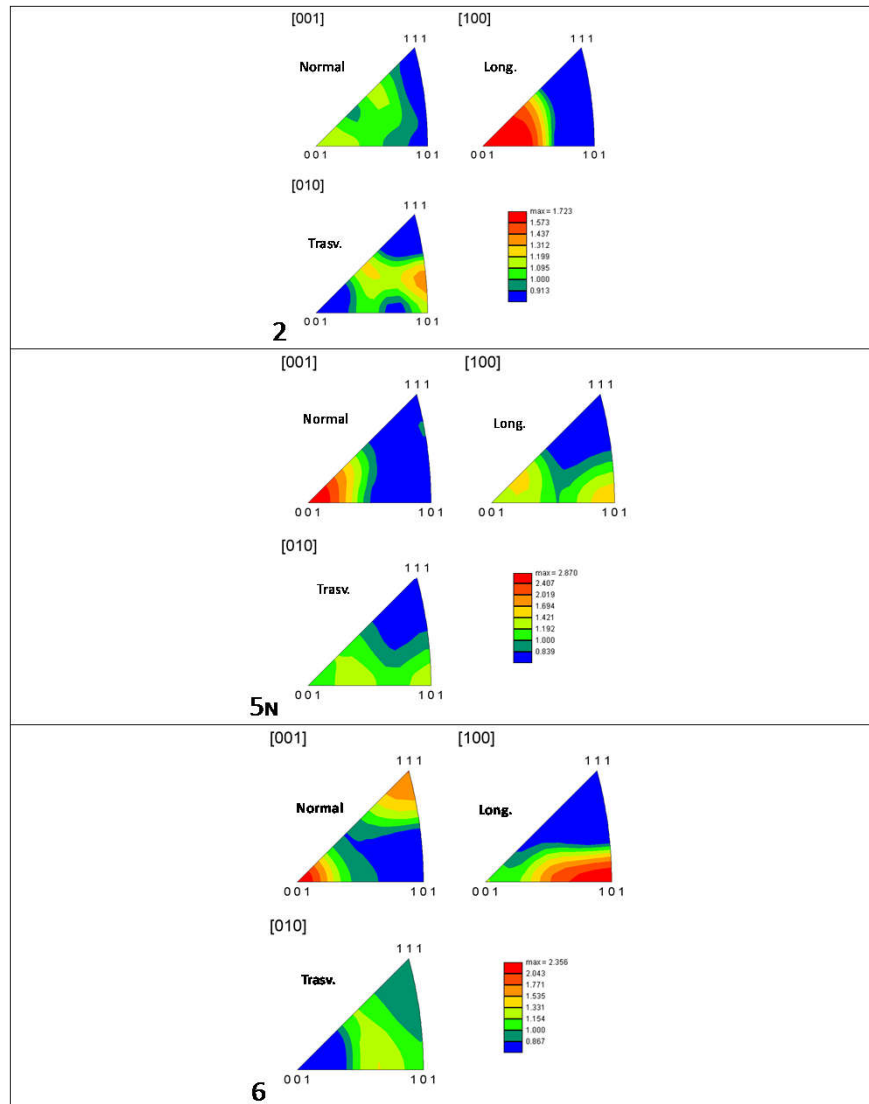
TEXTURE (IPF)

100 μm SURFACE LAYER

Intensity levels of cleavage-related plane normal weak and rather similar

Intensity in L direction		
Brick	<001>	<110>
2	1.57-1.72	< 0.91
5N	1.19-1.41	1.42-1.69
6	1.15-1.53	2.04-2.36

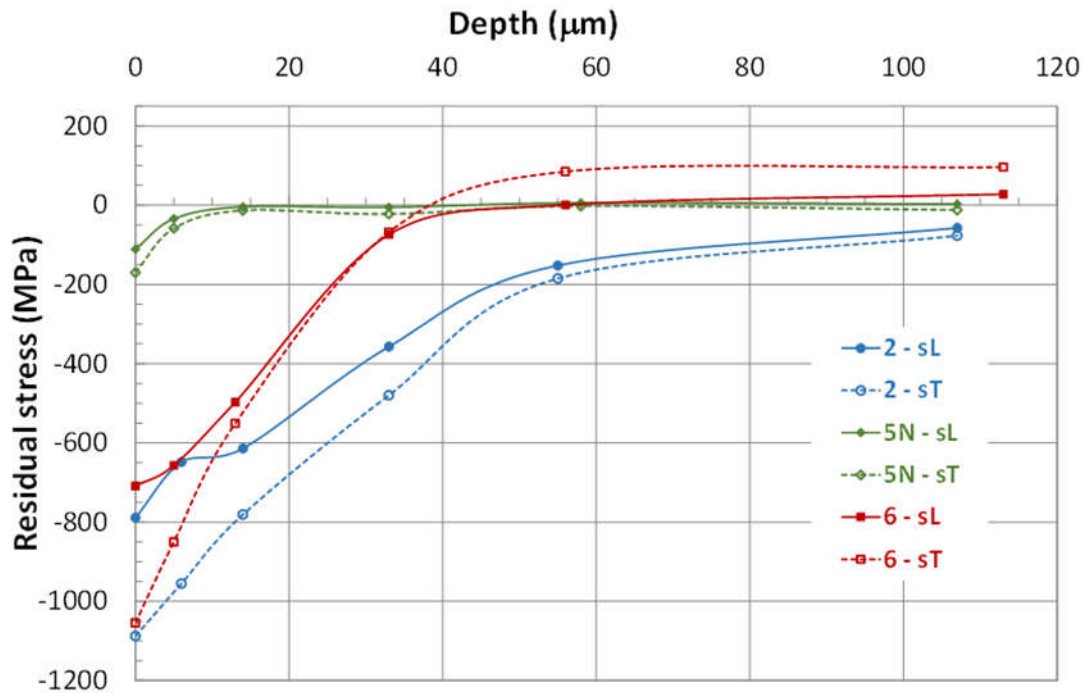
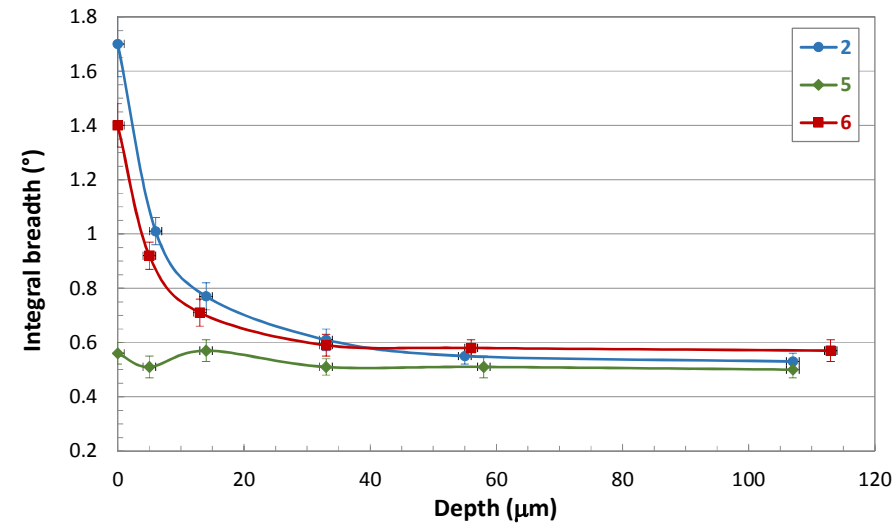
Residual stresses

Bricks 2 & 6: strong level of sub-surface biaxial compressive stresses up to resp. 30 and 50 μm

Brick 5N: weak compressive surface stress up to less than 10 μm

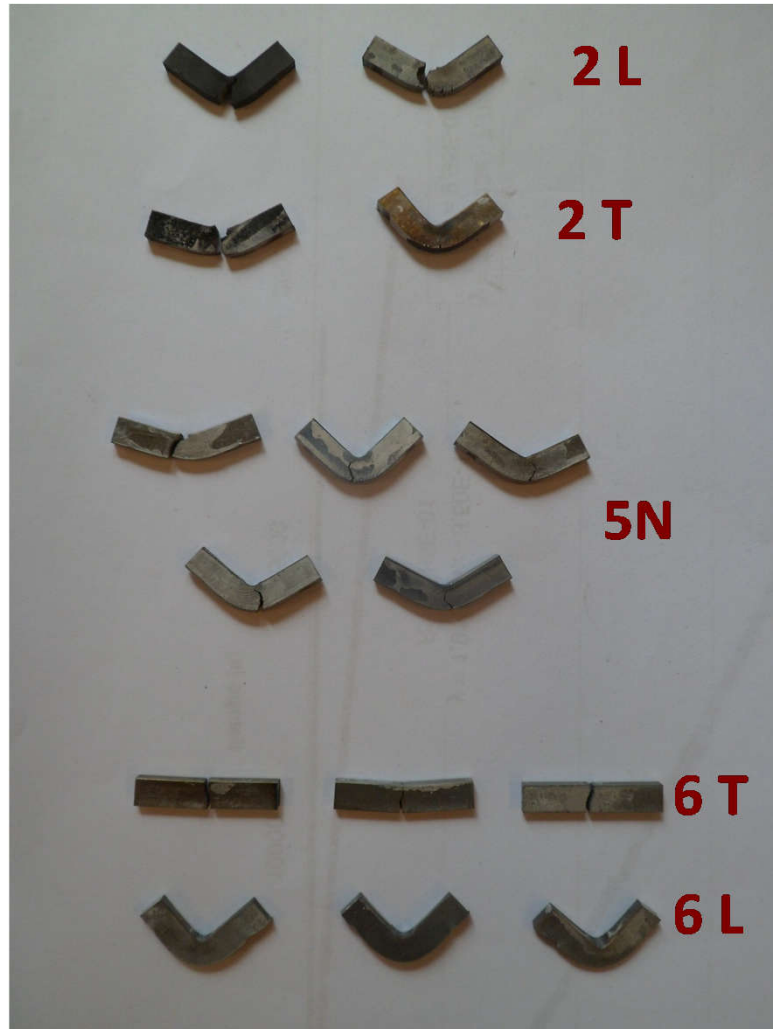
Series of broken samples, fracture nucleated from EDM surface

In contrast with the RT behavior (brittle fracture in the elastic loading range), all fractures at 400°C occurred after some plastic deformation (although samples 6 of T orientation broke after a minimal strain after the elastic limit)

The facies of the fracture surfaces was brittle in all cases (mainly by distorted cleavage, with some intergranular decohesion for bricks 2 and 6, mainly by intergranular decohesion for brick 5N)

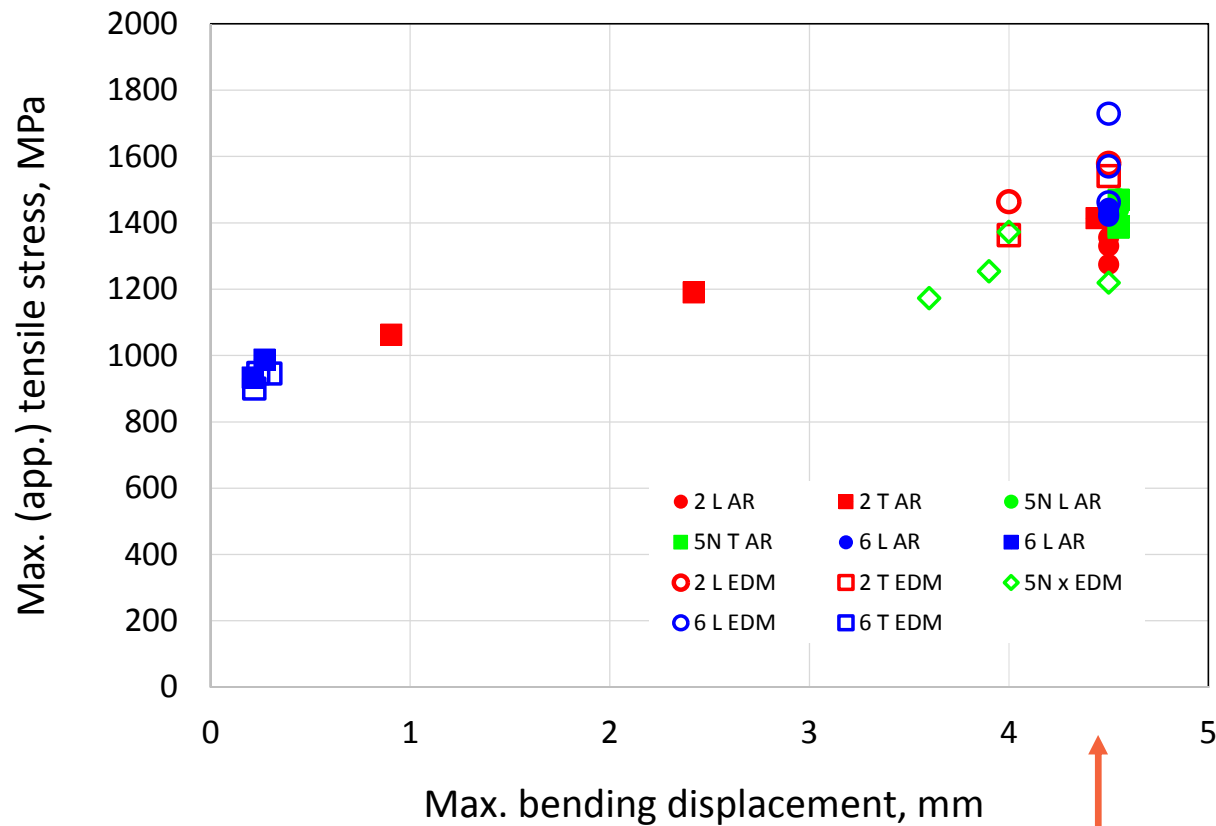
Tensile strength, 400°C in air (3P bending)

L and T orientations, fracture nucleated either from as-received or from EDM surface

Surface in tension:

AR: as-received surface, filled symbols

EDM: electro-discharge machined

Circles, L direction (long.)

Squares: T direction (transv.)

The maximum displacement allowed by the bending rig was 4.5 mm

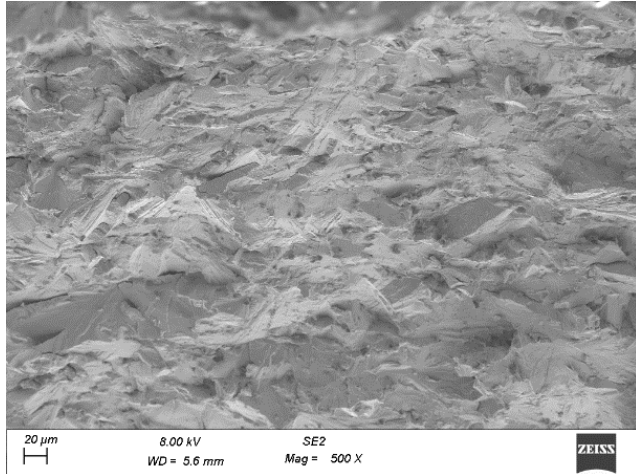
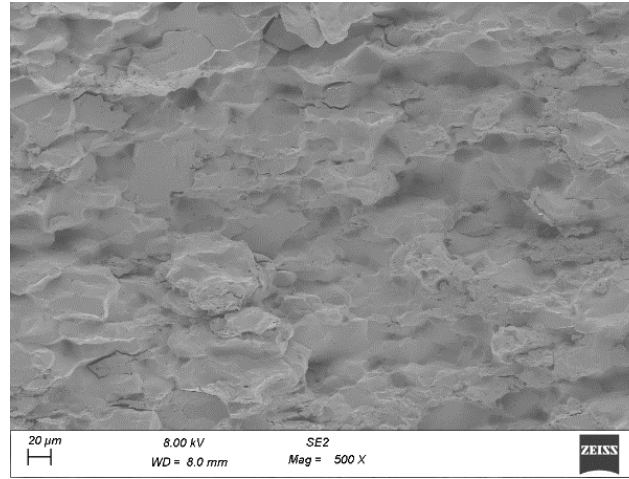
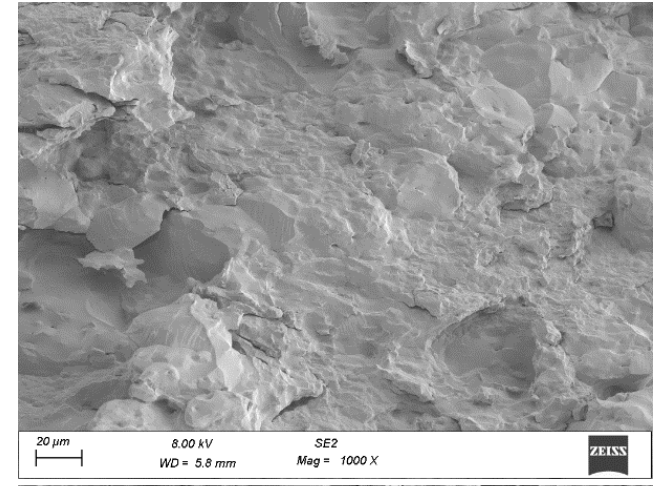
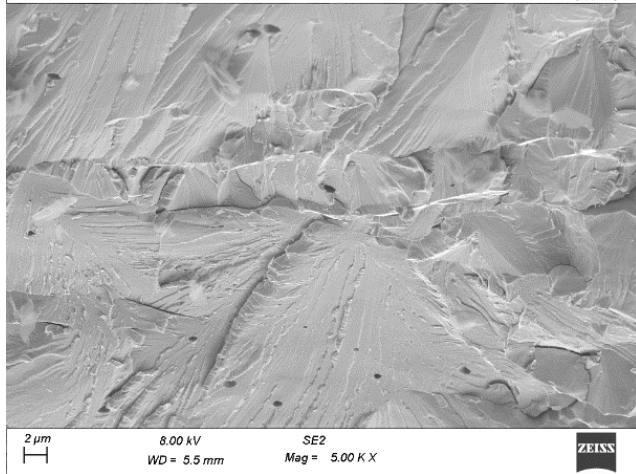
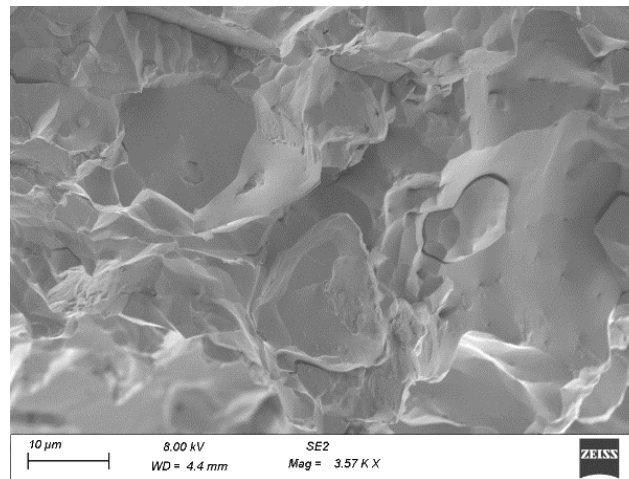
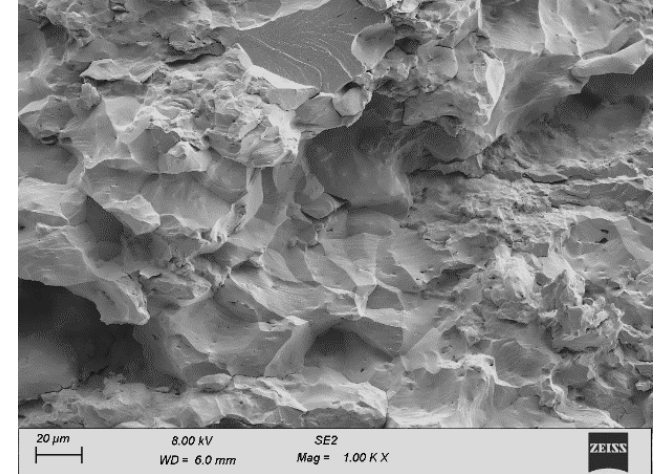
3P-bending, 400°C in air, L orientation of tensile stress

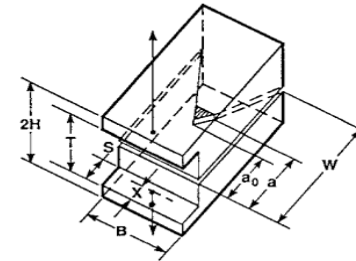
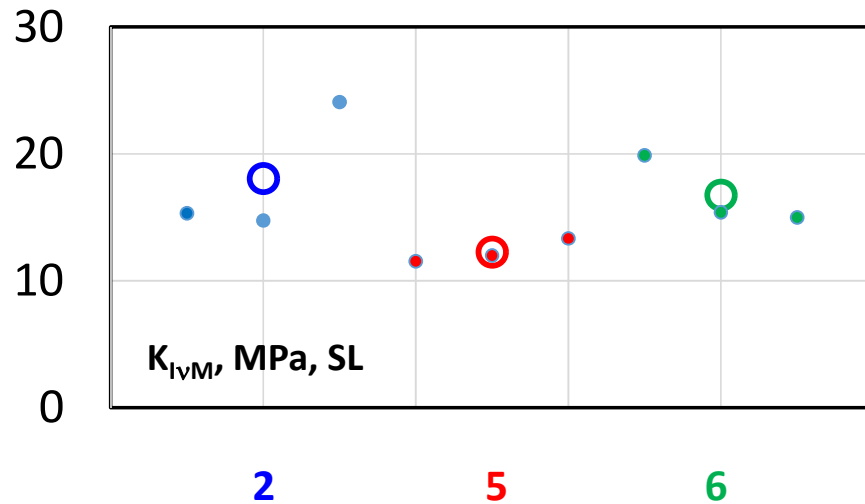
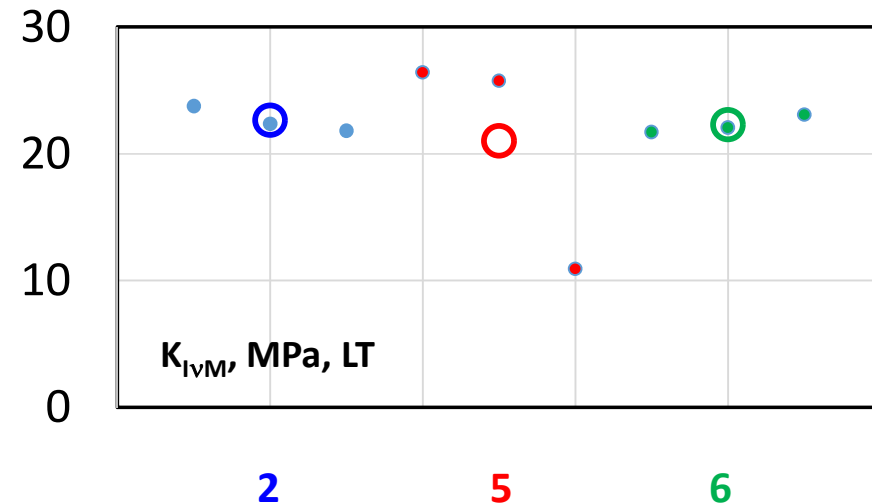
RT plane-strain FRACTURE TOUGHNESS

Barker chevron-notched specimens

Crack propagation toughness, ASTM 1304-97

Orientation convention: SL: S (short-transverse) loading direction, L (longitudinal) crack propagation direction
 LT: L loading direction, T (transverse) crack propagation direction

Considerable anisotropy, smaller toughness for crack propagation parallel to the rolling plane
