Experience from the RF testing at FREIA

Magnus Jobs¹,

¹) Uppsala University, Physics & Astronomy, FREIA

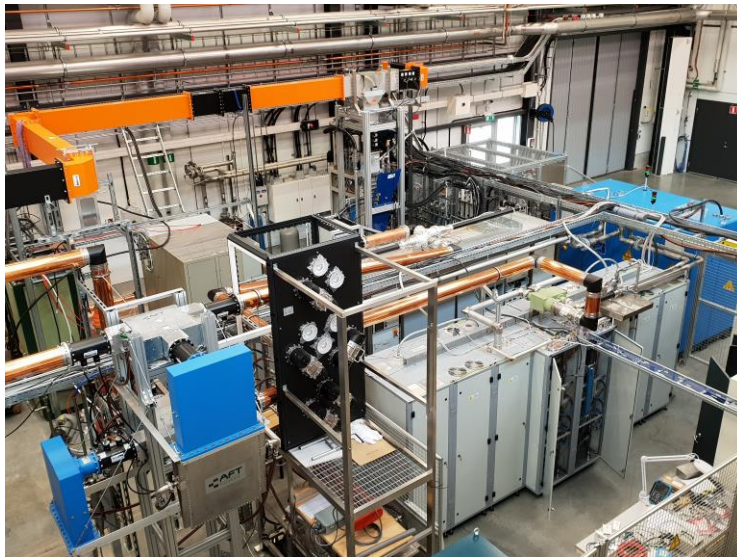
Prototype RF Line

- 1) Prototype Modulator - Tested
- 2) Prototype Klystron – Semi-Tested
- 3) Prototype Control – Semi-Tested
- 4) Prototype Circulator - Untested
- 5) Prototype Load - Untested

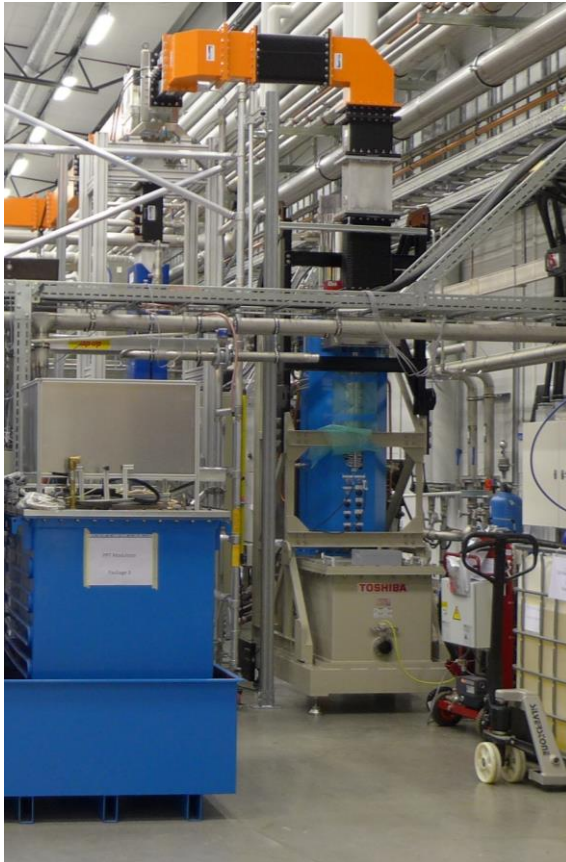
Toshiba 704 MHz Prototype Klystron

- 1) First Commissioned + Tested In Lund
- 2) Suffered Arcing in Lund, repaired and sent here
- 3) 1.5 MW at 3.5 ms 14 Hz
- 4) Delays in getting operational due to facilitating 2 modulators & 2 control systems
- 5) Commissioned on-site up to 1 MW due to limitations set by RF load
- 6) All operational parameters correspond well with the Toshiba FAT

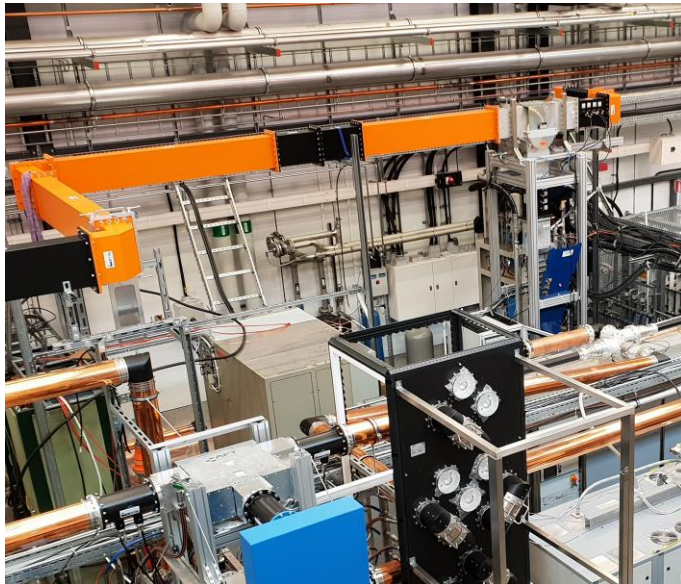
Waveguide Distribution

- 1) Standard Mega-Ind waveguides
- 2) H-bend straight after the output of the klystron
- 3) Very limited changes on guide electrical length
- 4) Support provided to easy removal of individual parts

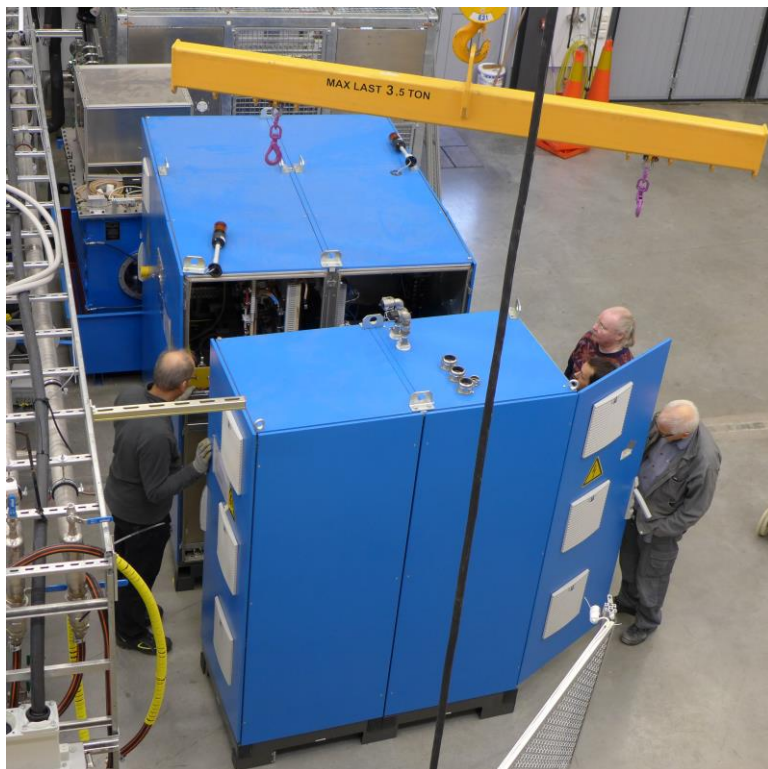
PPT Ampegon Modulator

2.8 ms at 14 Hz
Single Klystron

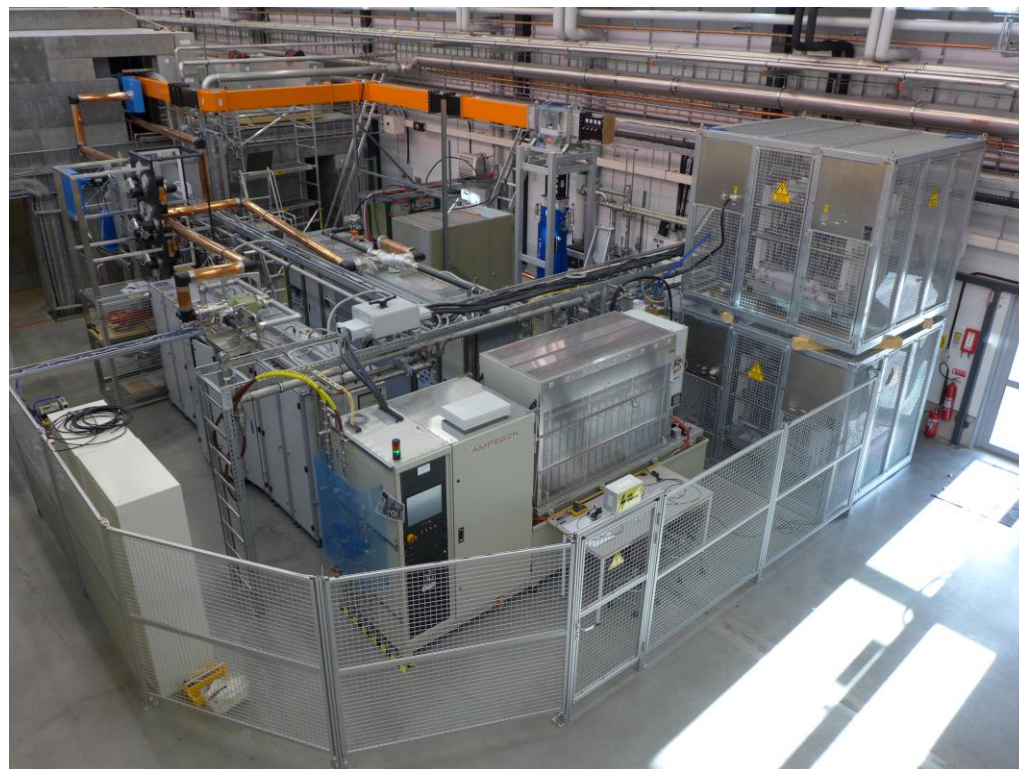
Ampegon Modulator

3.5 ms at 14 Hz
Dual Klystrons

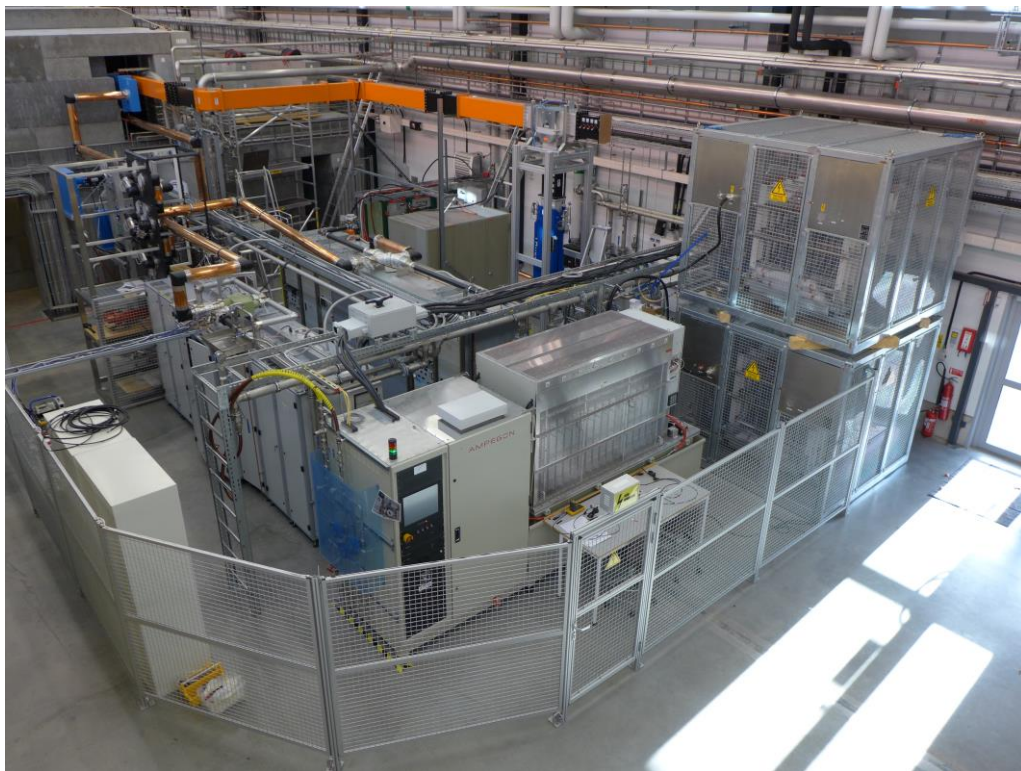
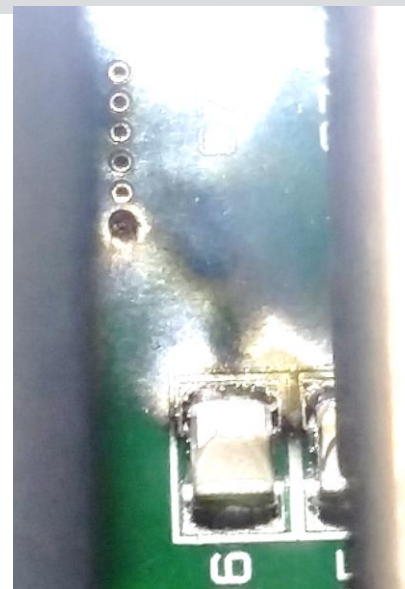
Ampegon Incident

- 1) Lost one high-voltage module
- 2) Several modules were showing unusually high ripple
- 3) Destroyed at 90 kV

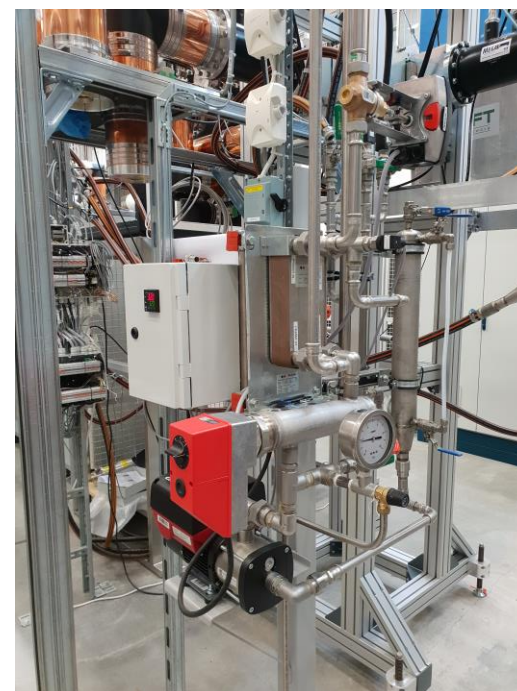
704 MHz Ferrite Circulator

Ferrite brand circulator designed for
14 Hz, 3.5 ms, 1.5 MW

- 1) Running unregulated-tuning due to short RF pulses
- 2) Required dedicated cooling system due to very high sensitivity of temperature
- 3) Variations in both cooling temperatures as well as internal temperatures directly affects the klystron gain
- 4) Example: Same input power with change in temperature causes output to drift from 300 to 380 kW, even though reflected power was always below the 5 kW interlock threshold
- 5) Experiences some thermal runaway

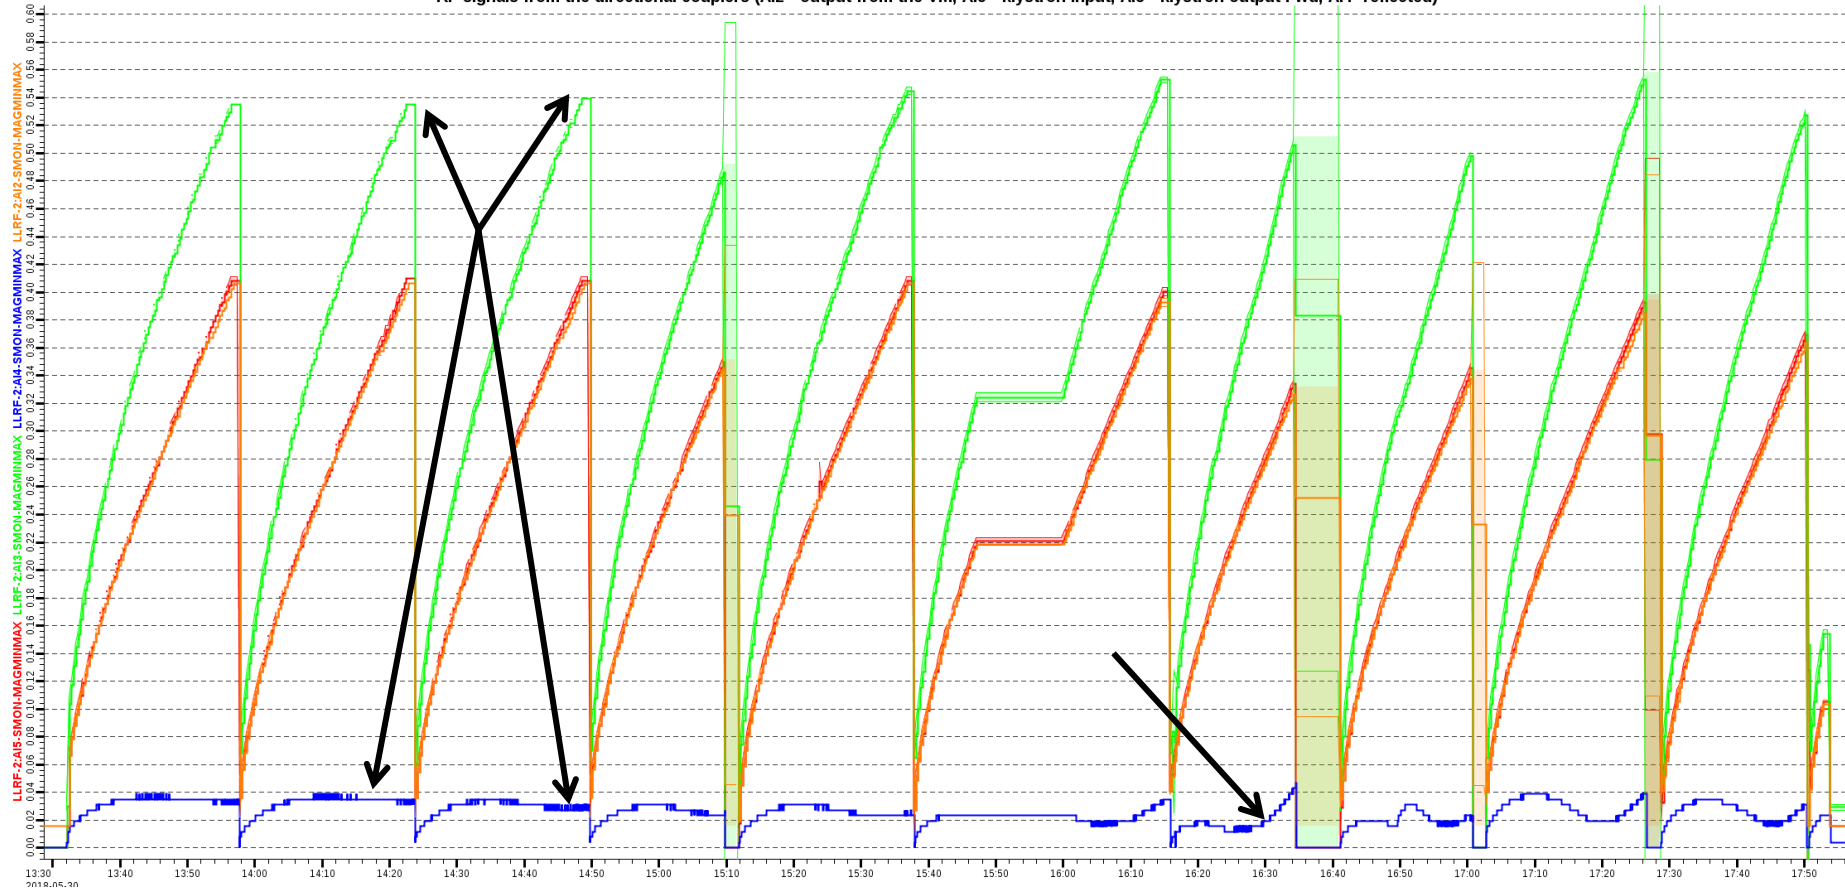
RF signals from the directional couplers (AI2 - output from the VM, AI5 - klystron input, AI3 - klystron output Fwd, AI4 -reflected)

Ramping power to 1 MW with increase pulse length and rep-rate

Green Line: Klystron Output, Blue Line: Circulator Reflected Power

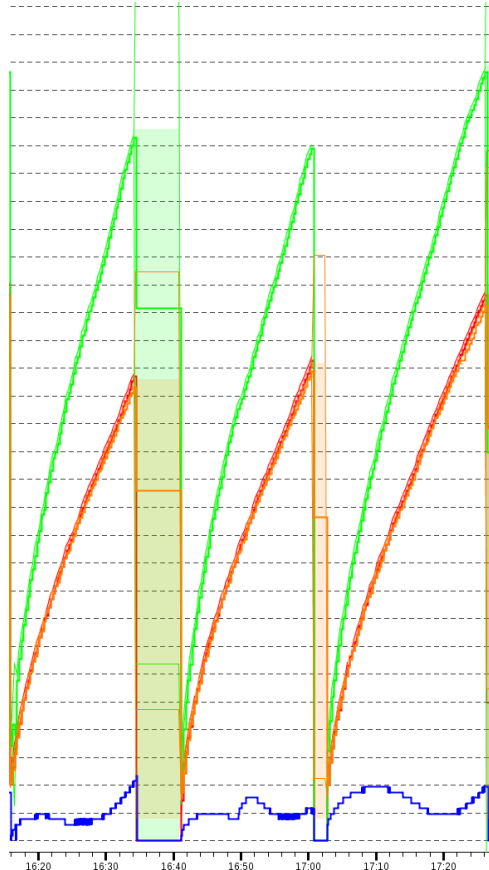
- 1) At room-temperature it was not possible to use the electrical tuning
- 2) For adequate tuning at 27 degree cooling water the coil-bias current was at maximum
- 3) Currently regulating by cooling temperature control
- 4) Reflection can drift from -20 to -30 dB during start of pulse due to internal heating

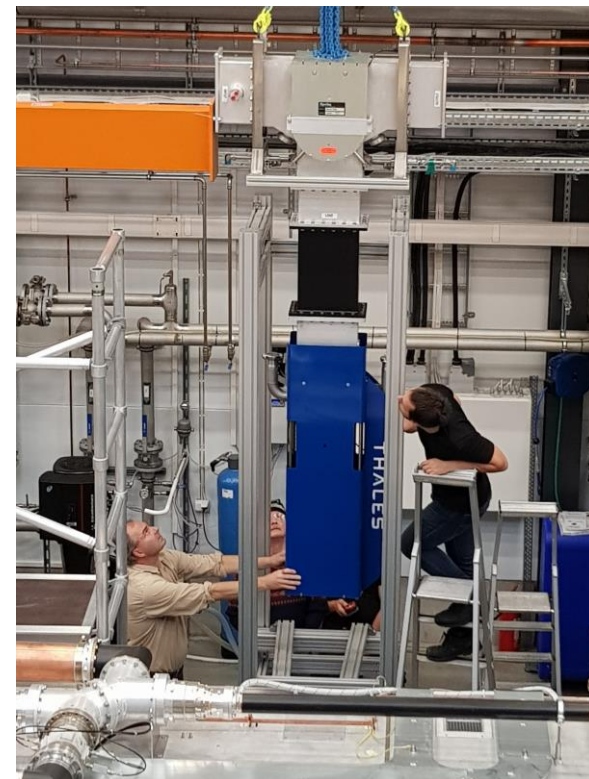
Thales 704 MHz Load for 3.5 ms 1.5 MW

- 1) Water-based load
- 2) Designed for both “hot” and cold cooling water
- 3) Damage due to internal arcing
- 4) Repaired and tested to 1 MW
- 5) Still exhibits occasional arcing at high average power

- 1) Sustational arcing around ceramic window due to uneven quality of window
- 2) Was not intended ceramic window, shipping was pressed due to time

Temporary repair while waiting for final solution. Copper lower gasket and upper wire gasket.

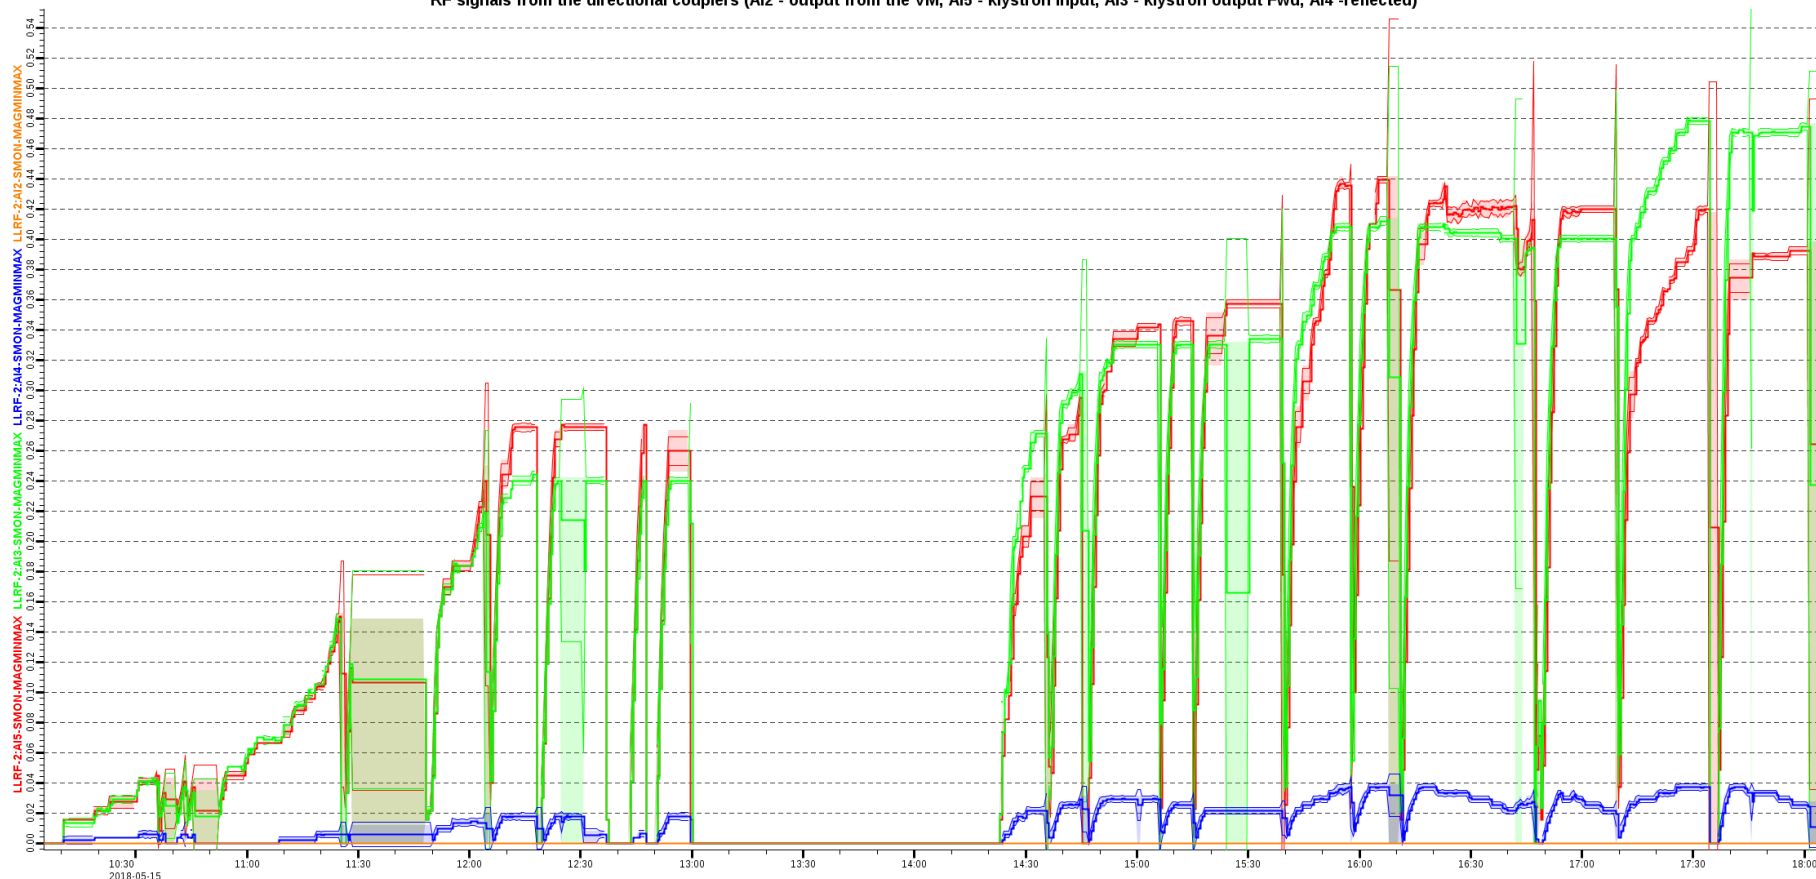
704 MHz Load

RF signals from the directional couplers (AI2 - output from the VM, AI5 - klystron input, AI3 - klystron output Fwd, AI4 -reflected)

Load was gradually pushed up to 1 MW while also retightening the flange. Some initial smaller arcs but then stable. Still considered a temporary fix.
