Experiences of remote maintenance for the mercury target system for the pulsed neutron source

Neutron Source Section, MLF Division

J-PARC / JAEA

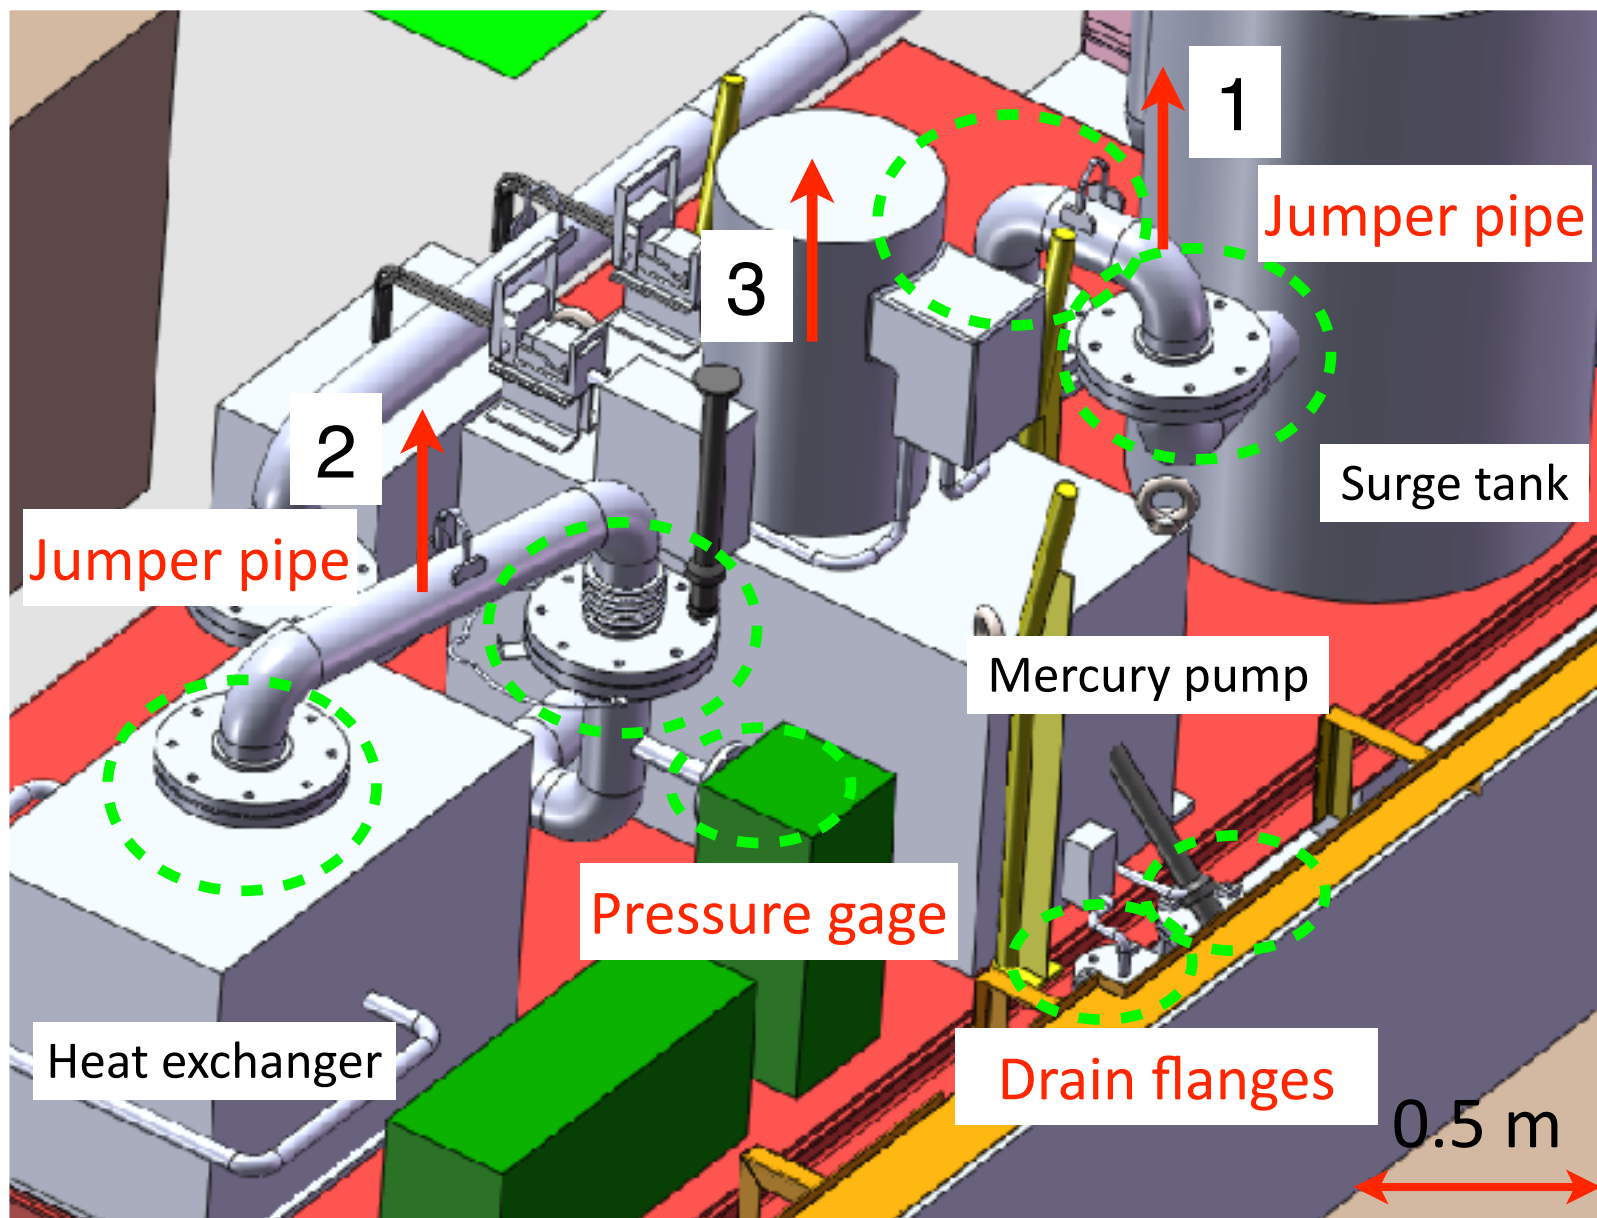
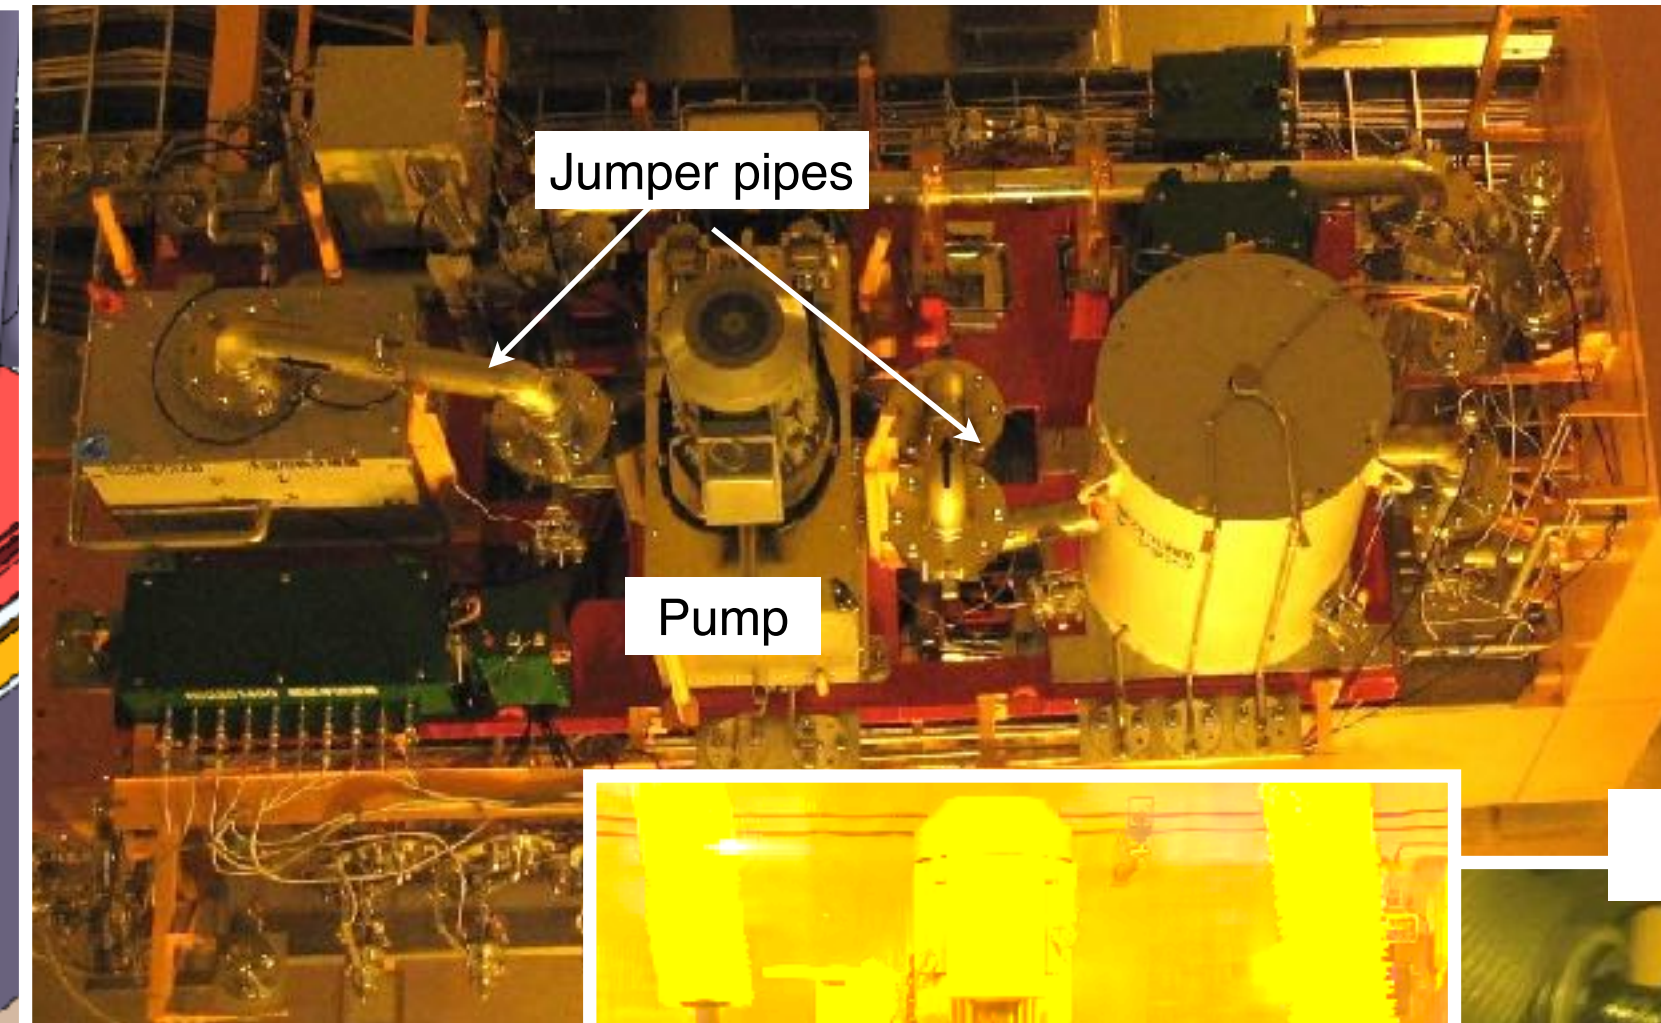
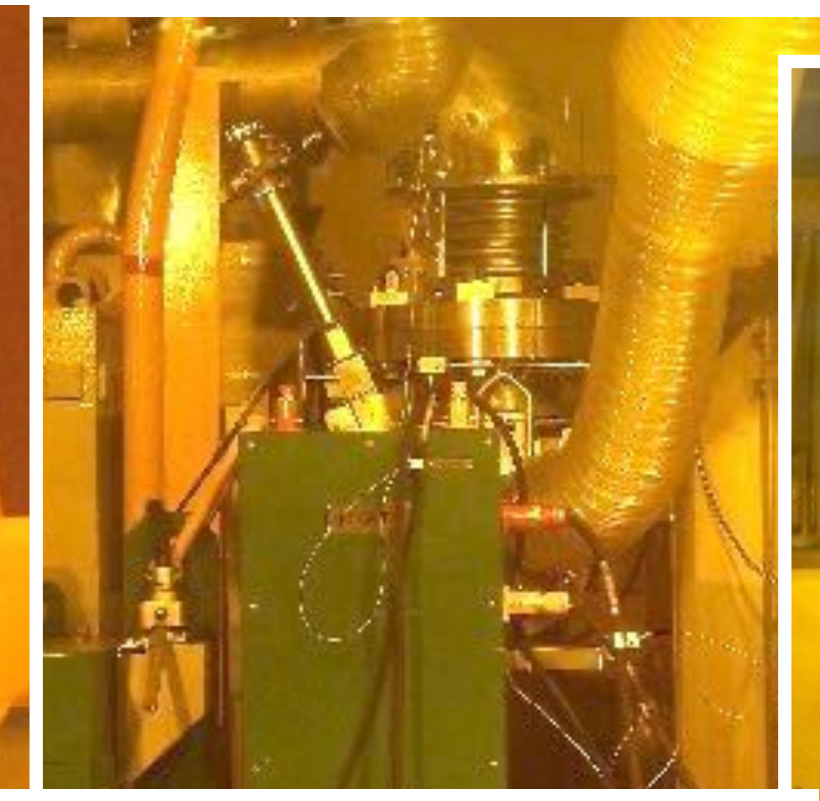
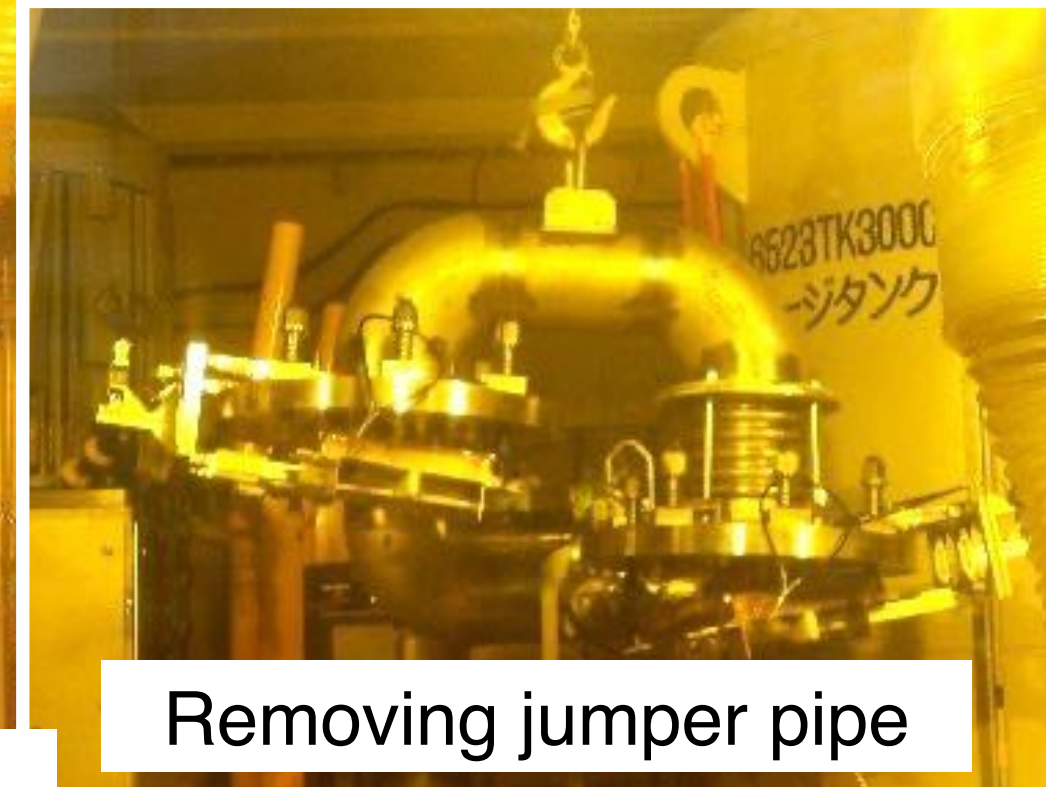
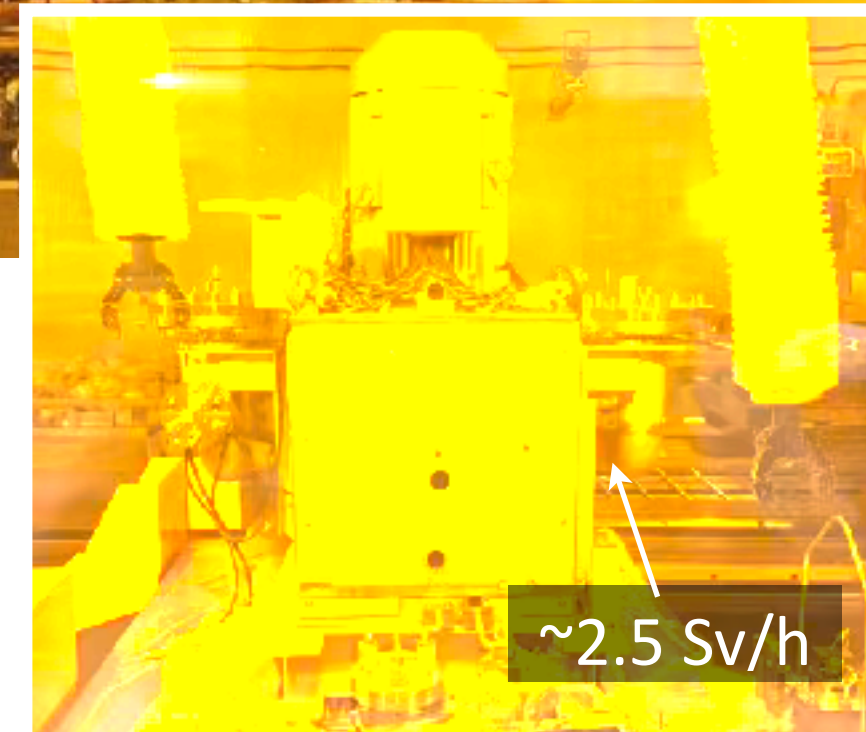
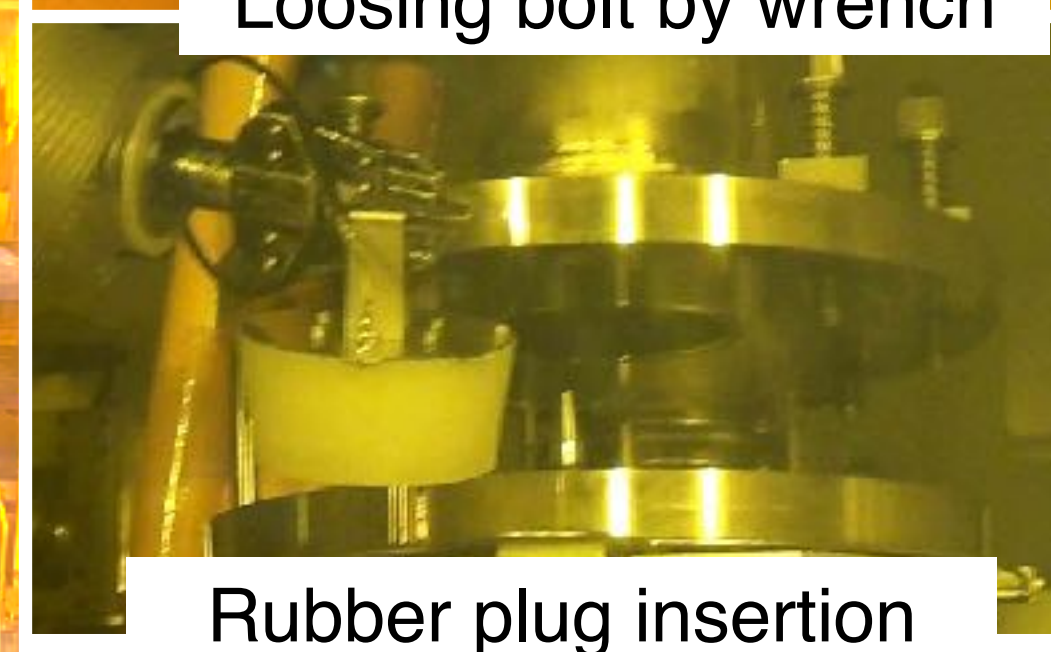
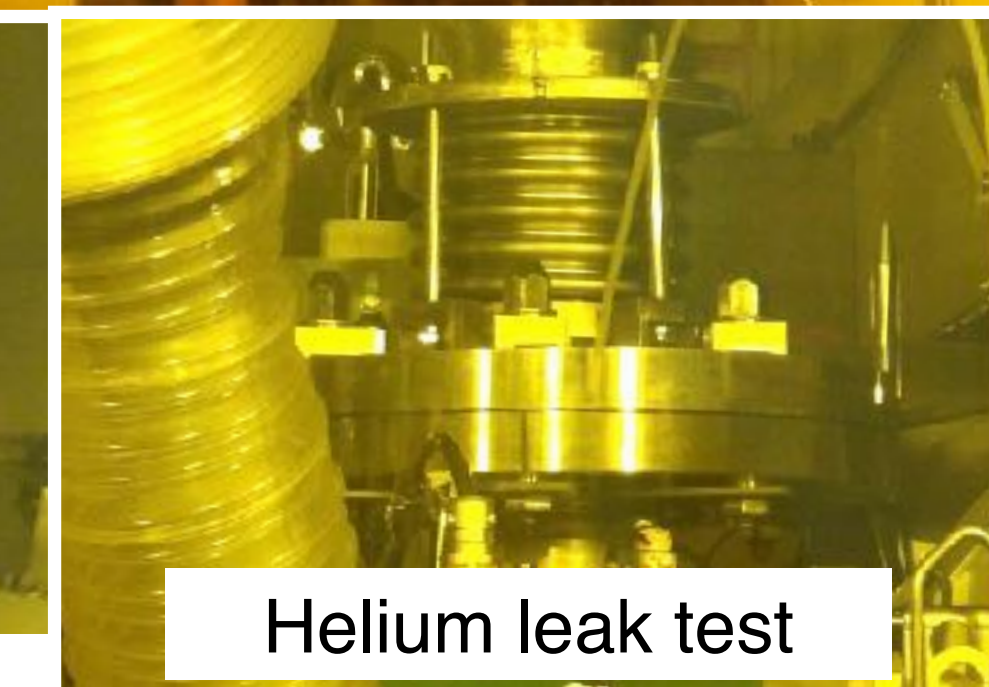
Pump replacement by remote handling

Mercury pump (weight: 3 ton)

- Remote handling test and training were conducted carefully for rubber plug insertion and metal seal replacement using mockup target trolley
- 7 flanges should be opened for pump replacement, and insert rubber plugs to prevent tritium release from opening parts
- Replacement work and leak test were successful but amount of tritium release was slightly larger than expected

Predicted/ Result :141GBq / 160 GBq

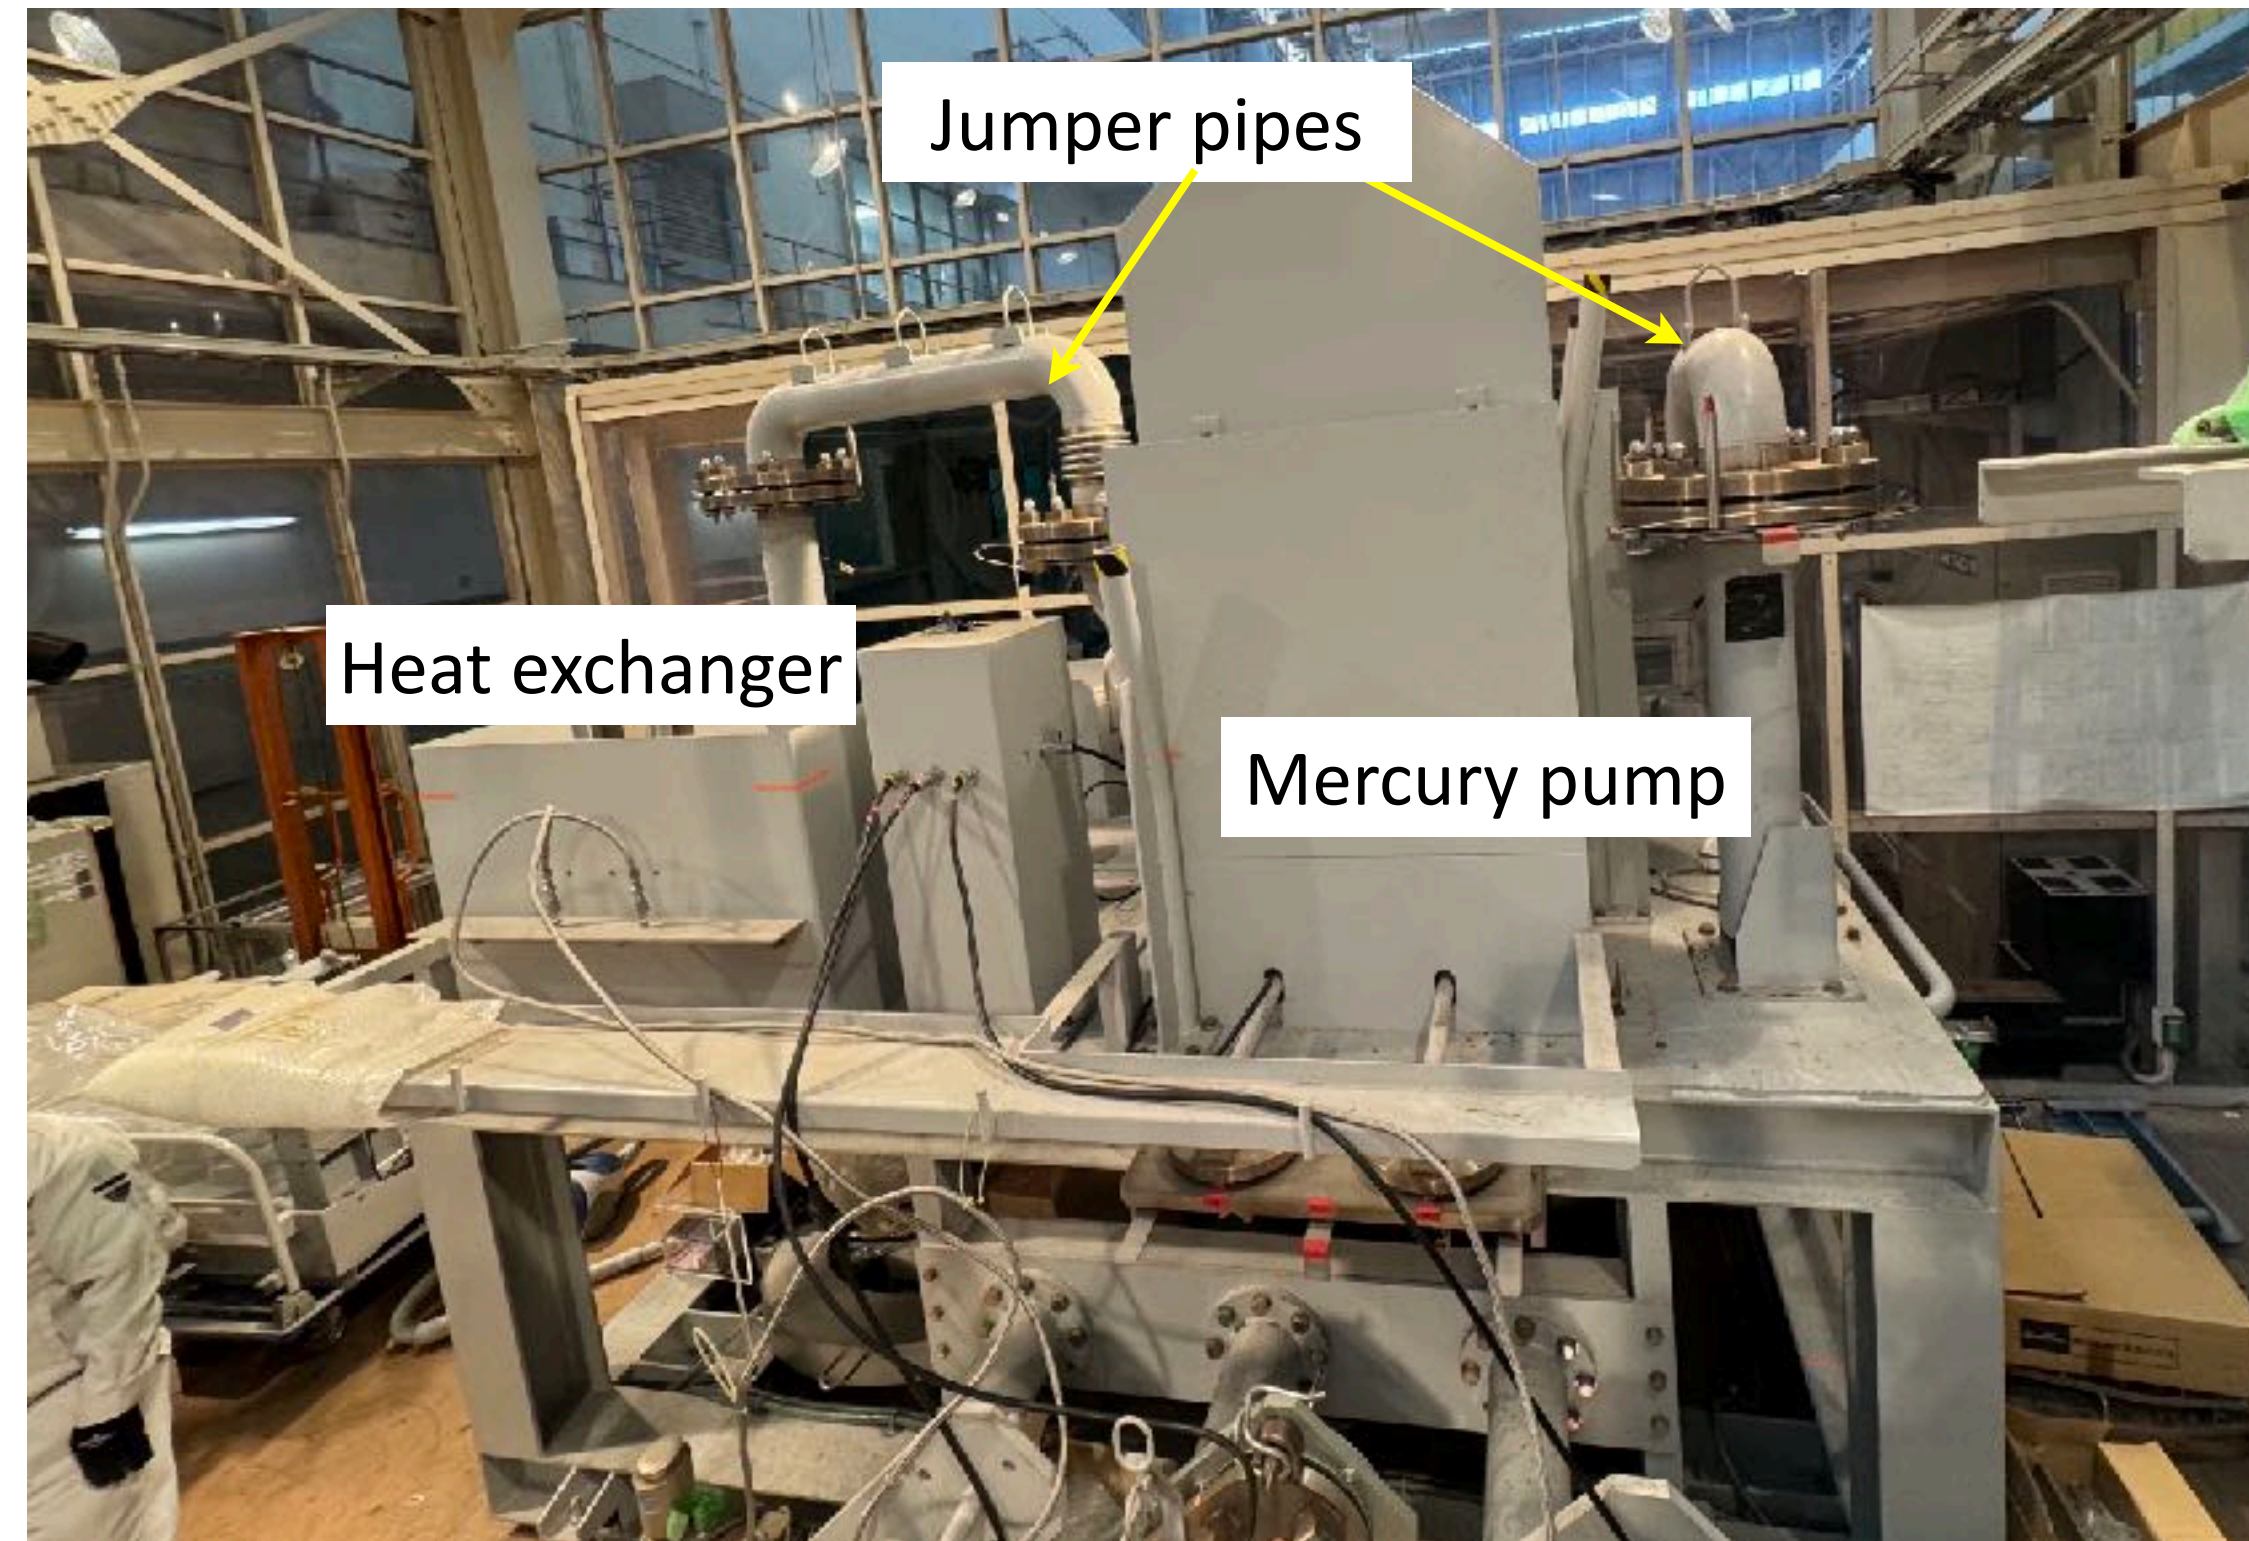
Target trolley mockup

- To investigate the reason of flange leak and improve the seal replacement procedures by remote handling, mockup tests using flange element and jumper pipe were conducted
- Vacuuming leak test was selected to detect leak in high-precision, although the actual target system is available only sniffer test

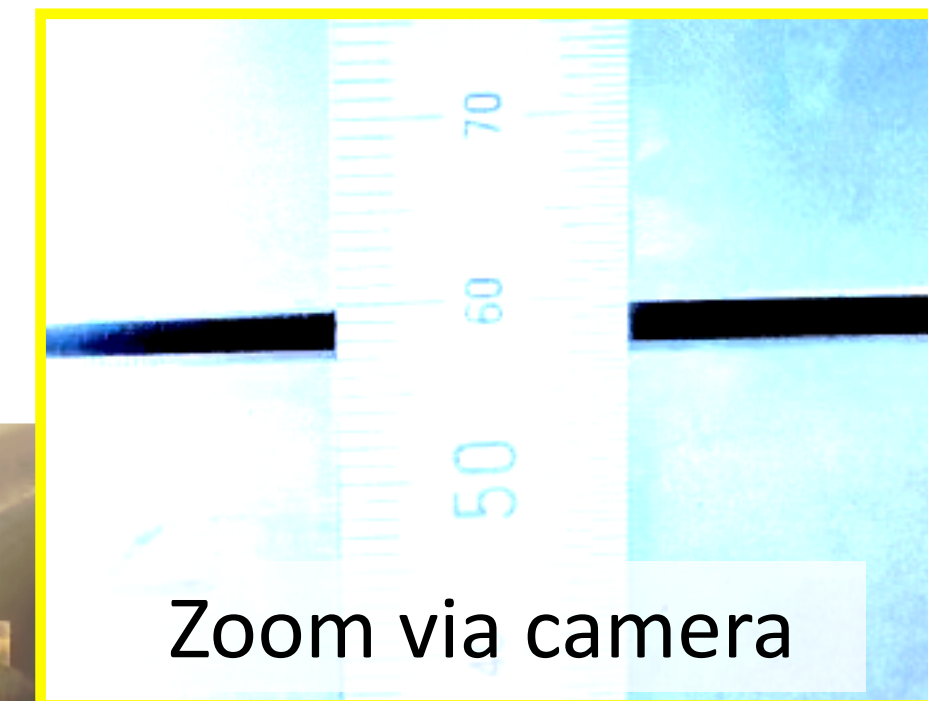
Flange gap measurement

Decide order of tightening bolt by gap visual inspection

- We learned that the ideal fine-torque management (5–10 Nm steps) is effective for securing leak tightness, but it is not feasible for a power manipulator
- To reproduce the even tightening achieved by manual work using the power manipulator, we conducted 10 flange mock-up tests and 6 jumper-pipe mock-up tests, varying the bolt-tightening procedures to confirm reproducibility
- Based on these results, we decided to focus on achieving even flange gap, rather than managing tightening torque
- The final procedure is: Initial tightening at 20 Nm (sequence: 1, 2, 3, 6, 5, 4), Adjust as needed to achieve an even flange gap at 40–120 Nm, Apply final star-pattern tightening at 160 Nm and 200 Nm

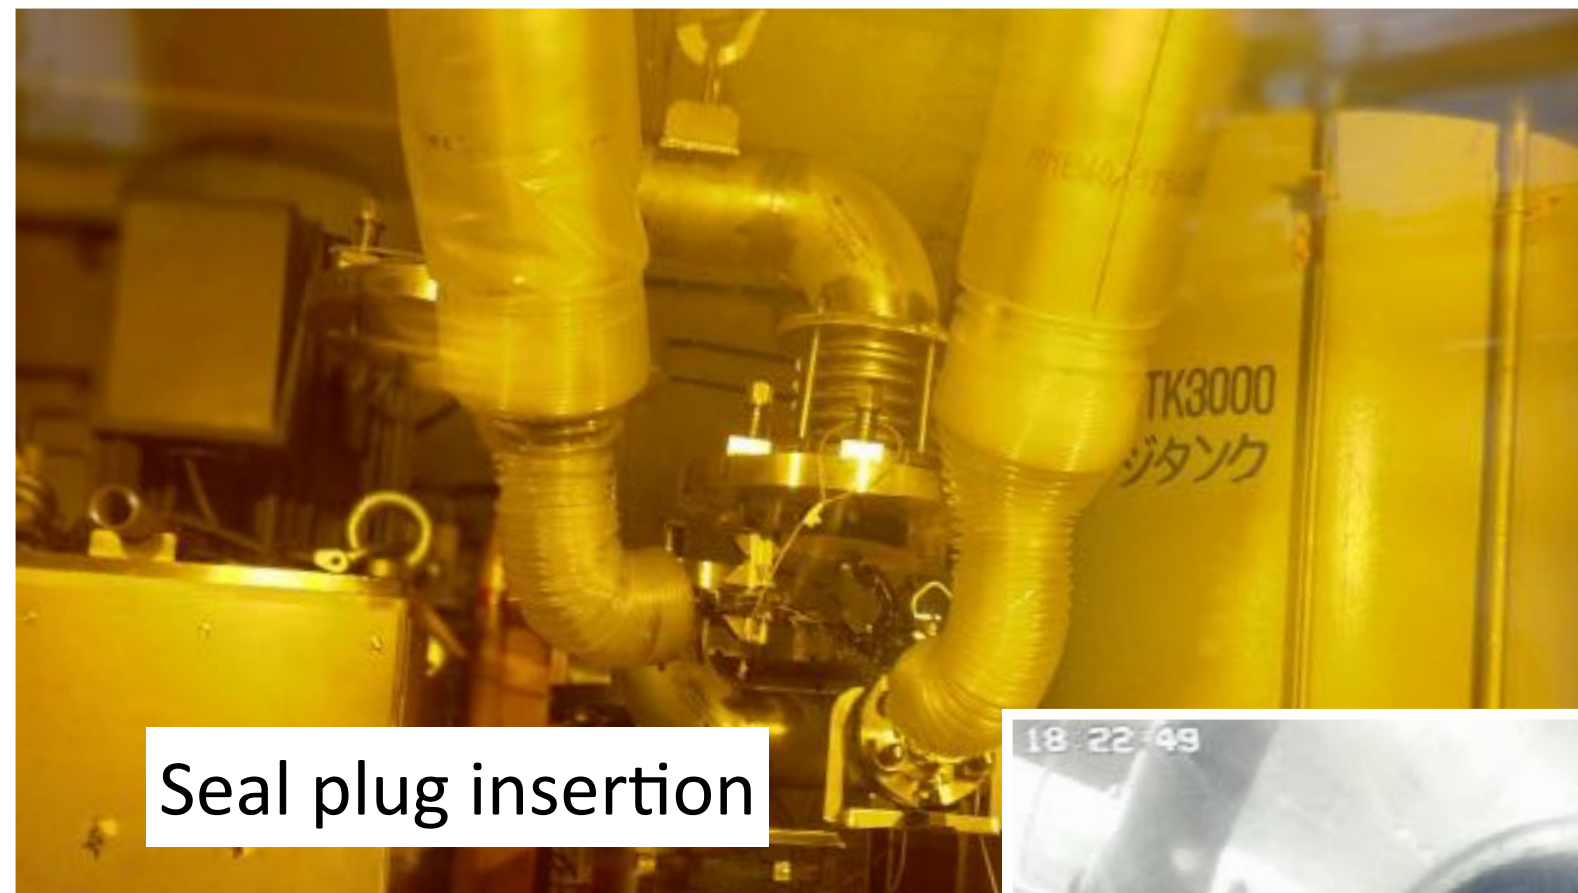
Seal plug insertion

- Based on experience during the pump replacement, we changed seal plug for the jumper pipe
- Due to a risk of damaging the sealing surface of flange, we skipped flange cleaning process in pump replacement, but for seal replacement, we decided to add a flange cleaning process for the seal replacement
- We conducted training for the newly added tools and cleaning procedure

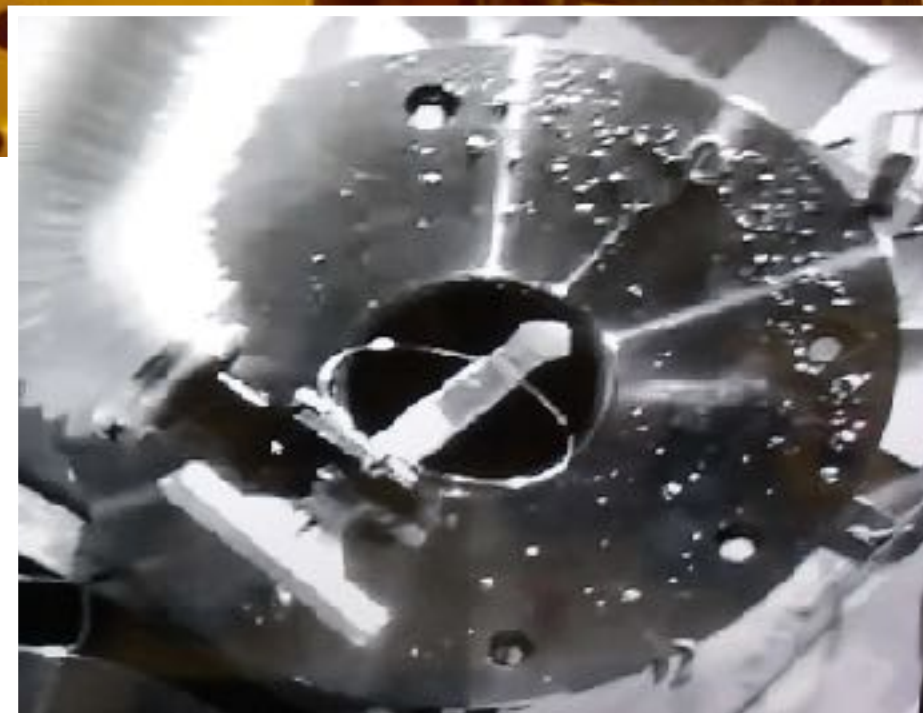
Seal replacement

- Helium leak test showed below detectable limit for all flanges after seal replacement
- Stuck monitors are recovered usual value in beam operation

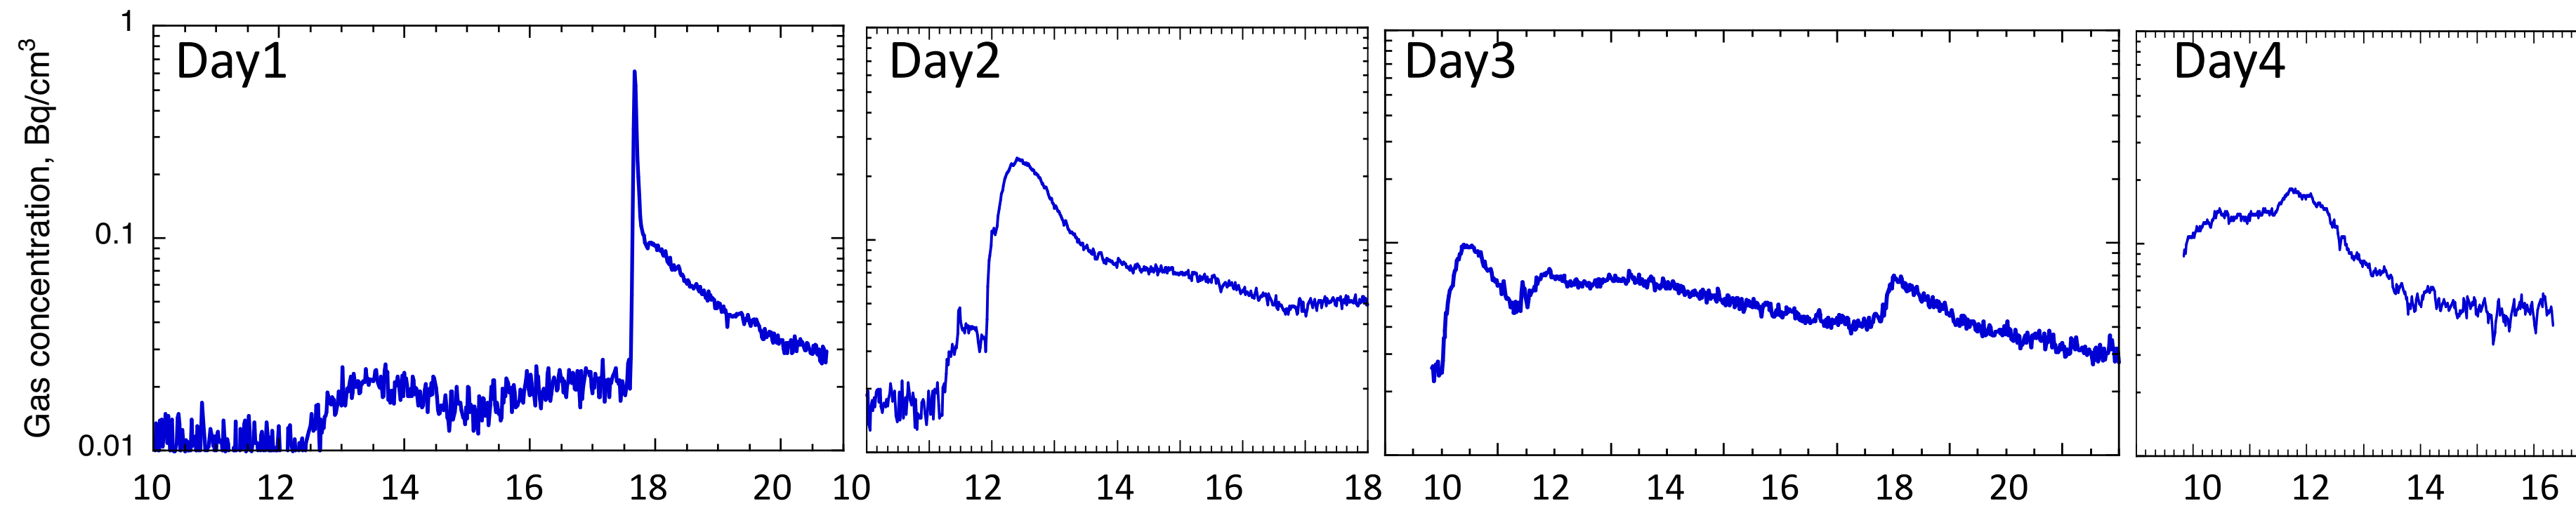
[GBq]	Total	Day1	Day2	Day3
Pump replacement	Ion chamber	268	32	139	97
	Silica gel	160	18	68	74
Seal replacement	Ion chamber	6	6.0	ND	
	Silica gel	7.4	5.2	2.2

The main reason why the value of the stack ionization box is higher than that of cell silica when replacing the pump is This is because the count of rare gas element nuclei is also evaluated as tritium.
