System Acceptance Review meeting for LoKI

LoKI Neutron Detector System & Detector Electronics
=ESS.NSS.H01.LOKI.B01.B01 & ESS.NSS.H01.LOKI.B01.C01

2025-09-15

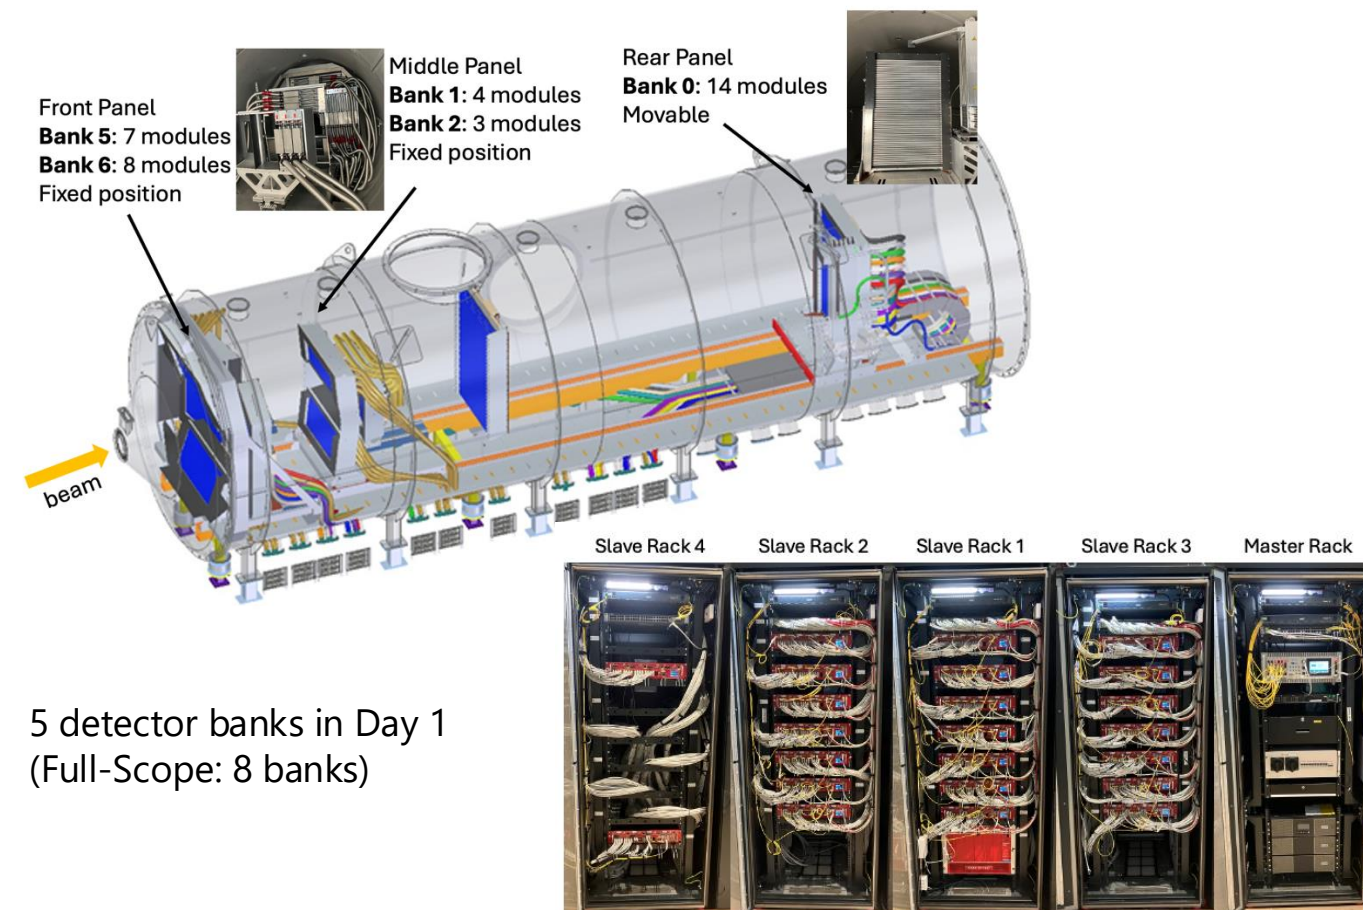
Equipment delivered and installed

5 detector banks in Day 1
(Full-Scope: 8 banks)

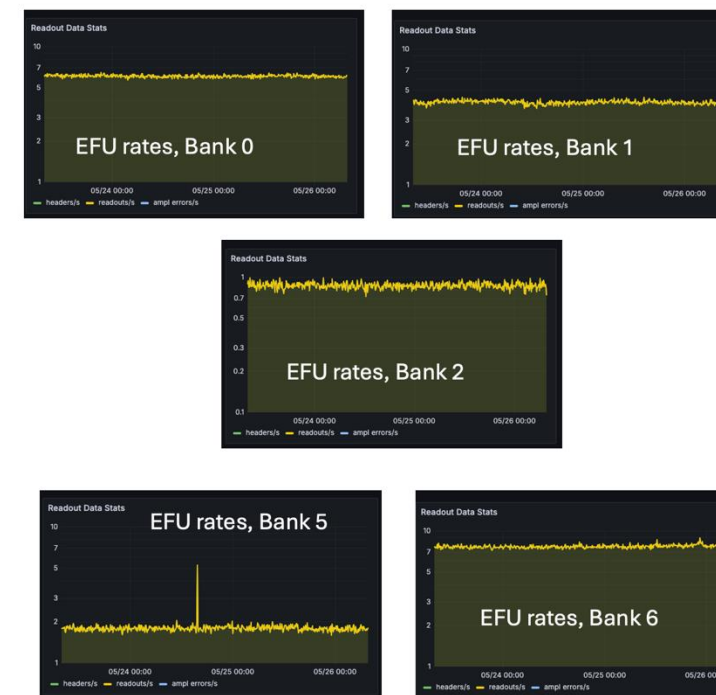
Grafana plots

- All tests were performed with cosmic background continuously counting for 3-4 days (weekends) with the detectors operating with vacuum and with air in the tank. Weekdays were used for testing activities by the other teams (e.g., MCA).
- No grounding issues observed (uniform detector rates across all banks and modules, see plots).
- Test report ESS-5716334 was released at the end of June. Detector & electronics systems deemed ready for integrated testing.
