TECHNICAL REPORT

“Assessment of tungsten bricks (intended for the target of the ESS) according to a technical selection protocol agreed with ESS-Bilbao.

Stage 2 results of tests of three batches selected after Stage 1”

Document Code: MT / 120033-2 / 15 / R 02

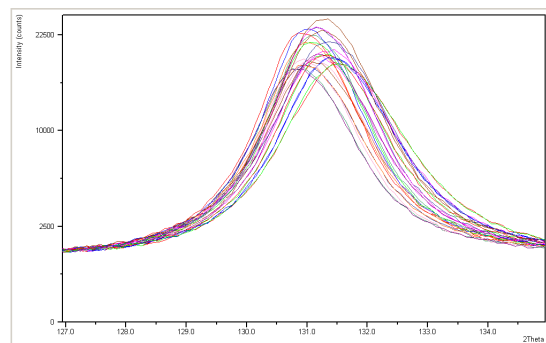
The relatively narrow double peak of fig. 2, ground or polished brick 5, is very different from the surface diffraction peaks of the other bricks, as was noted in the report of the Stage 1 tests. In figure 3 the surface diffraction peak of batch 2 is shown for comparison, the peaks of the other bricks were qualitatively similar. Such broad peak is associated to a deformed structure, the double peak of brick 5 corresponds to a nearly undeformed material. Indeed, the OM and EBSD observations show that the structure of bricks 5 is recrystallized and very different from the structure of bricks 2 or 6, as explained below in this report.

Figure 3. Diffraction spectrum from the surface of brick 2 (Stage 1).

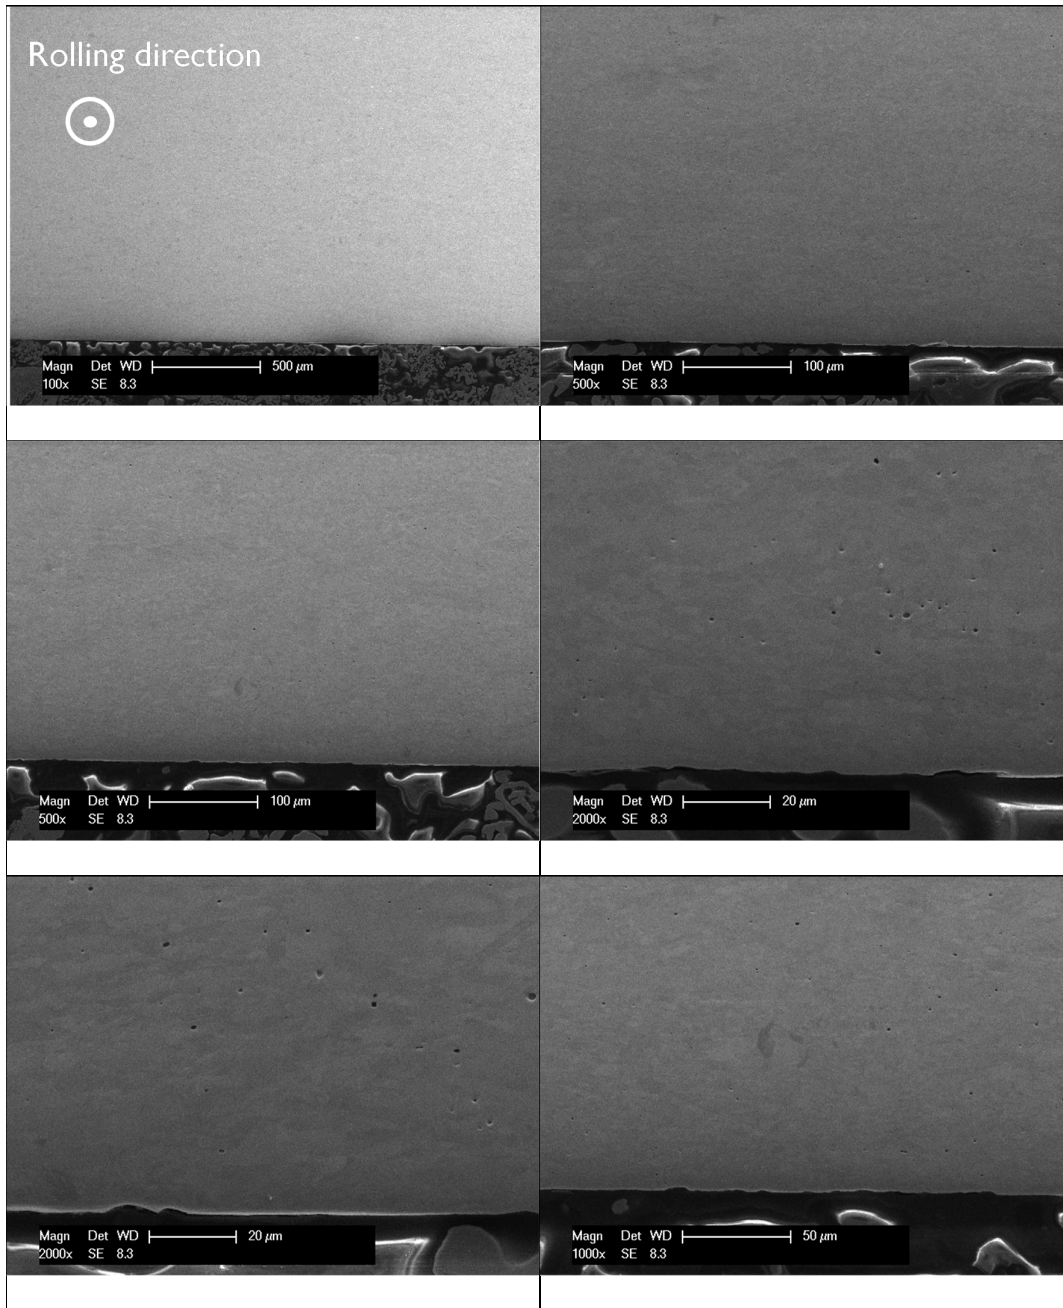
The edges of the LN and NT cross sections have been explored for microcracks or other surface-nucleated defects; the interior, for porosity. Examples of such observations are presented in figures 7-12. The superiority of the surface state (in terms of smoothness and absence of geometrical defects) of brick 5 (polished) is evident. At the surface of brick 6 some folding of the ground subsurface have been detected; again, a more detailed and quantitative characterization should be undertaken for differentiating bricks 2 and 6 with respect to the population of such type of defects. More porosity is detected in brick 2.

Figure 8. Brick 2, unetched, NT section, SEM secondary electrons images.

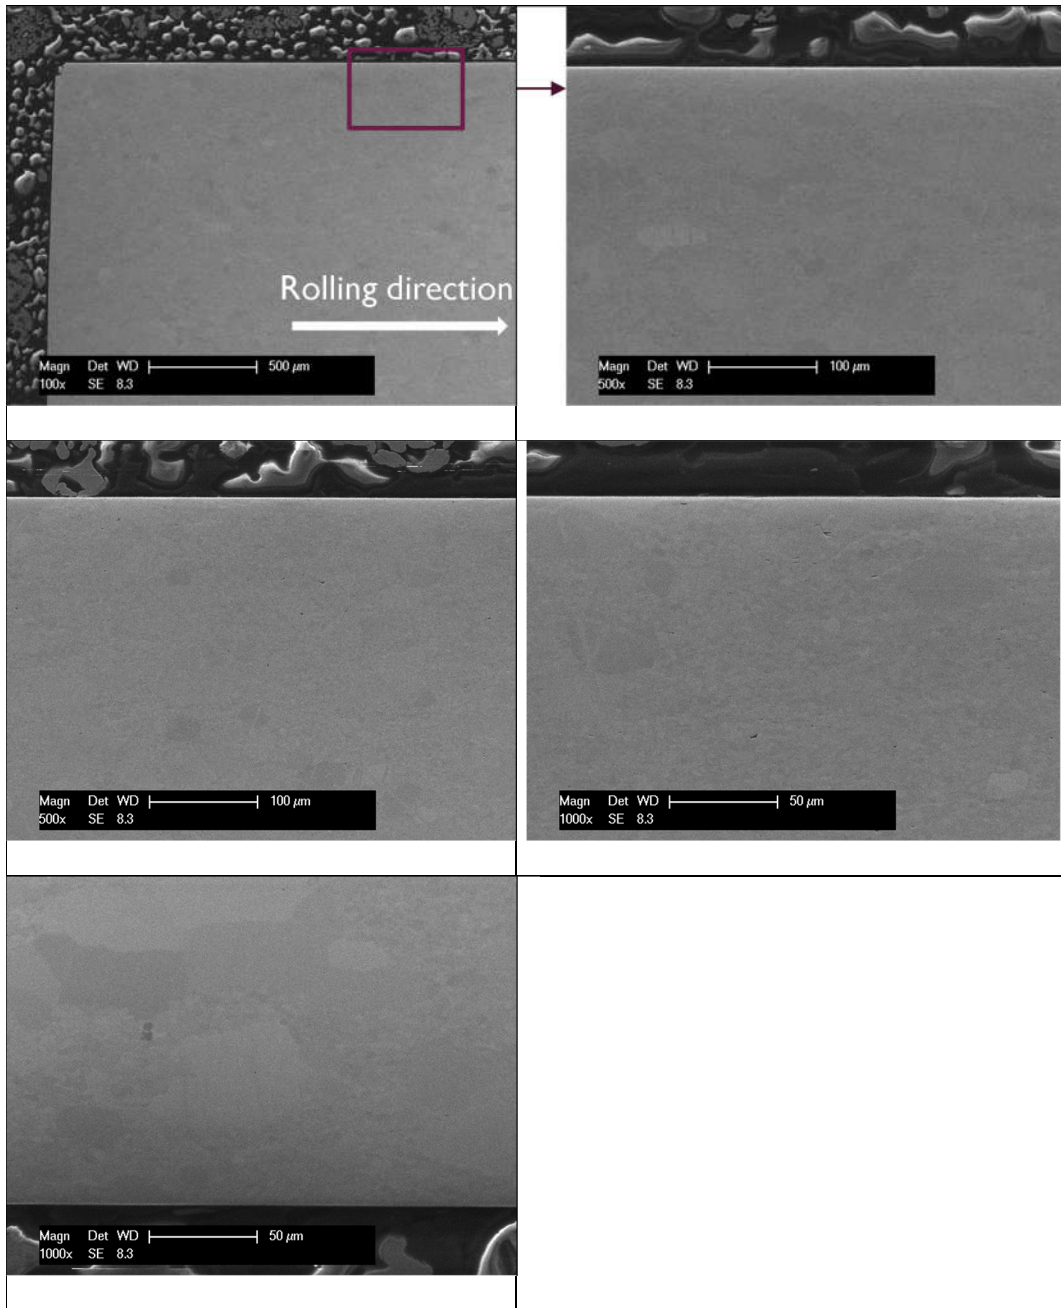
Figure 9. Brick 5, unetched, LT section, SEM secondary electrons images.

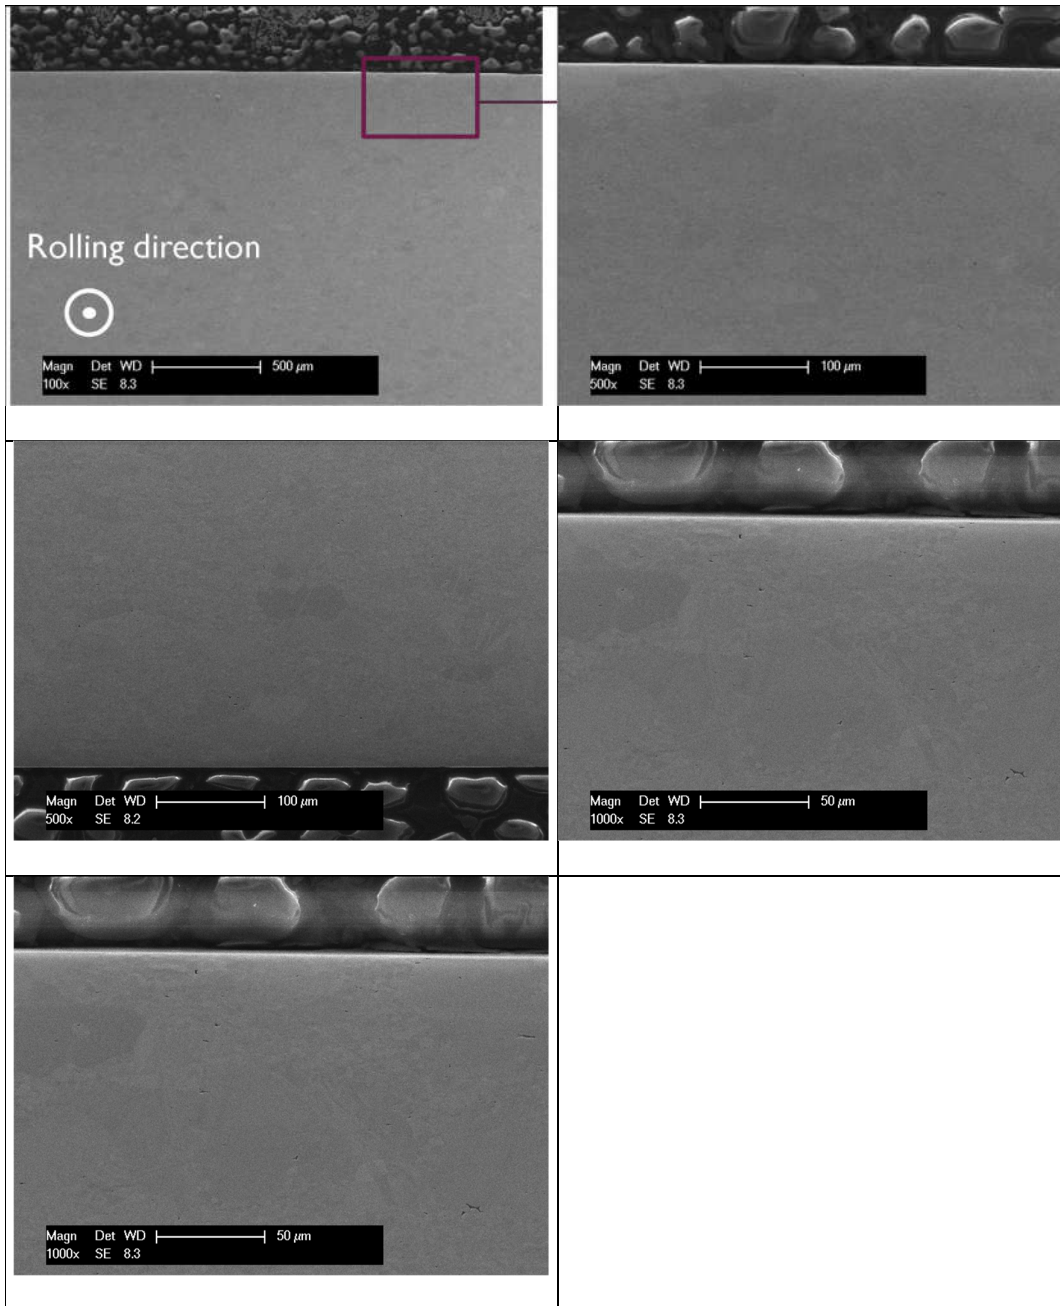
Figure 10. Brick 5, unetched, NT section, SEM secondary electrons images.

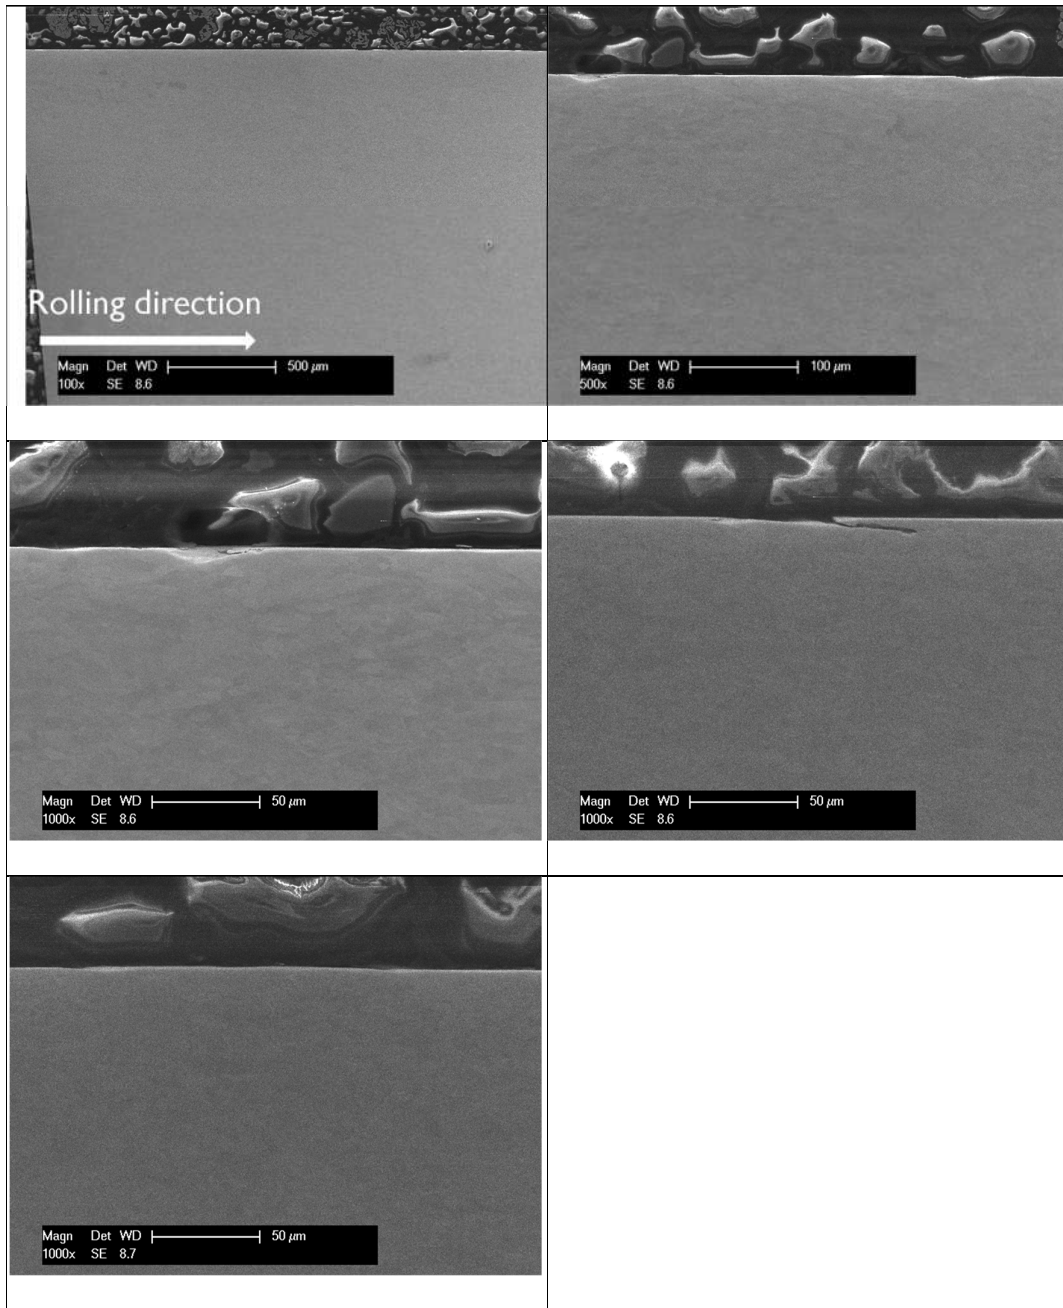
Figure 11. Brick 6, unetched, LN section, SEM secondary electrons images.

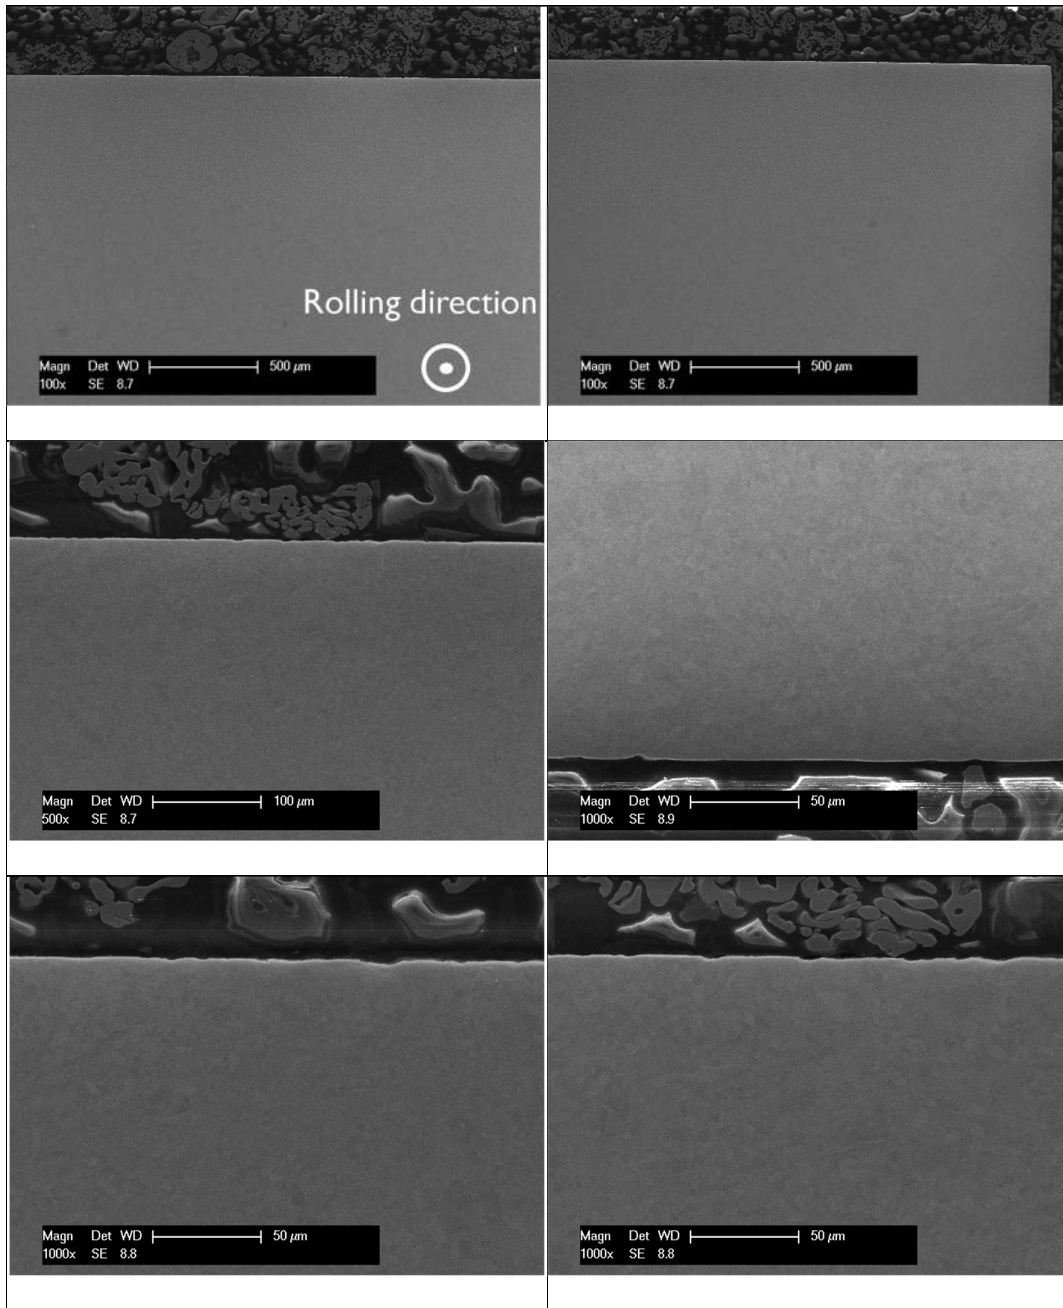
Figure 12. Brick 6, unetched, NT section, SEM secondary electrons images.

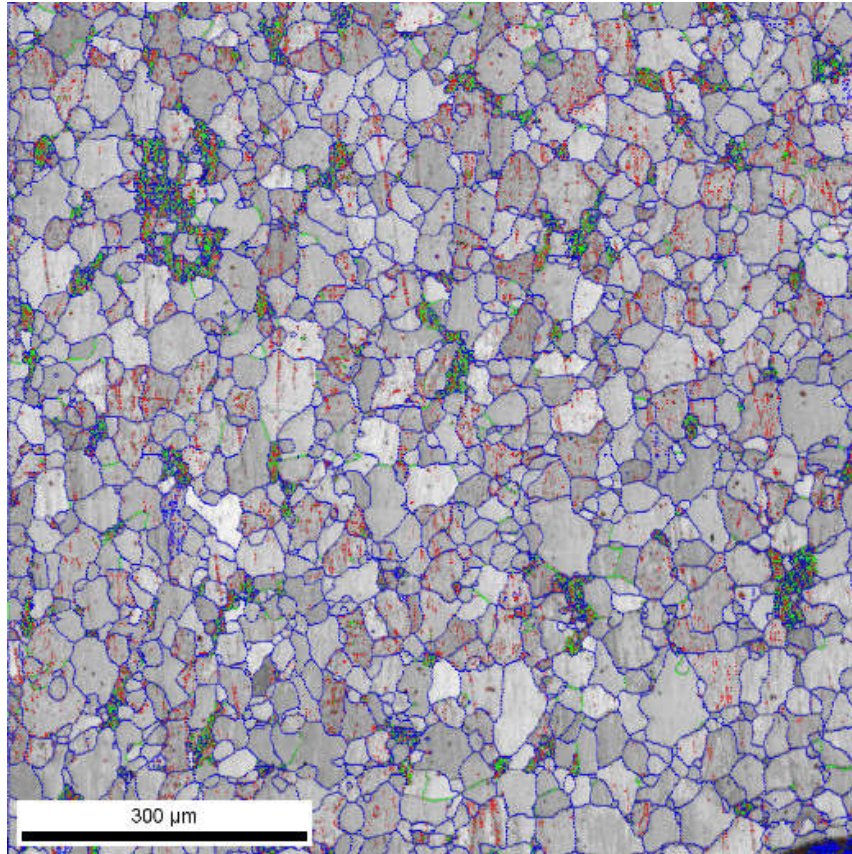
Figure 14b. Brick 5N, midplane. Bimodal grain size distribution with small fraction of fine grain size regions. Grain interiors nearly devoid of deformation substructure.

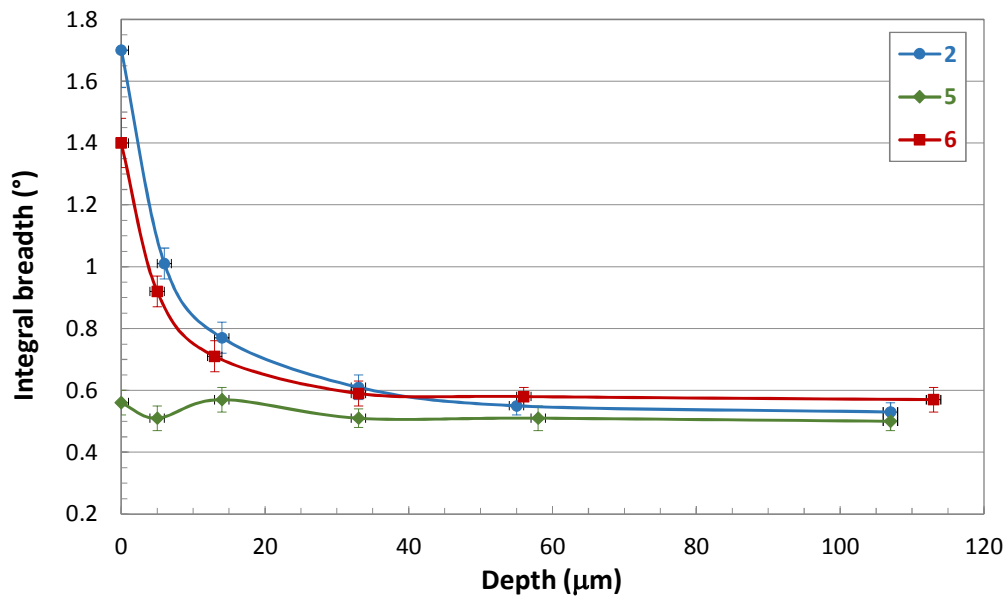
The results are summarized in Table 5 and figs. 23 and 24.

Figure 23b. Integral breadth (peak area/peak maximum height) vs. depth.

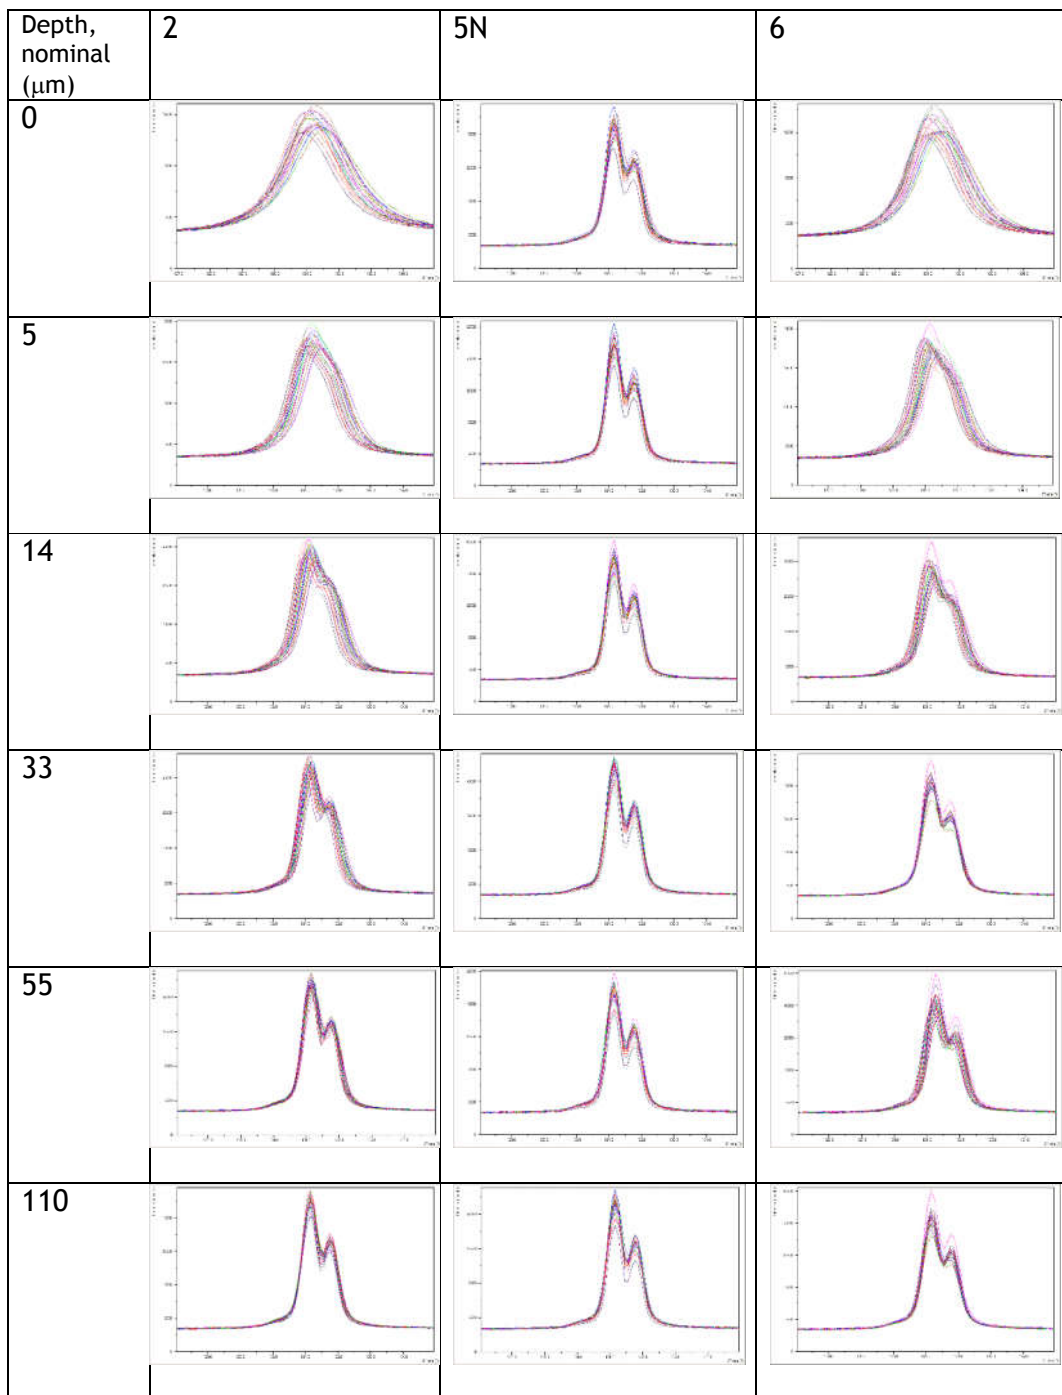
Figure 24. Diffraction peaks used for measurements of residual stresses on planes parallel to the rolling surface of bricks as a function of sub-surface depth. Measurement performed on lattice plane $\{321\}$ using $\text{Cu } K\alpha$ radiation ($2\theta = 131^\circ$).

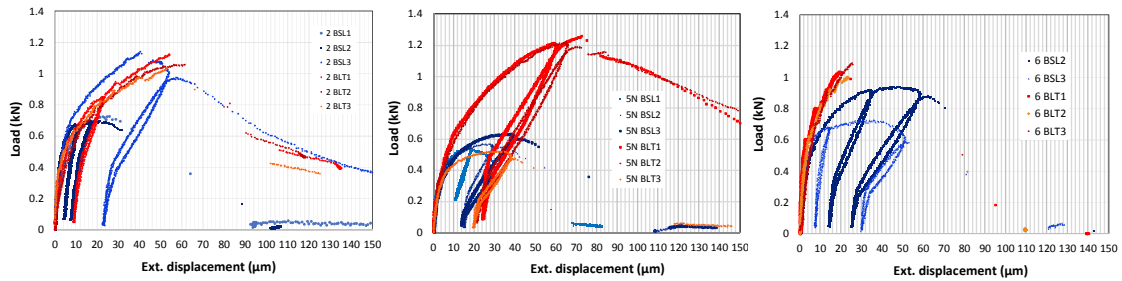
The load vs. mouth-opening displacement curves are mostly of the smooth crack growth type, although some curves show small jumps. In some cases, unloadings were made for checking the possibility of using the method based on loading-unloading cycles (the brittleness of the samples makes difficult to use the loading-unloading method). The results are presented in fig. 35.

Figure 35. Load vs. mouth opening displacement, chevron-notch specimens, room temperature.

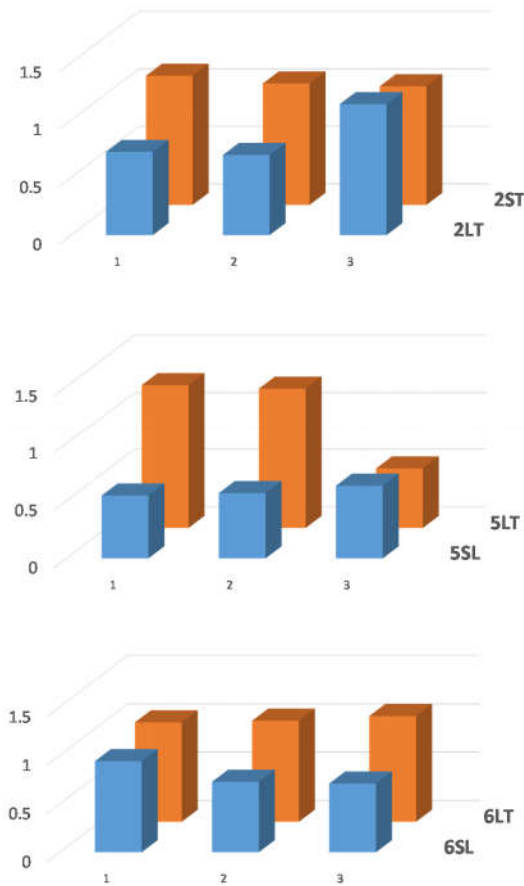
The coefficient Y_M^* is, for the geometry used, 29.90. The maximum loads are displayed in fig. 36.

Figure 36. Maximum load (kN) in chevron-notch tests, room temperature.

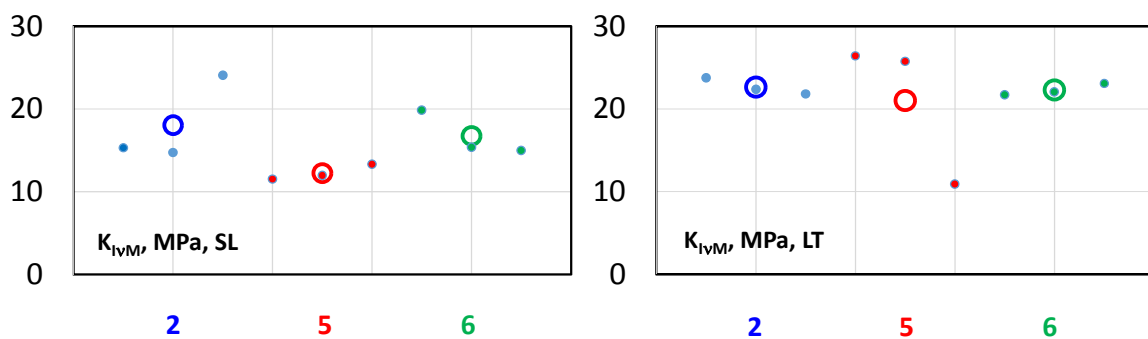
Consequently, they can be considered valid K_{IVM} plane-strain fracture toughness values. They are given in Table 7 and fig. 37.

Figure 37. Plane-strain fracture toughness (crack propagation).
