Target status at J-PARC

Hiroshi Takada
Neutron Source Section
Materials and Life Science Division
J-PARC Center

JSNS 1MW spallation neutron source

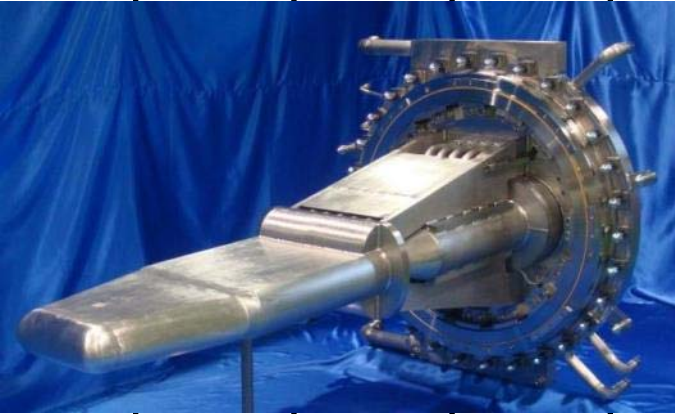
#5					#5 target (bubbler + double-walled front) 330~513kW, 670 MWh Failure on outer water shroud

#6										
#7							#7 target Max. 505kW, 170 MWh Failure on inner water shroud

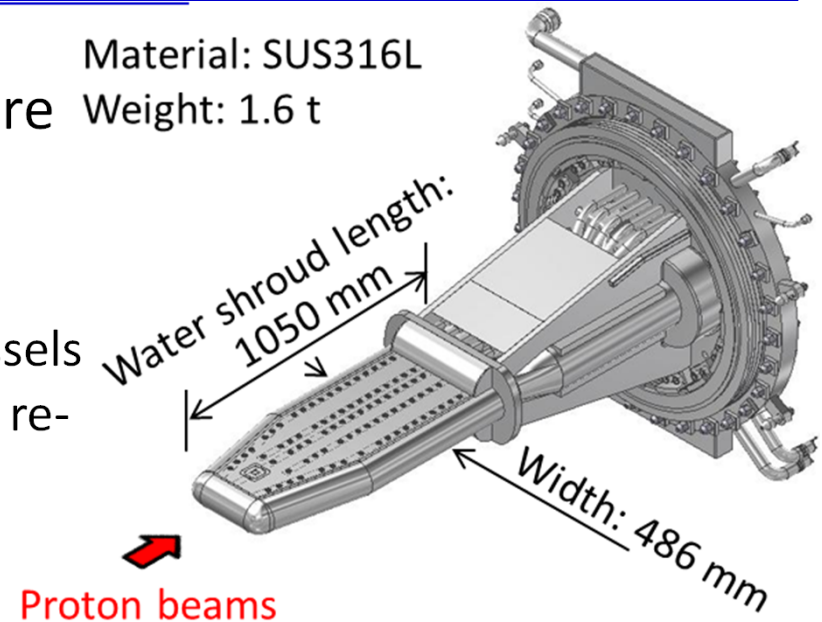
- Improvement of target vessel structure to have enough robustness for high power operation (>500 kW)
 - ✓ Failure in water shroud of the target vessels at 500 kW operations was the trigger to re-design the target vessel.

Material: SUS316L

Weight: 1.6 t

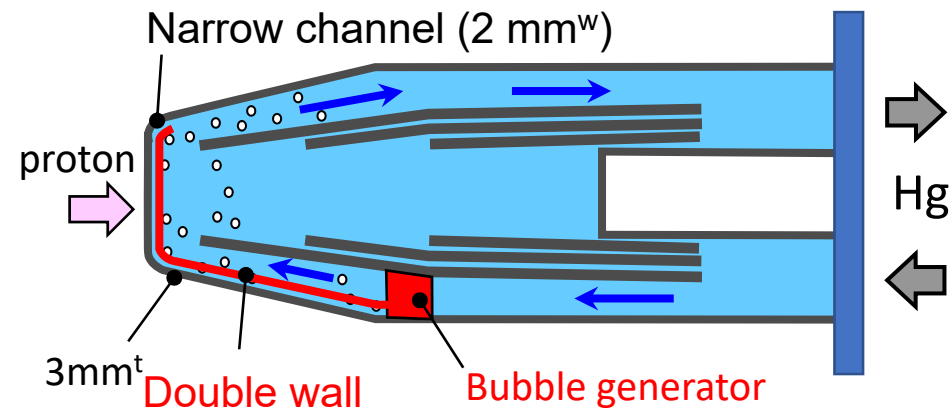
- Mitigation of pitting damage on the target front
 - ✓ Current approach: faster mercury flow in narrow channel & gas-micro bubbles injection

Note: Higher pressure wave is induced in mercury than in the SNS target due to lower repetition rate (25Hz)

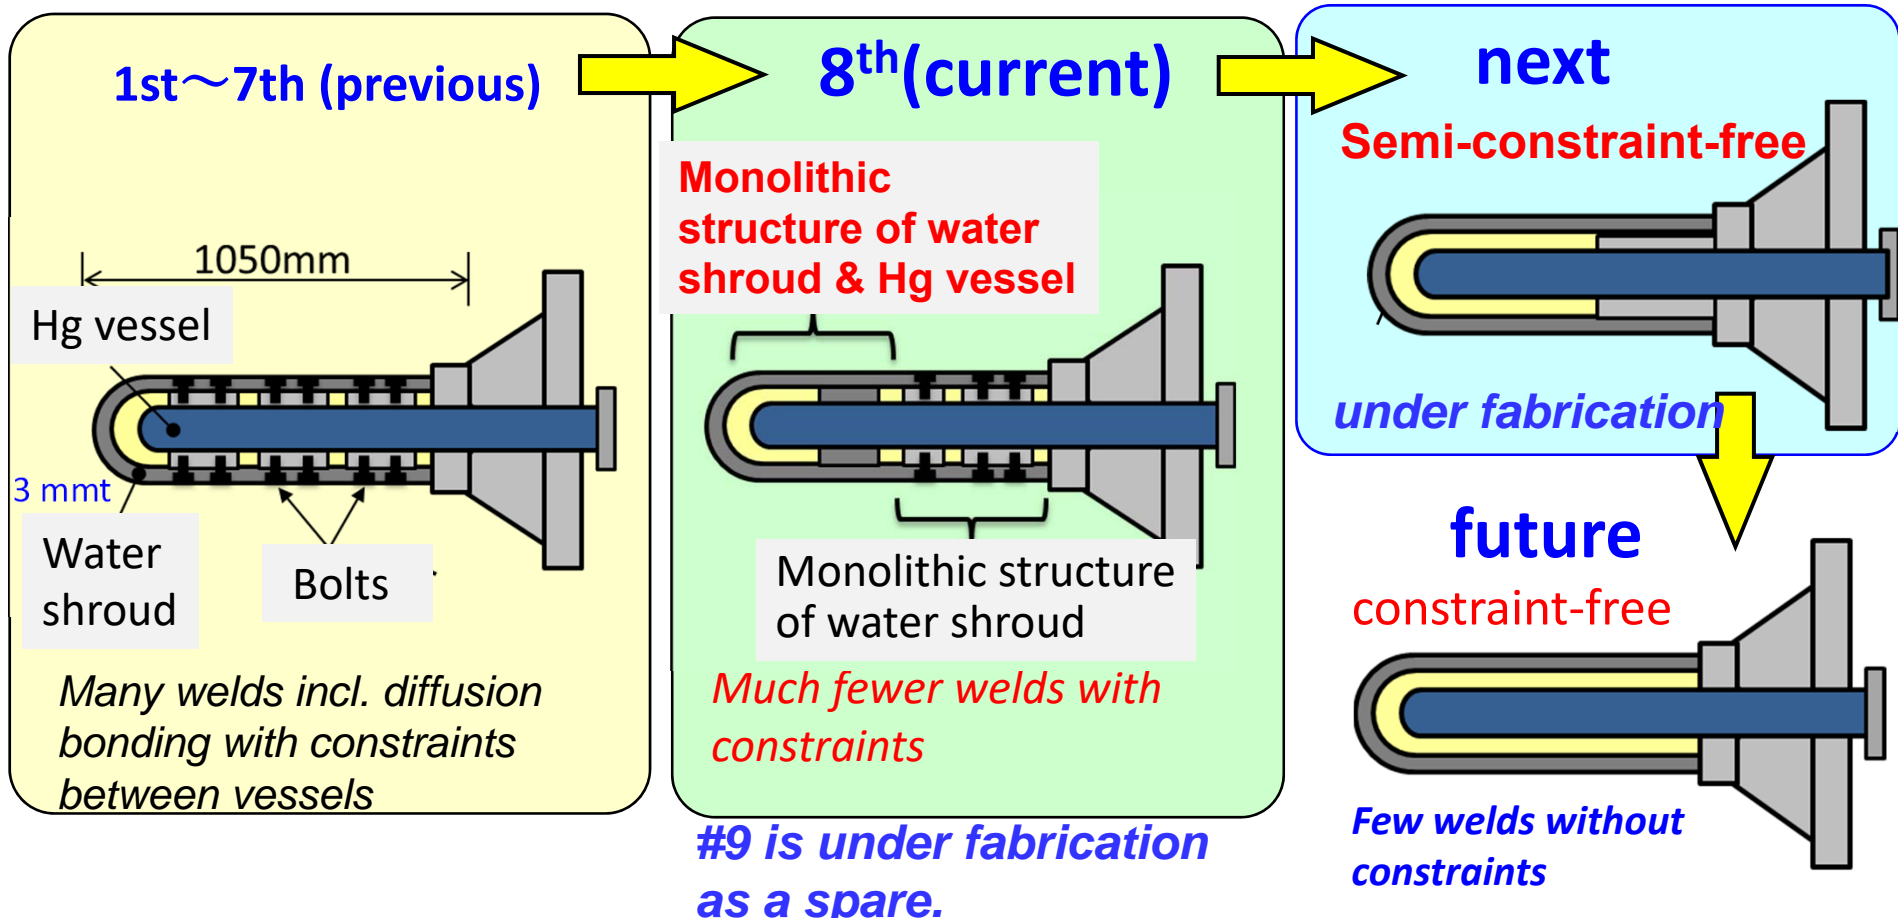
- Defect in joining and/or welding is initiation of crack propagation
- Eliminating risk to generate initial defect is important.
 - Reduction of joint lines by adopting monolithic structure
 - ◆ Further change to constrain-free between shroud and Hg vessel.
 - Improvement of inspection method by combination of RT, UT, and PT.

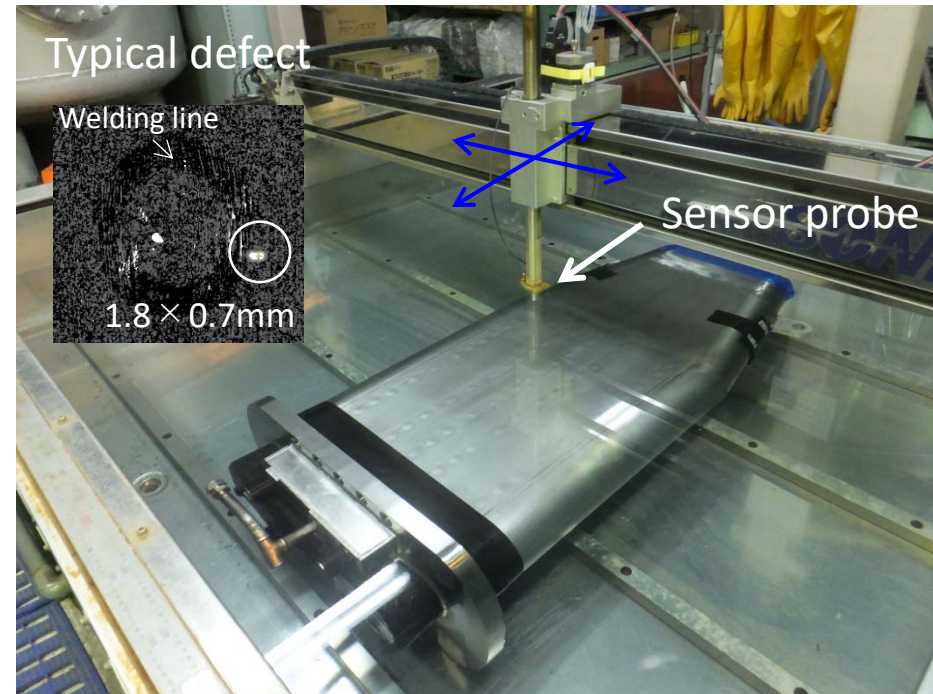
Welding inspection on water shroud (3 mm^t)

<u>FlexScan (Insight K.K.)</u>		} Minimum detectable size of defect: 0.2 mm
Immersion ultrasonic system		
Scan pitch	: 0.1 × 0.1 mm	
Sensor probe		
Frequency	: 50 MHz	
Diameter	: 6 mm	
Focal length	: 40 mm

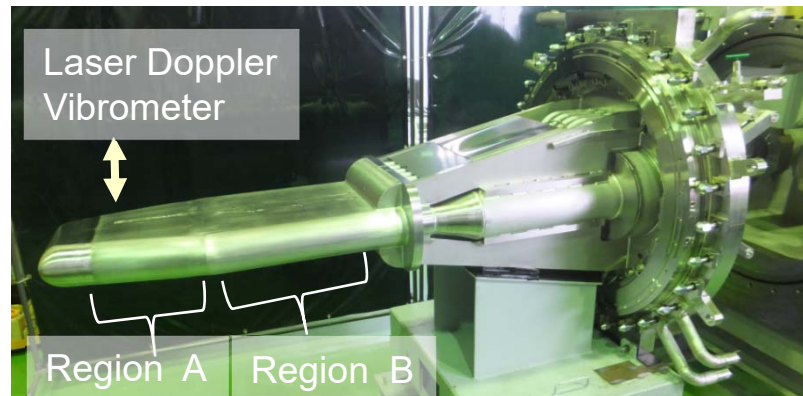
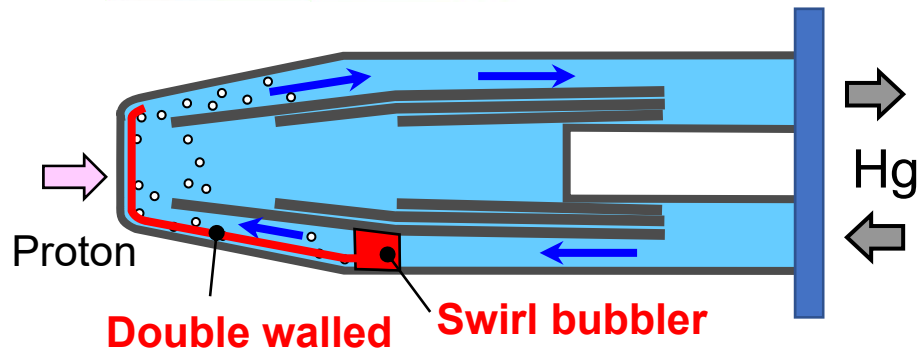
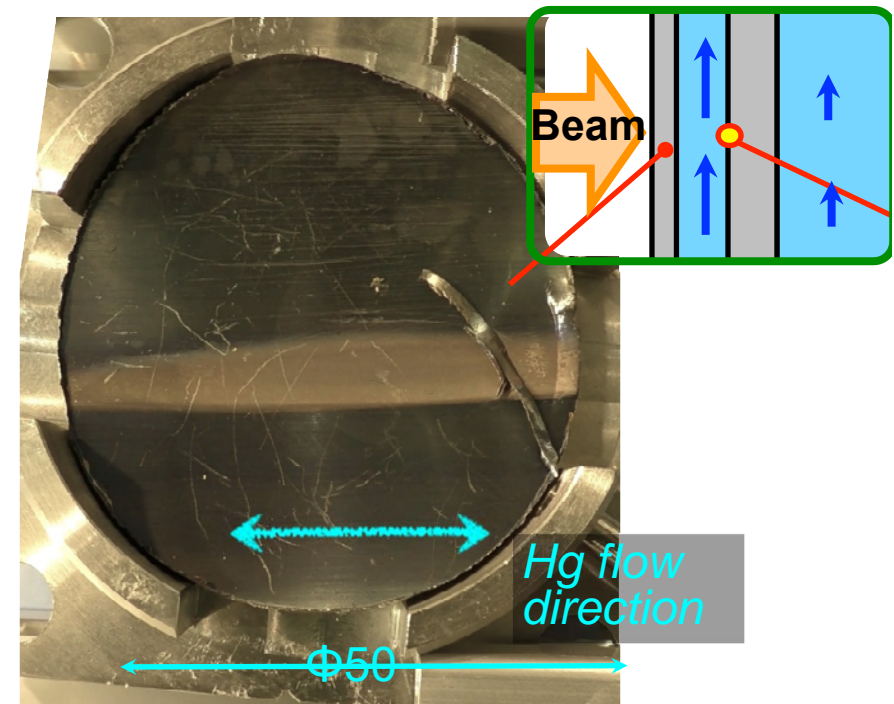
- Operational beam power was 300 kW from Oct. 24 to Dec, ramped up to 400 kW from January to March and is planned at 500 kW from April to June.
- It was demonstrated that the velocity amplitude at the proton beam injection was reduced to ca. 1/3 with gas micro-bubbles injection.
- Investigating damage on the target front after operation at 500 kW is important to estimate lifetime because there was a pit with depth of about 25 μm on the 5-th target vessel after 670 MWh (av. 406 kW) in 2015.

Outer mercury vessel
