EUROPEAN
SPALLATION
SOURCE

ESS LLRF RAMI Analysis

ESS LLRF Critical Design Review, Lund

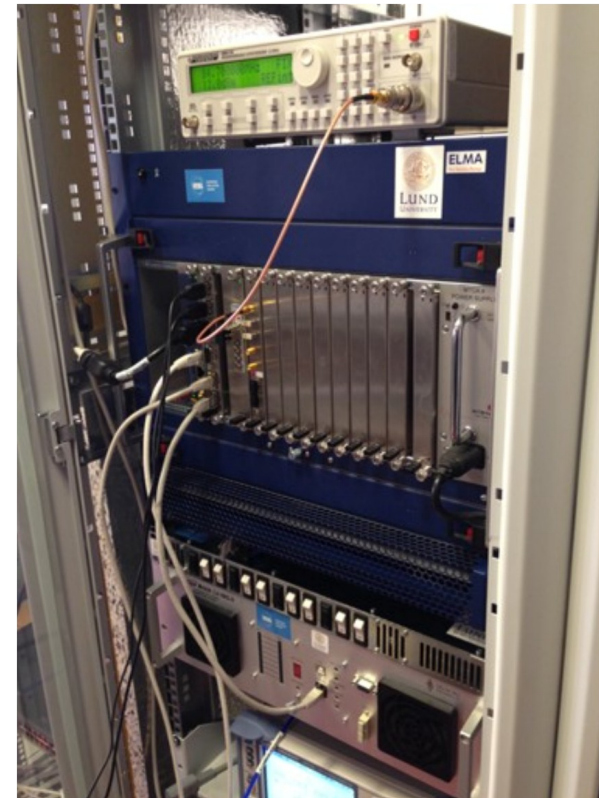
Layout of the equipment

LLRF Systems will be implemented in the MTCA.4 form factor standards, where single LLRF unit supporting one RF feedback loop (amplifiers, cavity, etc.), will be implemented using one MTCA.4 crate.
