EUROPEAN  
SPALLATION  
SOURCE

# TBL Personnel Safety System

Instrument Safety Readiness Review for TBL

2025-10-10

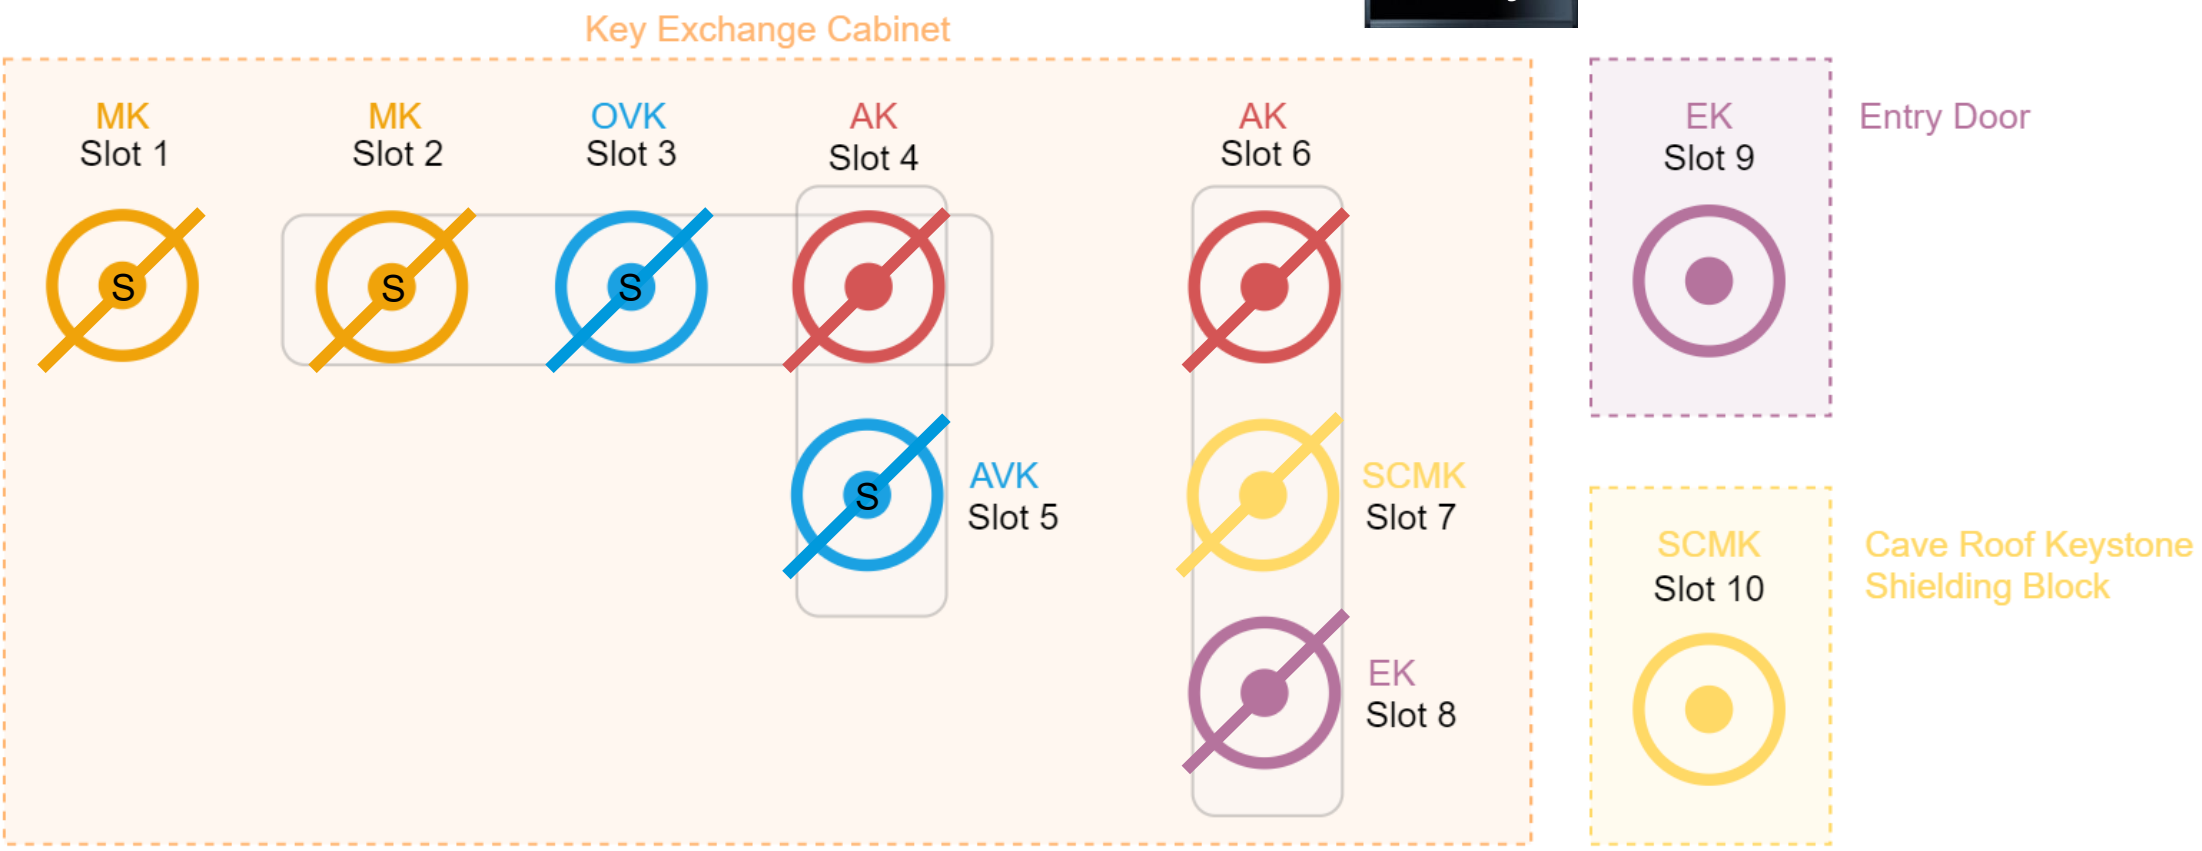
# Enabling the Instrument Shutter to Open

Mode of Operation: Position
