# Implementation of icBLM algorithms

dr inż. Grzegorz Jabłoński, dr inż. Wojciech Jalmużna, dr inż. Rafał Kiełbik

13.02.2019

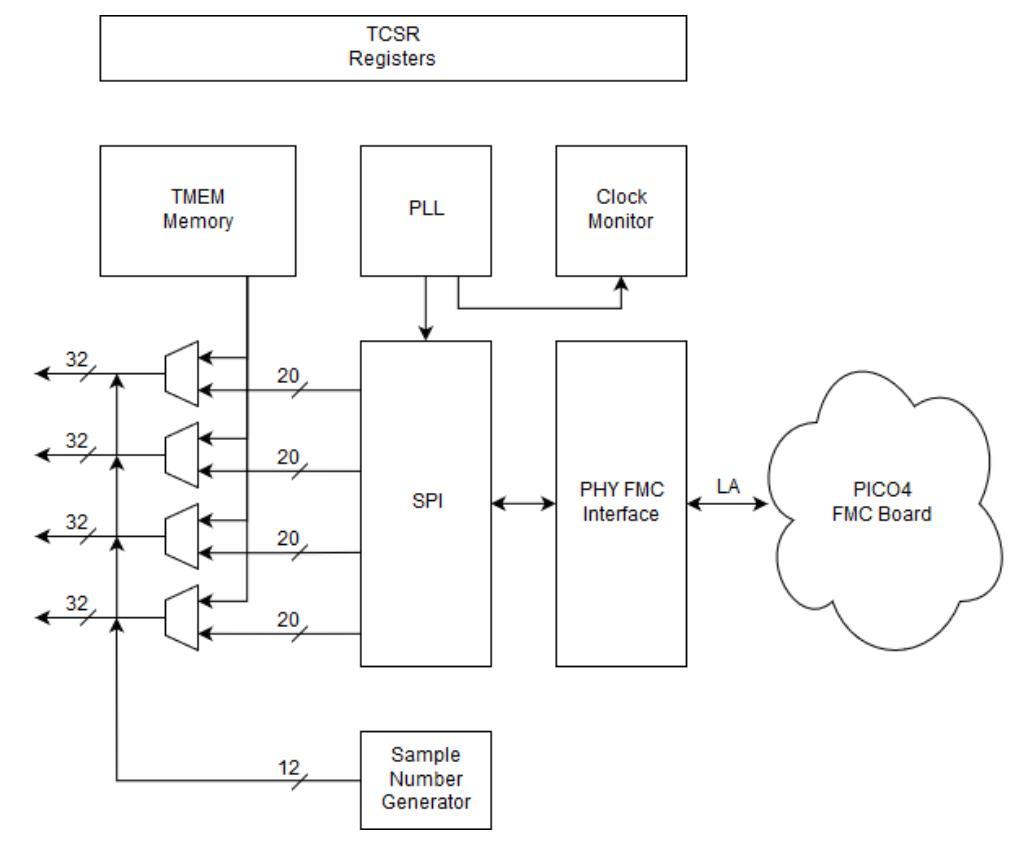
# icBLM BEE hardware platform PICO 4

- High Resolution multichannel current measurements up to ±10 mA (different versions available)
- 4 Current-Input Channels -Bipolar
- 1 MSPS simultaneous and independent sampling
- 20-bit Resolution
- Floating up to 300 V

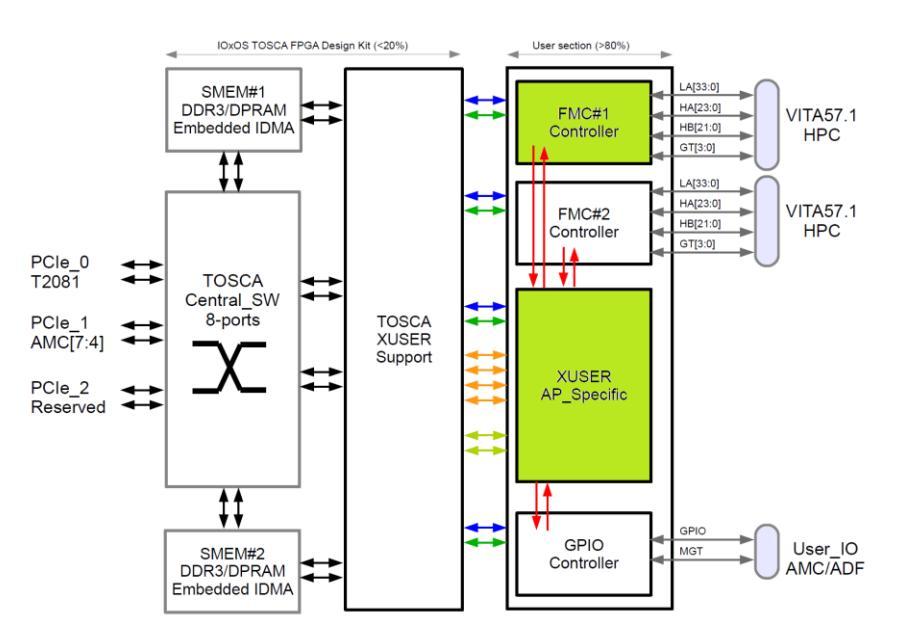
# Hardware-software interface

- Using circular buffers in DRAM to stream data to CPU
- Using TSCR interface for control and algorithm parameters
- Both DDR bank (currently) via SMEMDIR interface @275MHz, 1900 MB/s bandwidth
- Not needing such large Block RAMs overlapping initial part of DDR

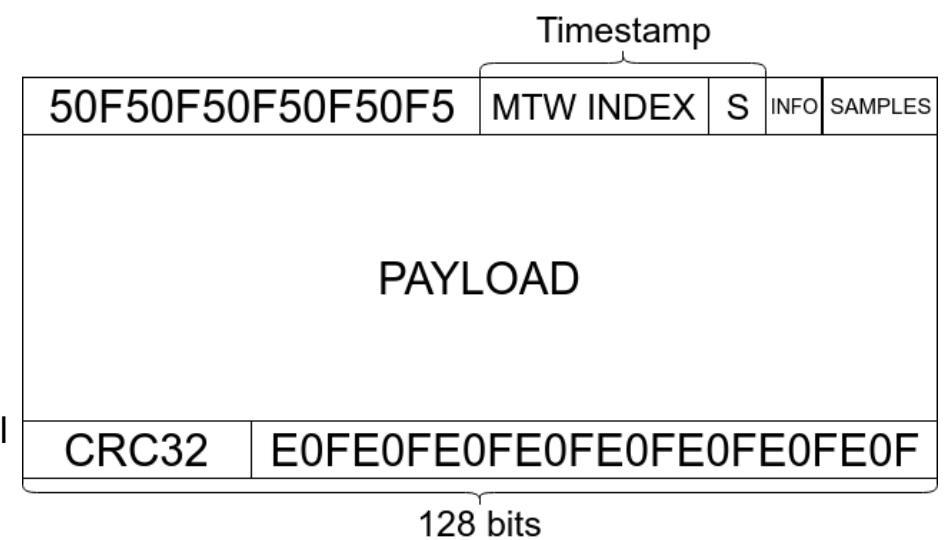
### Frame layout

- Start-of-frame pattern
- Timestamp
  - Serial number of the 1-microsecond window
  - Sample index within the window.
- 1 generic information byte
- 16-bit number of samples in the frame
- Payload packed back-to-back on the bit level without any additional padding
- 32-bit CRC of all the previous words in the frame followed by the End-of-frame pattern.

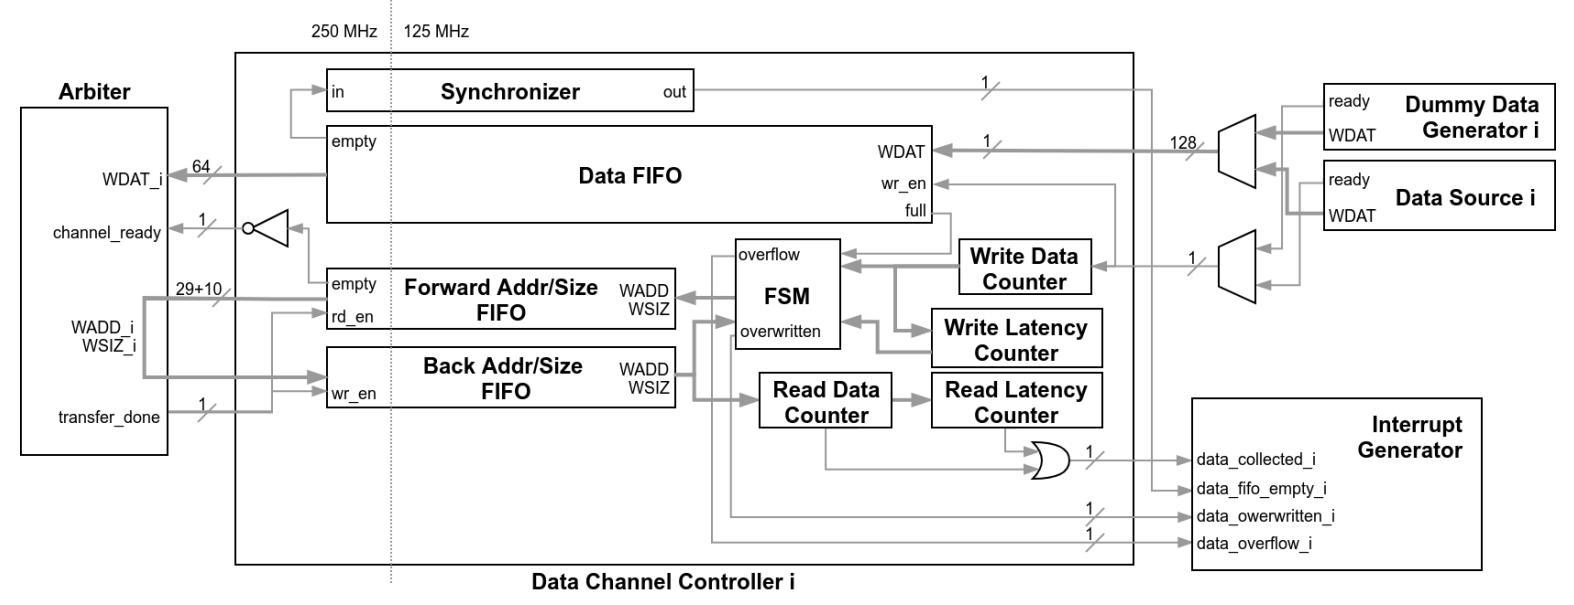
# **Circular Buffer Implementation**

- Read pointer, write pointer for each channel
- Overflow not able to write data to DDR at given input data rate
- Overwrite data readout by DMA too slow

- Read pointer at the moment of overwrite recorded

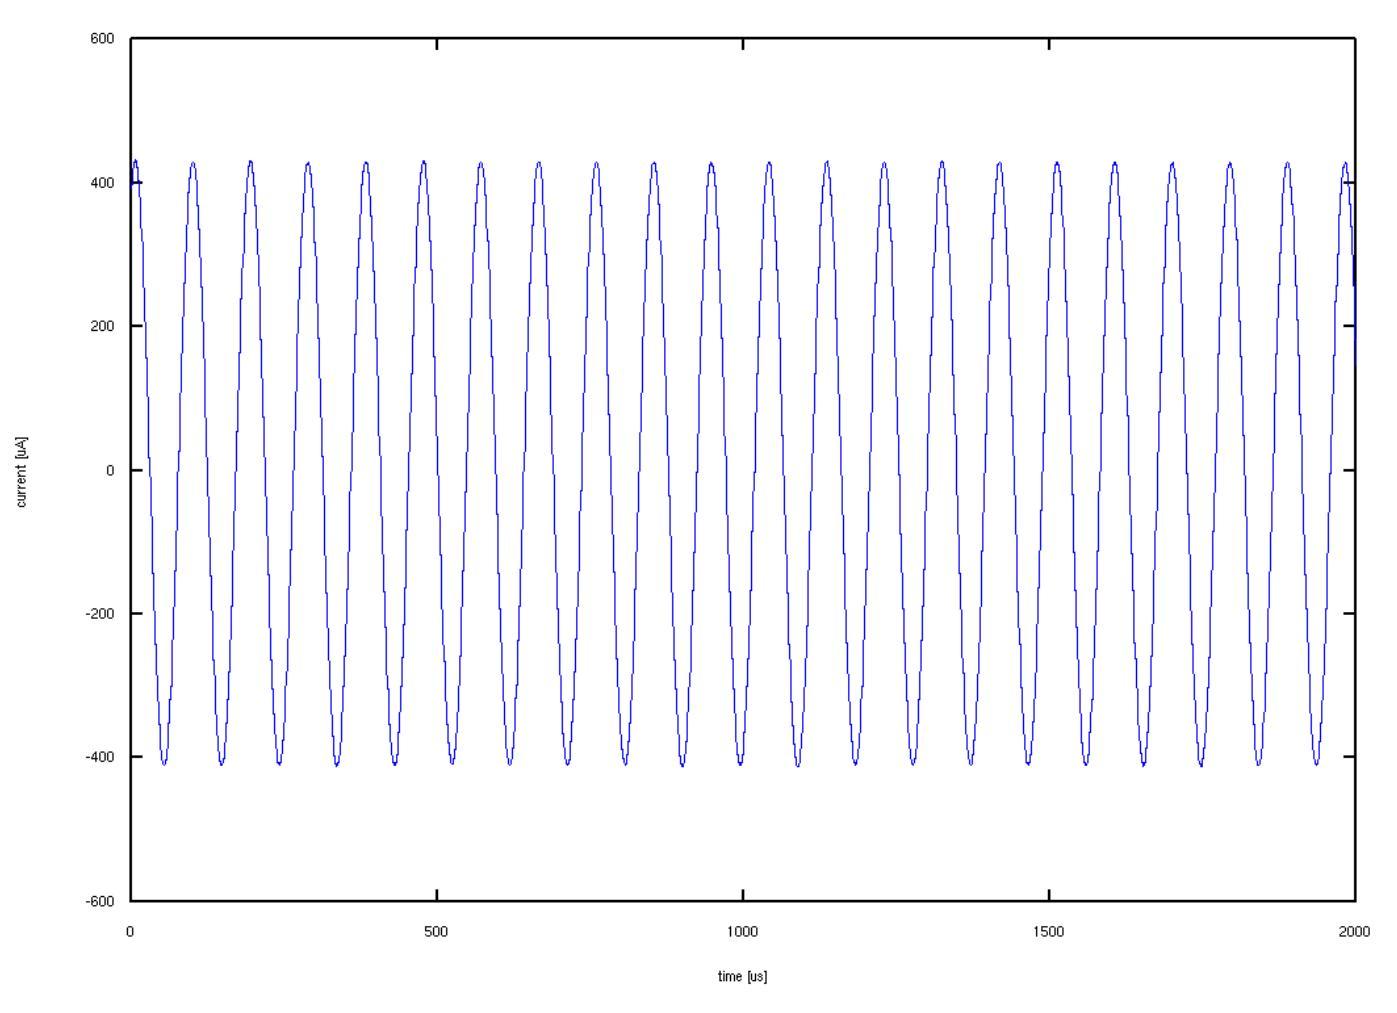
### 10 kHz Raw Data

Raw data acquisition for 4 ADC channels
